EXPERIMENTAL TESTING OF A 1MW sCO₂ TURBOCOMPRESSOR

Logan Rapp
Sandia National Laboratories
Albuquerque, NM, USA

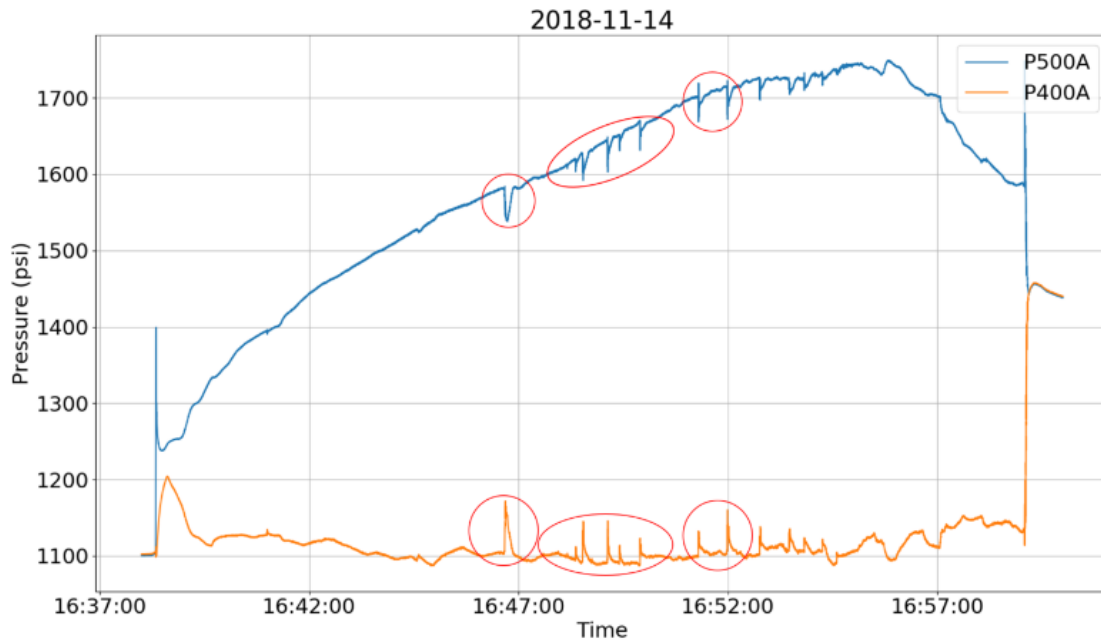
In Tests #1-3, both the thrust bearing and the radial bearings experienced rubs/failures. Figure 5 shows the compressor inlet and discharge pressures plotted versus time with spikes in pressure circled in red. These spikes correspond to thrust bearing touchdown rubs, where the rub caused the rotor to slow down momentarily.

Figure 5: Compressor inlet and discharge pressure showing thrust bearing rubs

By adjusting the back pressure on the turbine using the turbine control valve (TCV) as well as adjusting the setting for Valve F in the secondary flows, the thrust balance on the rotor can be equilibrated. Valve F is part of the secondary flow control system and regulates the venting pressure on the aft side of the thrust disk of the rotor. This serves as a balance piston in the design and permits real-time adjustment of rotor thrust within a certain range. The testing on 2018-11-14 was performed with Valve F completely closed, so for the next test, both TCV and Valve F were opened using prescribed settings from the updated secondary flow analysis. Additionally, a proximity probe was added to monitor the axial movement of the shaft during the test. This allowed the proximity to be monitored and valve adjustments to be made in real time should the axial position start to change during a test. The plot of compressor inlet and discharge pressure for Test #5 is shown in Figure 6 and the proximity data is shown in Figure 7.

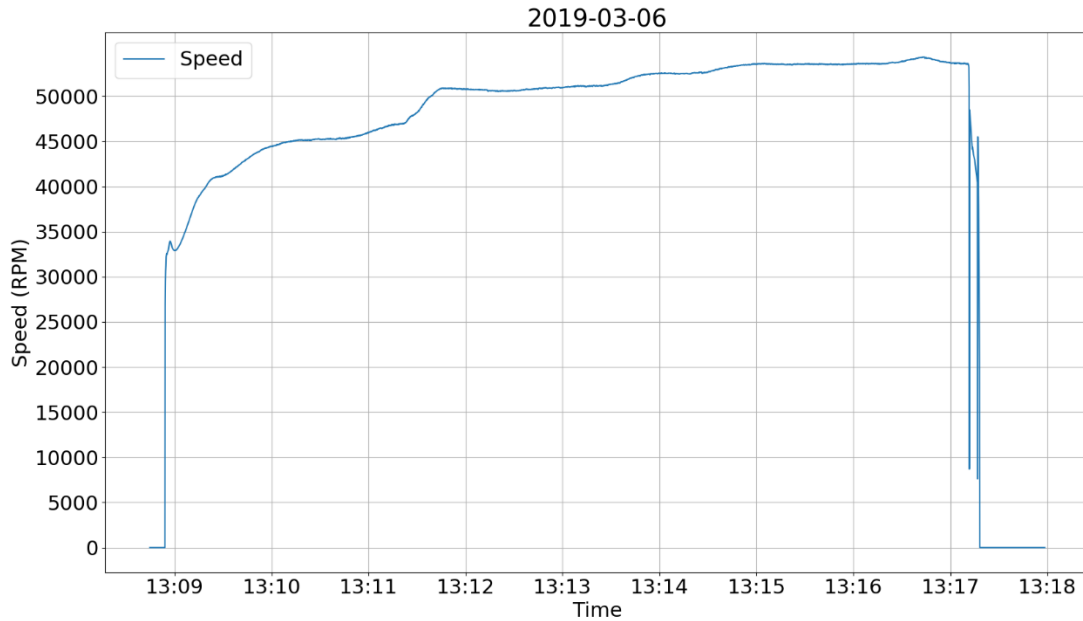
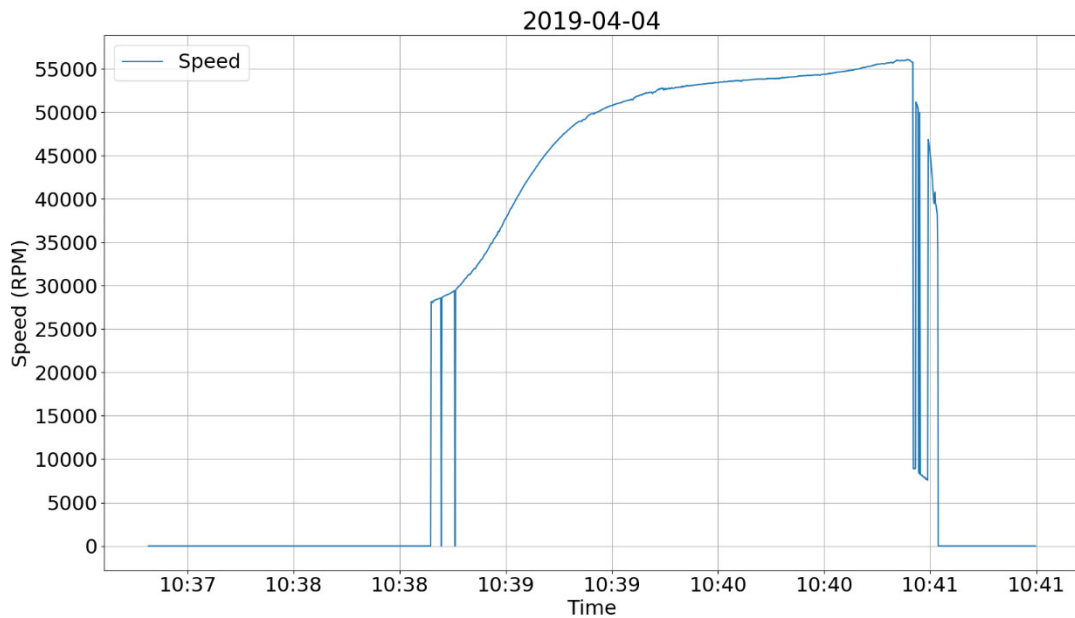
During Test #6, the proximity probe malfunctioned at the start of the test. This can be seen in the lack of data until approximately 10:38 in Figure 9. However, once the sensor began working the speed can be seen increasing until reaching approximately 56,000 rpm. Comparing Figure 8 and Figure 9, the plots show the bearing failed at approximately 55,000 rpm in both tests. Normally, this might indicate there is a critical speed near 55,000 rpm that is causing instability of the shaft and failure of the bearing. However, the physical evidence of the bearing failure only shows yielded foils at a specific clocking of the bearing; that is, the foils are not yielded uniformly around the entire circumference of the bearing. If the failure was due to a critical speed instability of the shaft, the expected result would be yielded foils around the entire circumference of the bearing instead of only at a particular clocking. It should be noted that rotordynamic analysis indicates that there are no mode crossings in the operating range above 35,000 rpm. This points to the failure being caused by a radial side load, which may be caused by non-uniform turbine inlet temperatures and/or flowrates.

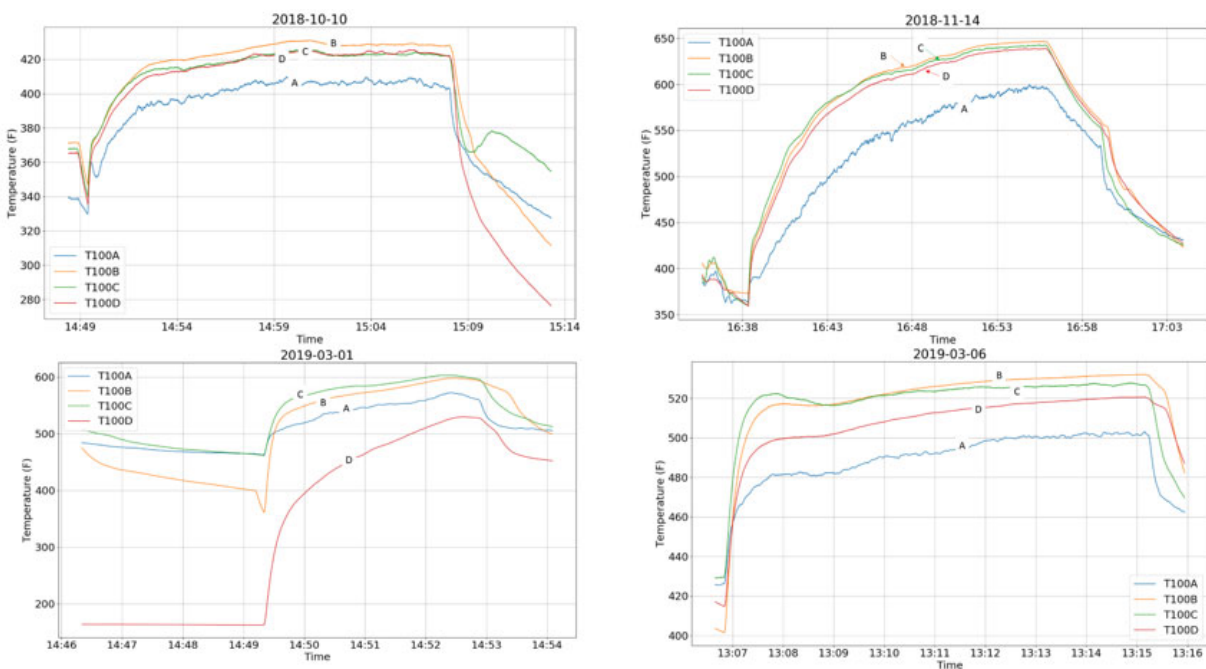
Figure 11: Turbine inlet temperature plots for Tests #2-#5

As can be seen in the plots of TIT, leg "A" is often significantly cooler than the rest, and in later tests leg "D" is also cool. It is believed that Leg "D" in Test #4 had a cold, dense slug that did not have sufficient time to clear. The temperature can be seen to increase rapidly once the turbocompressor is started and the leg experiences a higher mass flow rate. The temperature profile of leg "A" shows a very jagged trace, which would indicate the instrument was not inserted into the flow adequately. When the lengths of the

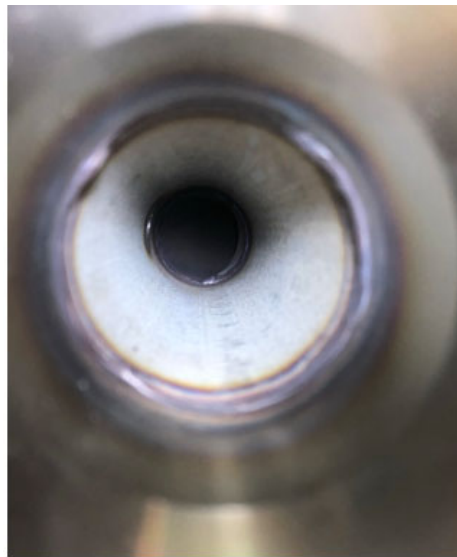
RTD's were measured, they were found to be within $\frac{1}{4}$ " inch of each other. However, the piping was not removed to physically see insertion depth of the instrument until after Test #6. When that was done, it was found that T100A was not inserted correctly. The original placement of T100A is shown in Figure 12.

Figure 12: Insertion depth of T100A RTD; original insertion (not visible)

As can be seen in Figure 12, the T100A was not inserted into the flow at all. Figure 13 shows that the temperature discrepancy of T100A is no longer a problem. New RTDs were ordered and the existing T100A-D were replaced with closer detail paid to the insertion depth. Figure 13 shows the original and new insertion depths of T100A-D.

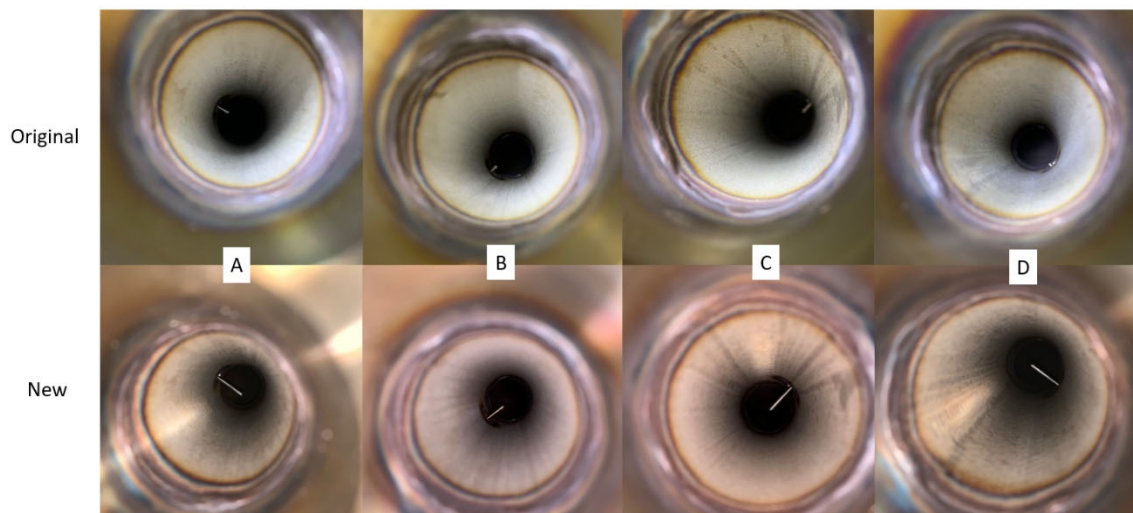
Figure 13: Original (top) and new (bottom) insertion depths of T100A-D

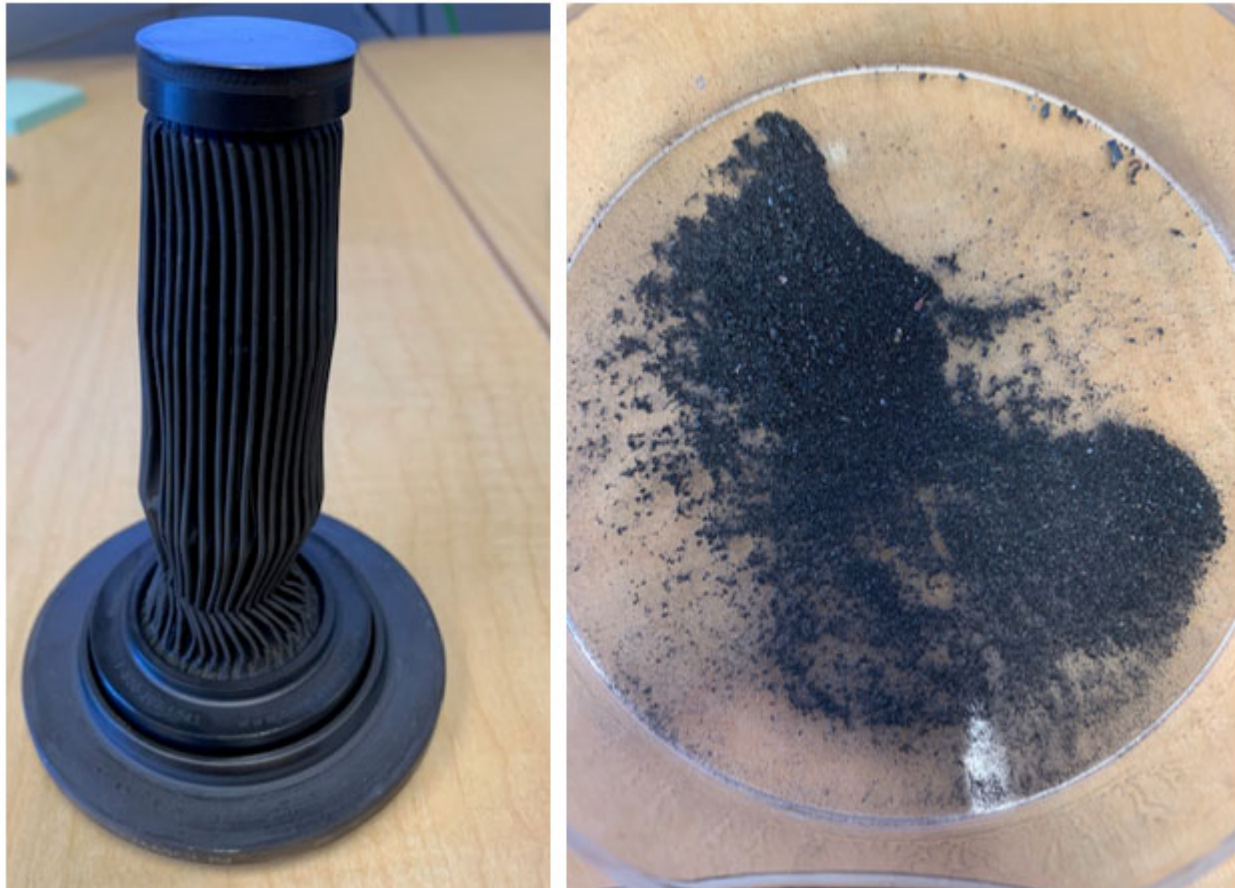
Figure 19 – Image of failed filter (left) and debris trapped in filter (right)

It is believed that the failure of the filter contributed to the observed compressor discharge pressure. The debris was identified as 2/3rds SS 316 and 1/3rd silicon and aluminum mixture. The source of this material is unknown and is being actively investigated. The filter has been replaced and the pressure drop across the filter will be monitored in future testing. Any additional accumulation of material will be collected and analyzed in order to assist in identifying the source of the material.
