Experimental Testing of a 1MW sCO₂ Turbocompressor

Logan Rapp
Sandia National Laboratories
sCO₂ Symposium
February 2022

6 Peregrine Turbine Technologies Turbocompressor

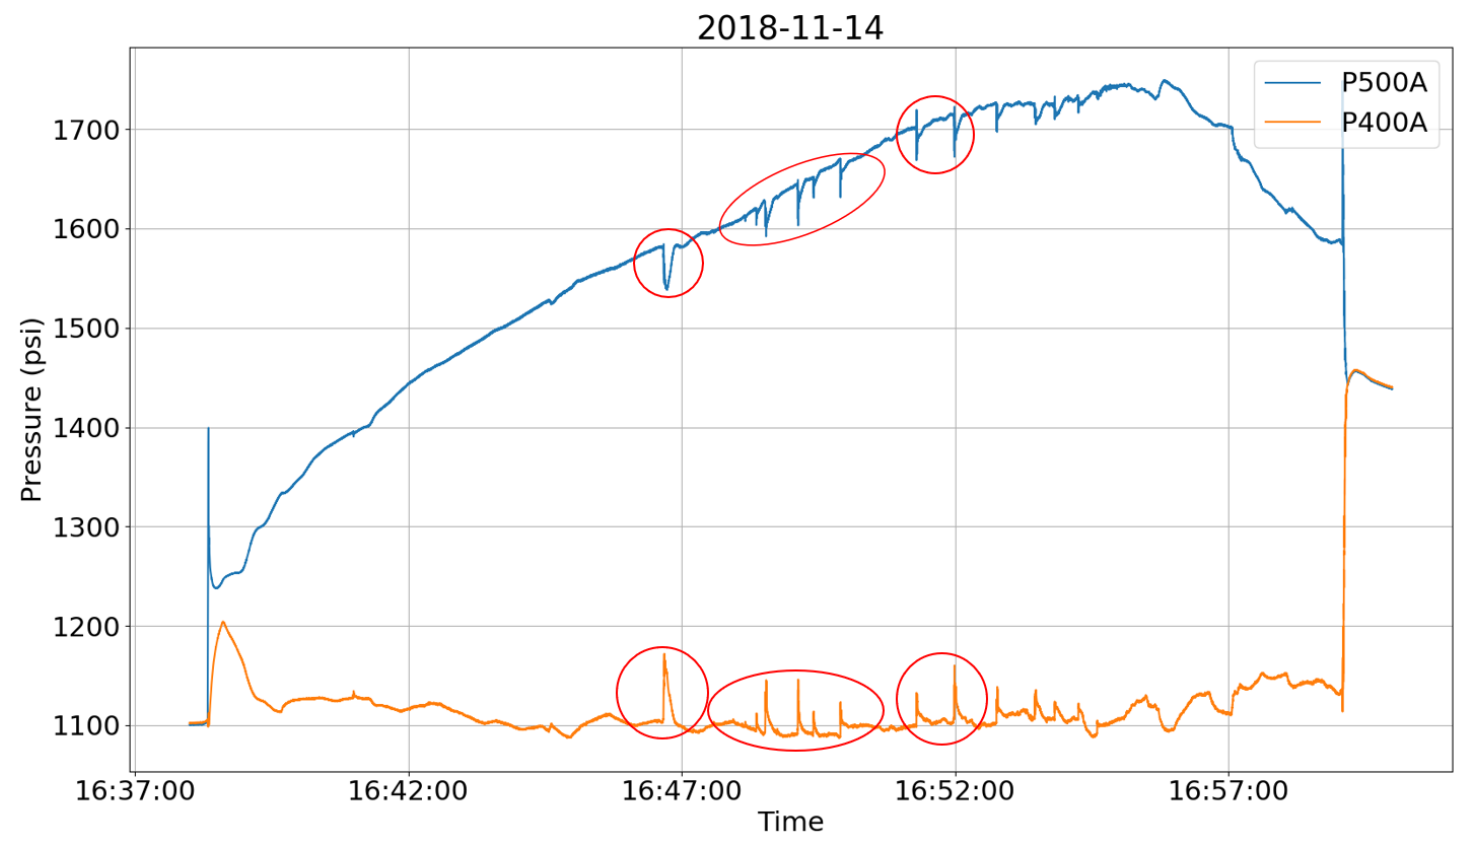
In Tests #1-3, both the thrust bearing and the radial bearings experienced rubs/failures

Spikes in pressure indicate thrust bearing rubs

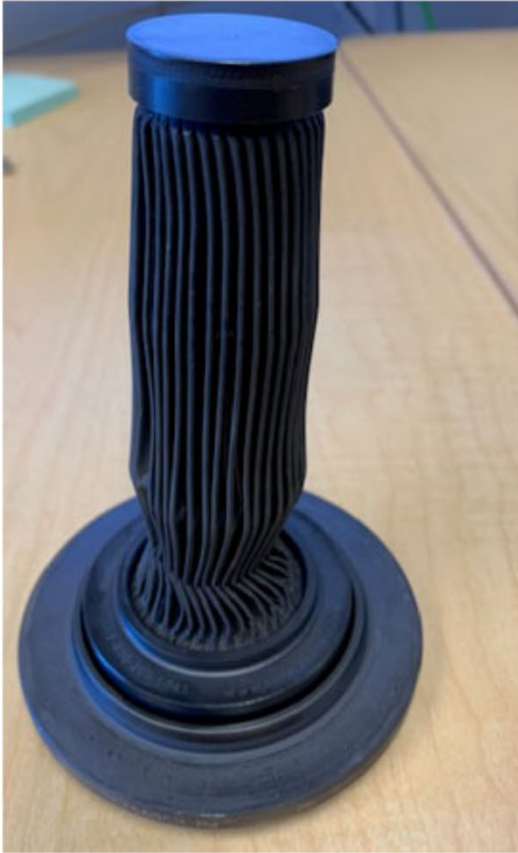
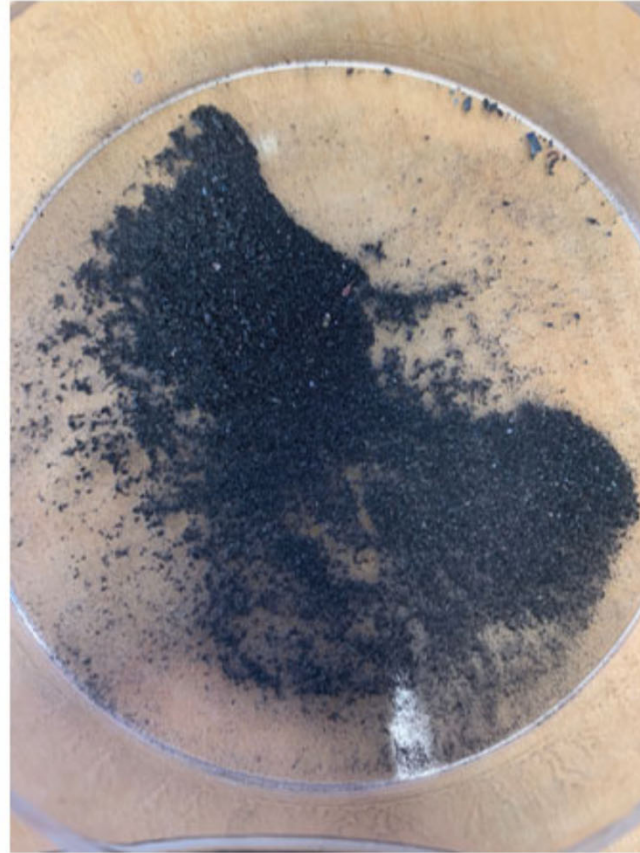
Filter Collapse

~2/3rds Common Stainless Steel, ~1/3rd Aluminum and Silicon, small percentages of Ca, Cu, Na, K, Ti.

- Indicates material is likely coming from stainless steel piping or recuperators
- Aluminum and silicon source unknown

- Accumulation of material has been significantly less than previously
- Perhaps bearing failures were causing accumulation?

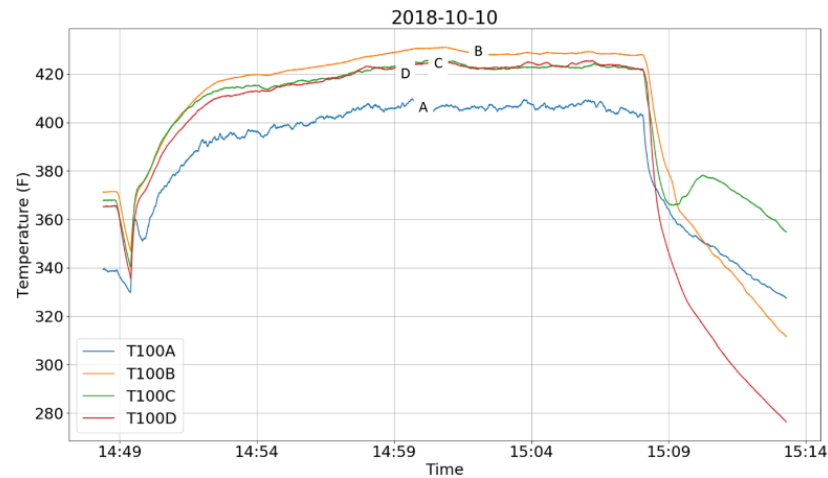
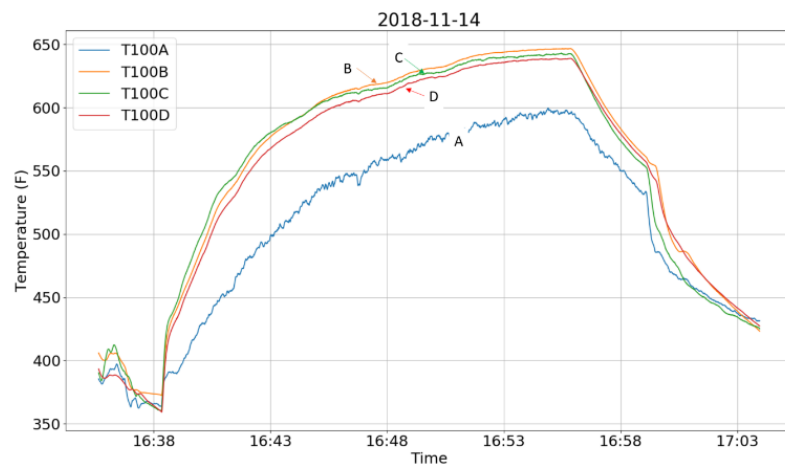
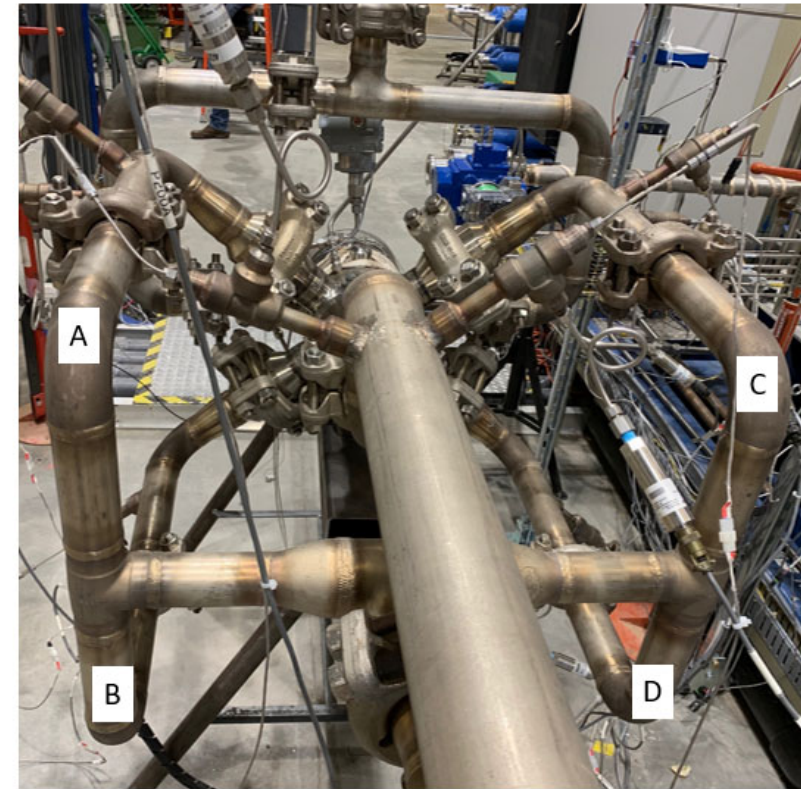
Turbine Inlets

Leg "A" was consistently lower temperature than the other 3

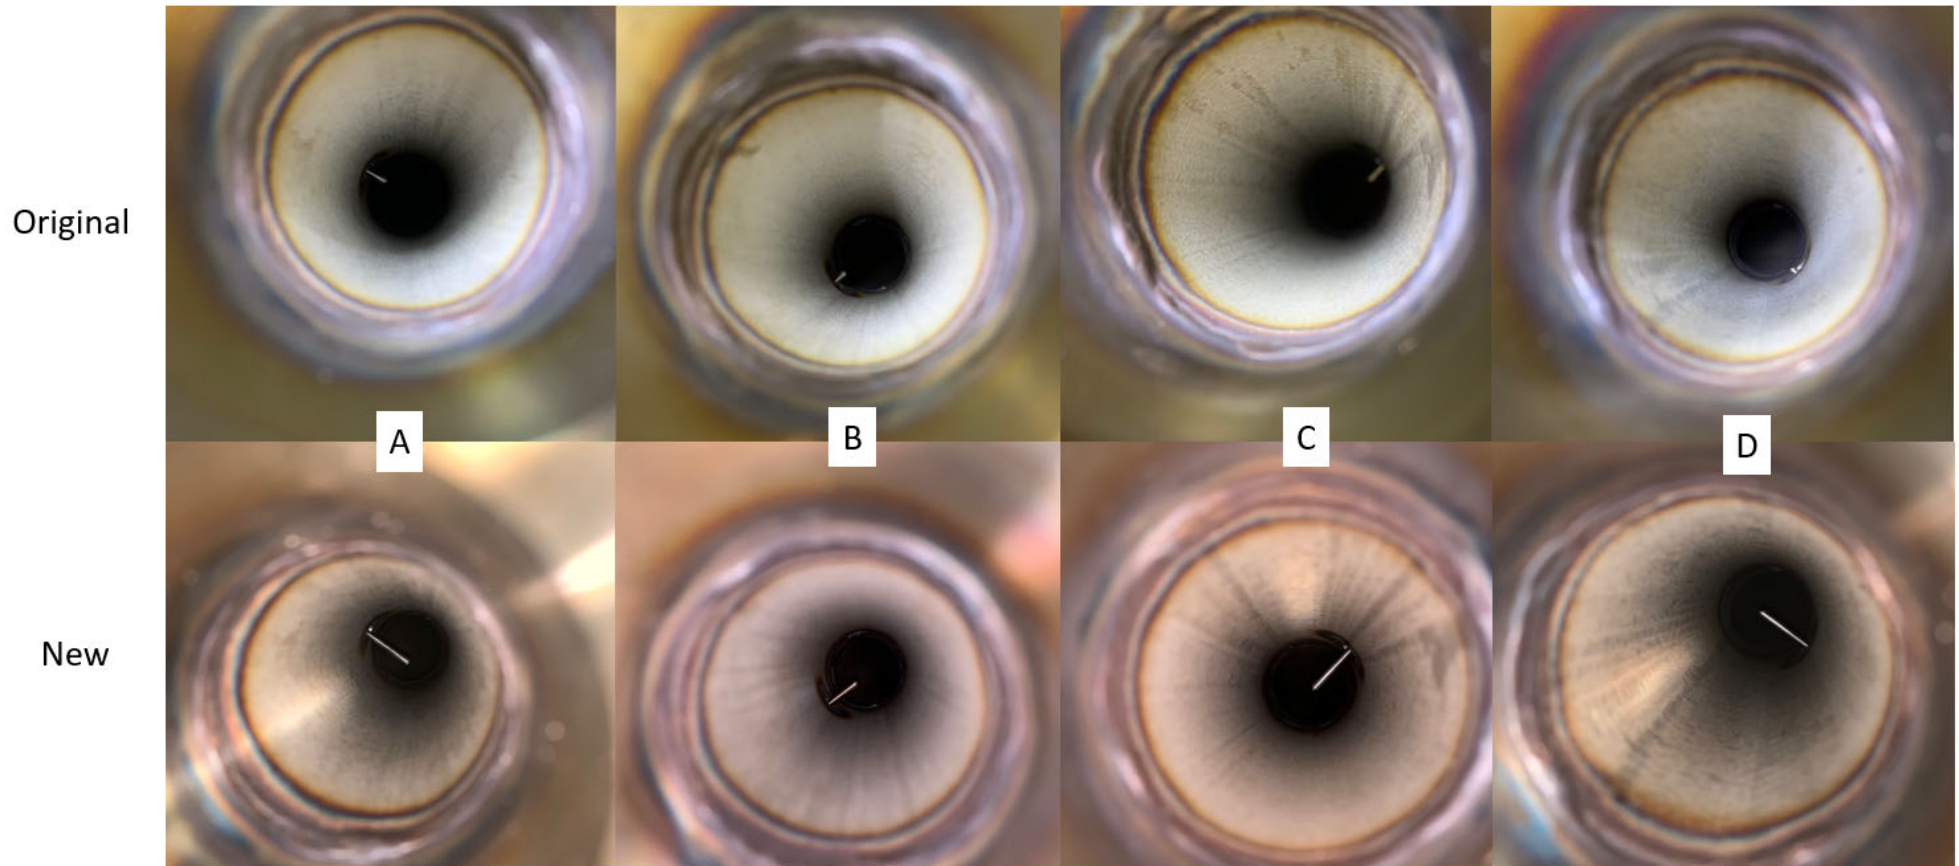
Original and New Turbine Inlet RTD insertions
