Investigation of Weldment Cracking During Fabrication of a 700°C Fired sCO₂ Heater

John Shingledecker, Ph.D., FASM
Senior Technical Executive
Electric Power Research Institute
Charlotte, NC USA

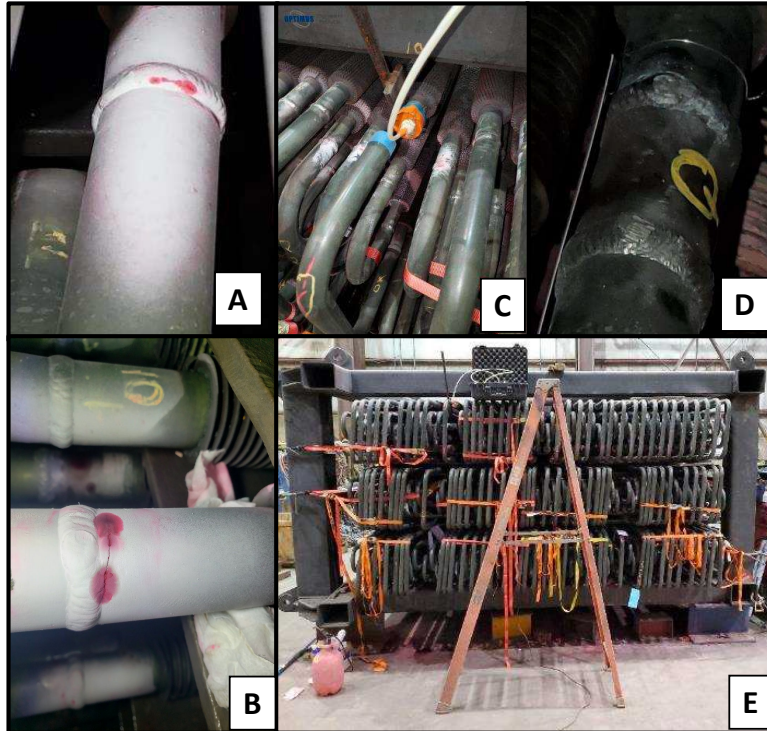
After PWHT, the hydrostatic a pressure test was conducted, and leaks were identified in 12 tube-to-tube butt welds (11 on the return side). Figure 5a and 5b shows the typical observed leaks. A repair plan for these welds (Figure 5c-e) involved moving the tube-sheet and flexing the existing tubes to gain access, removing the entire weld and cracked area on both sides of the welds, preparing a short 'pup piece' to bridge the gap, inner diameter cleaning, rewelding and inspection, local PWHT using heating pads, and post-PWHT inspection.

Figure 5. Cracking observed after PWHT (a and b) in 740H tube butt welds and repair procedure including removal (c), pup-piece replacement (d), and moving tubes for welder access (e)

Subsequent pressure test and visual inspection revealed four additional through-wall leaks (16 total). It was then decided to perform PAUT on 100% of the tube-to-tube butt welds. Additional welds were removed based on the PAUT findings, and the same repair procedure was applied. An additional hydrostatic test was successfully conducted after all repairs were completed, and the assembly was prepared for shipment to site.

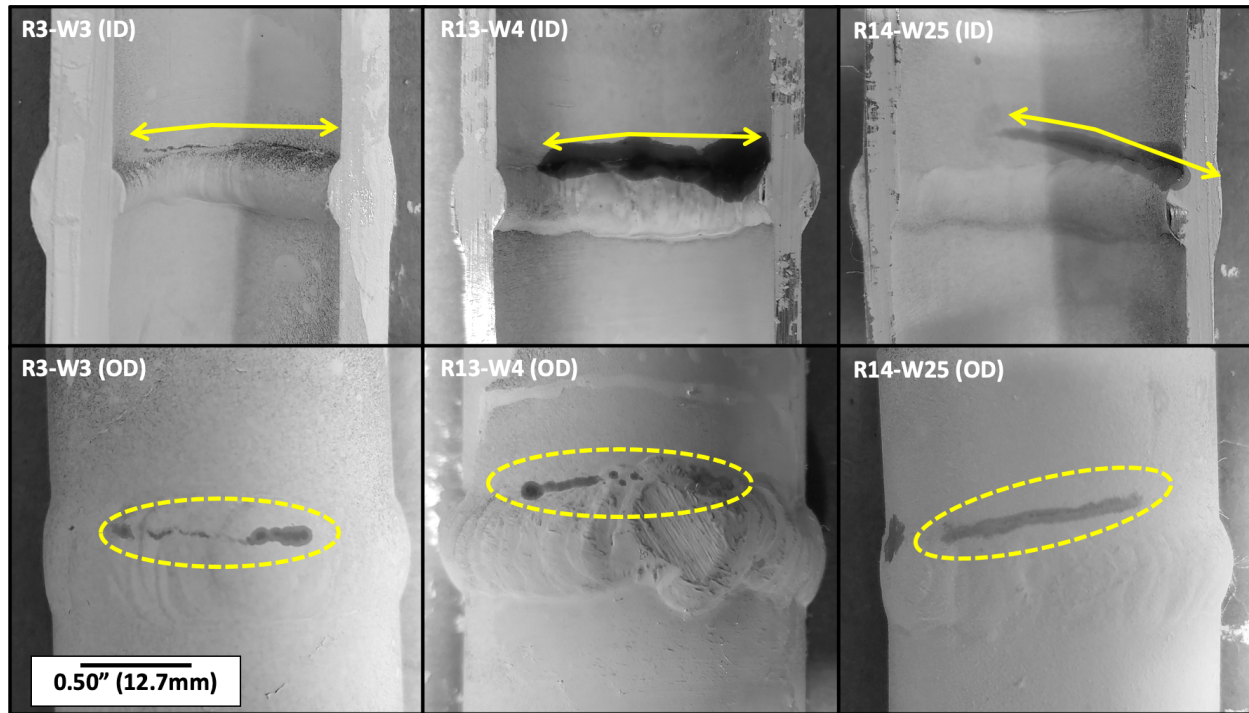
Macroscopic evaluation of through wall cracks showed variable crack locations upon visual inspection of the OD surface with cracks occurring in the weld metal, heat affected zone (HAZ) and/or fusion line (FL), and in the base metal (BM) as shown in Figure 5 (field observations) and Figure 7 (lab examination). Laboratory investigation of failed tubes confirmed variable OD crack location. However, cracking was consistently identified at the weld root FL area extending approximately 1/3 around the circumference of the tube (see Figure 7). Similar analysis on three cracked tubes identified by PAUT which did not leak showed cracking at this same ID location but without an OD-connected indication.

Figure 7. Die penetrate inspection showing ID fusion line cracking (top) and variable OD cracking (bottom) including weld metal (left), fusion line (center), and base metal (right). In all cases, cracks extended approximately 1/3 of circumference

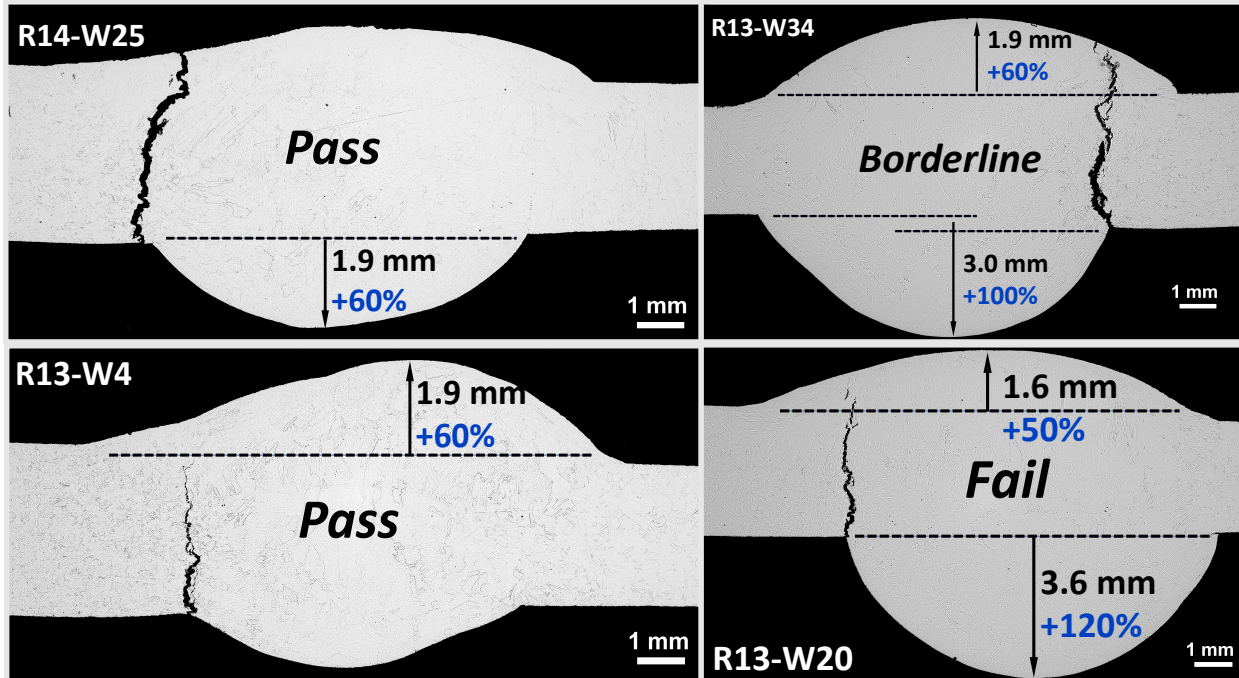
The review of over 30 metallurgical mounts suggested that lack-of-fusion, centerline cracking, or porosity could not be solely responsible for the observed pattern of damage. Additionally, cracking was identified for multiple welders, so a specific technique or adherence to the welding procedure did not appear to be directly related to the cracking propensity. However, as shown in Figure 8, the shape of the weld was highly variable between welds and (as shown in later figures) around the weld circumference, and there was significant to excessive re-enforcement both on the ID and OD of the tubes evaluated. Some of this variability can be attributed to the accessibility of the weld and is addressed later in this report. In most cases alignment appeared to be acceptable, but there were some examples of misalignment.

Figure 8. Examples of variable re-enforcement and weld profiles observed. Pass/fail criteria based on guidance provided by ASME B&PV Code Section I PW-35.1 [5]

- Excessive reinforcement and other local, geometric changes that might otherwise be regarded as stress concentrations should be avoided or removed. Automated welding processes may help reduced the propensity for such features.
- Volumetric inspection must be performed after PWHT, and in addition to staged or limited inspection during or after welding, to ensure that the component or system is free of defects consistent with SRxC.

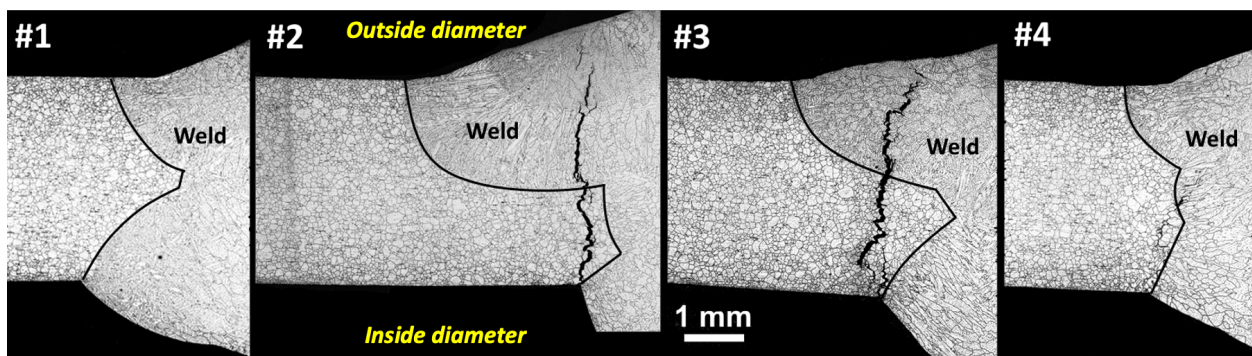
Inspection of the tubes and metallographic mounts taken from around the circumference of the tubes (see Figure 9 for an example on one tube) shows that cracking appears to initiate at the weld toe and propagate through the tube wall. Further evidence for crack initiation at the weld toe is shown in Figure 10 which is the center of a subsurface crack identified using PAUT. While the initiation is clearly found in the same region in all samples, crack propagation includes the HAZ, FL, weld metal, and in some cases the base metal (see Figure 7). In most cases, the eventual through-wall location appears to be dictated in-part by the variability in weld geometry as opposed to a specific microstructural constituent.

Figure 9. Cross-sectional etched micrographs for one side of a weldment (R14-W25) around the circumference showing crack initiation at the weld toe (#4), crack growth from weld toe through the HAZ and weld (#3 and #2), and no cracking (#1).

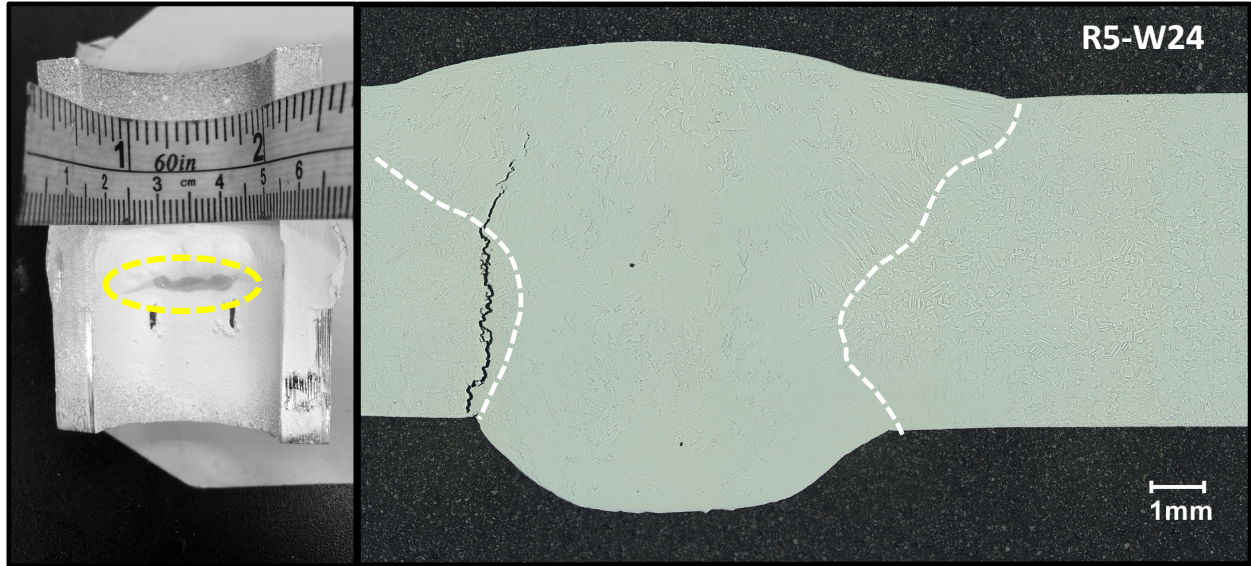
Figure 10. ID initiated cracking at weld toe (crack did not propagate through-wall)

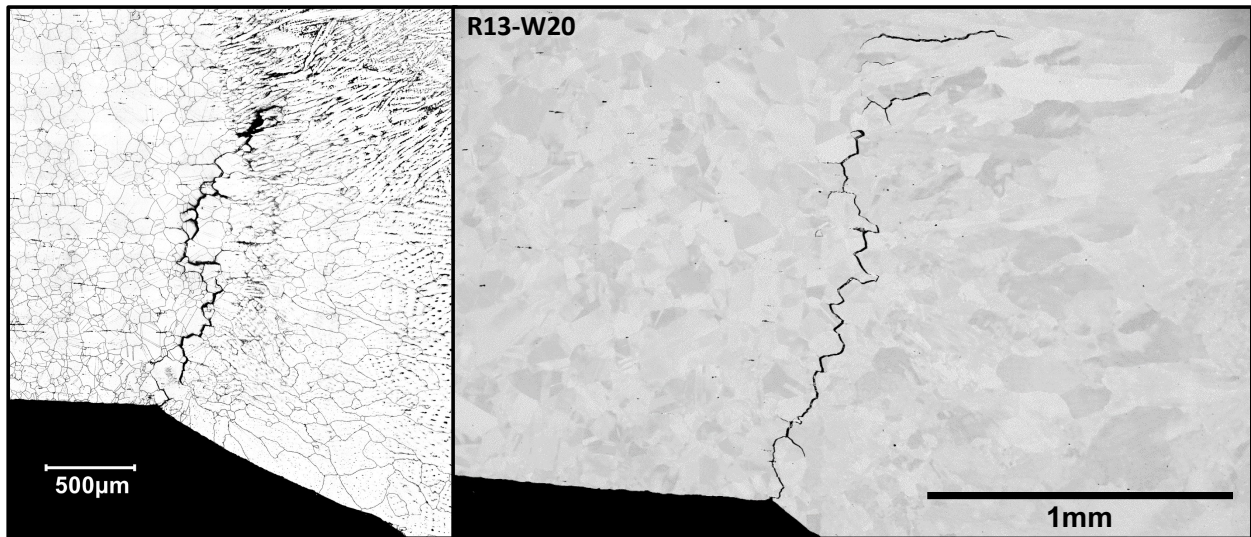
Further investigation shows that the cracking is intergranular. Figure 11 clearly shows that both crack initiation and propagation follows grain boundaries. Furthermore, inspection of all images presented in this paper show one main crack propagating (in some cases through-wall) with minimal branching. Additional SEM evaluation of the cracking morphology, figure 12, revealed isolated grain boundary cavitation ahead of crack tips. A very thin oxide scale, figure 12, was also identified within the cracks.

Figure 11. Etched optical (left) and SEM BSE image (right) showing intergranular crack initiation and propagation.

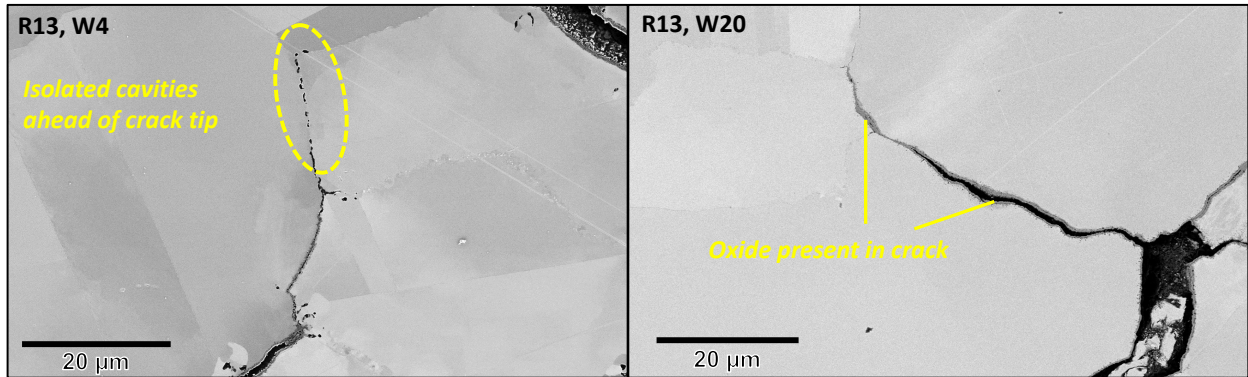
Figure 12. SEM image showing isolated cavities ahead of branching crack tips (left) and thin oxide scales in a main crack (right)

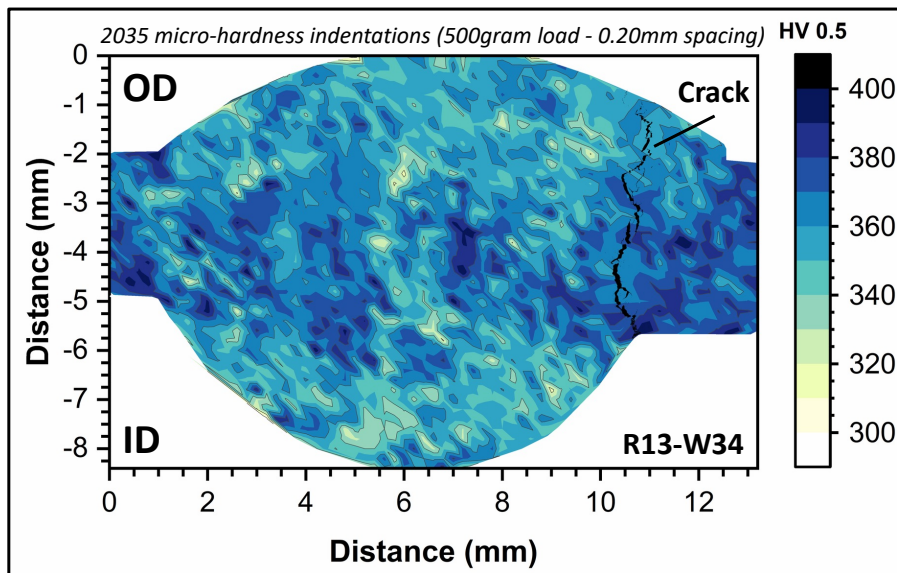
To examine the general microstructure of the base metal and weldments, micro-hardness mapping was conducted on selected samples, e.g., Figure 13. In general hardness was in the range of 350 to 375 HV0.5 which is typical for alloy 740H in the aged condition. The general microstructure of the alloy 740H base metal possessed equiaxed grains with occasional carbide 'stringers'. Cracking was not associated with these stringers and no preferential orientation of cracking to other microstructural features, beyond grain boundaries, were identified, Figure 14. Grain size was not explicitly measured for all heats, but as shown in Figure 15, there were different grain sizes observed in the examined tube samples. In general, no trend was observed with cracking and grain size, and, in the case of Figure 15, cracking was found in the finer grained base metal.

Figure 13. Hardness map showing typical and uniform hardness across the weldment

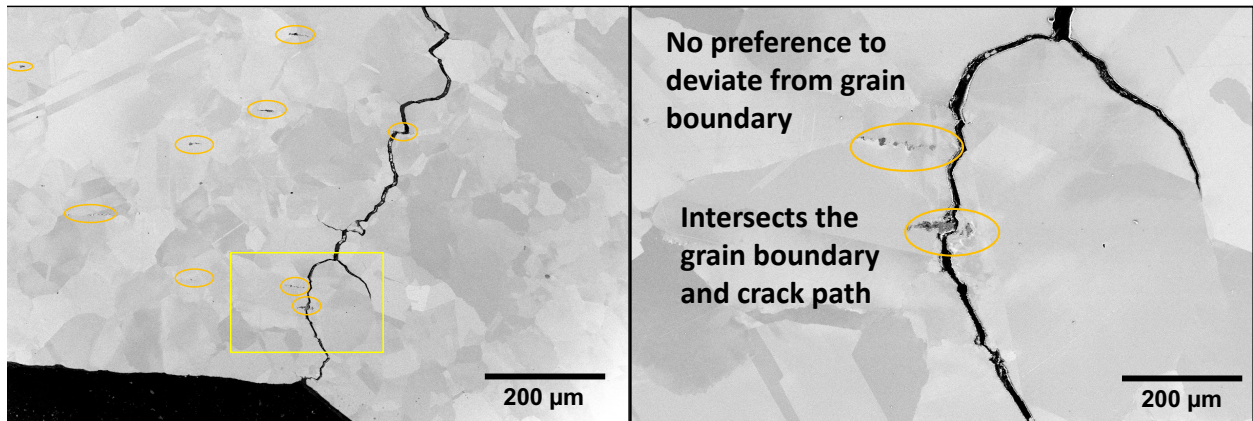
Figure 14. Lower magnification (left) SEM image and higher magnification of highlighted area (right) identifying carbide stringers throughout the matrix

- Non-metallic inclusions, porosity, and other 'hard' microstructural features can provide crack initiation sites and reduced strain accommodation. In this analysis the typical carbide stringers in the base metal matrix did not contribute to the crack initiation or growth, and the welds were of high quality with no observable porosity or microcracking. Furthermore, the observed intergranular nature of the cracking compared to the intragranular distribution of such inclusion or carbide stringers makes the association of damage with these features impossible in a 2D plane.

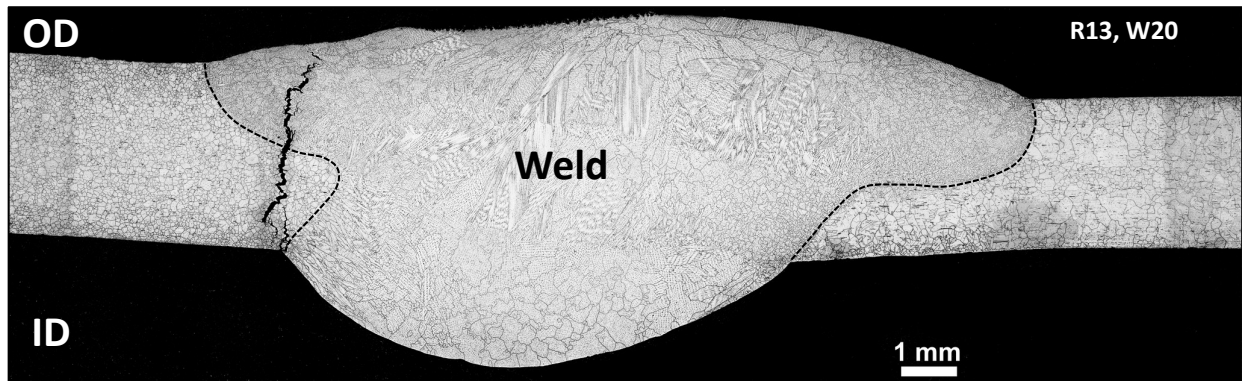
Figure 15. Etched optical image showing variation in grain size with finer grain size tubing heat (left) joined to coarser grain heat (right)

- Grain size has been shown to be an important factor in most solid-state cracking mechanisms in nickel-based alloys with larger grain heats generally possessing lower creep ductility and thus less able to accommodate the relaxation of stress by creep strain during the PWHT cycle [6]. However, in this work where there was a modest grain size difference in the same weld joint (see figure 15), the finer grain material showed cracking. This observation may suggest that grain size is not a dominant factor in the STEP heater cracking.

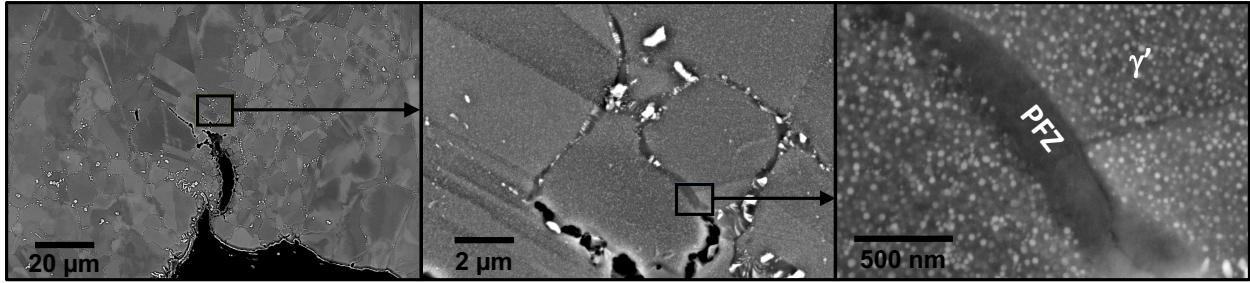
Higher resolution SEM analysis was conducted on selected samples near the ID-initiation of damage. Figure 16 shows successively higher magnification images of the same region near crack initiation and slightly removed from the crack tip. Fine spherical gamma prime (γ') precipitates are observed in the grain interiors and as expected. Inspection of the grain boundaries show coarsened grain boundary precipitates and corresponding precipitate free zones (PFZs) in the regions ahead of the crack tip. Figure 17 provides further evidence for the occurrence of PFZs near the weld root in the HAZ, and as compared to a location well-removed from the weld. The base material grain boundaries are decorated with precipitates and γ' precipitates are present to the boundary without any evidence of PFZs. Subsequent interrogation of the FL region at the weld root toe where cracking appears to be initiating showed a small region of equiaxed fine grains (Figure 18). A strong channeling contrast was also observed suggesting a highly strained region.

Figure 16. SEM images at 1,500X (left), 15,000X (middle), and 100,000X (right) showing microstructure ahead of possible crack initiation site including precipitate free zones (PFZ) along the grain boundaries

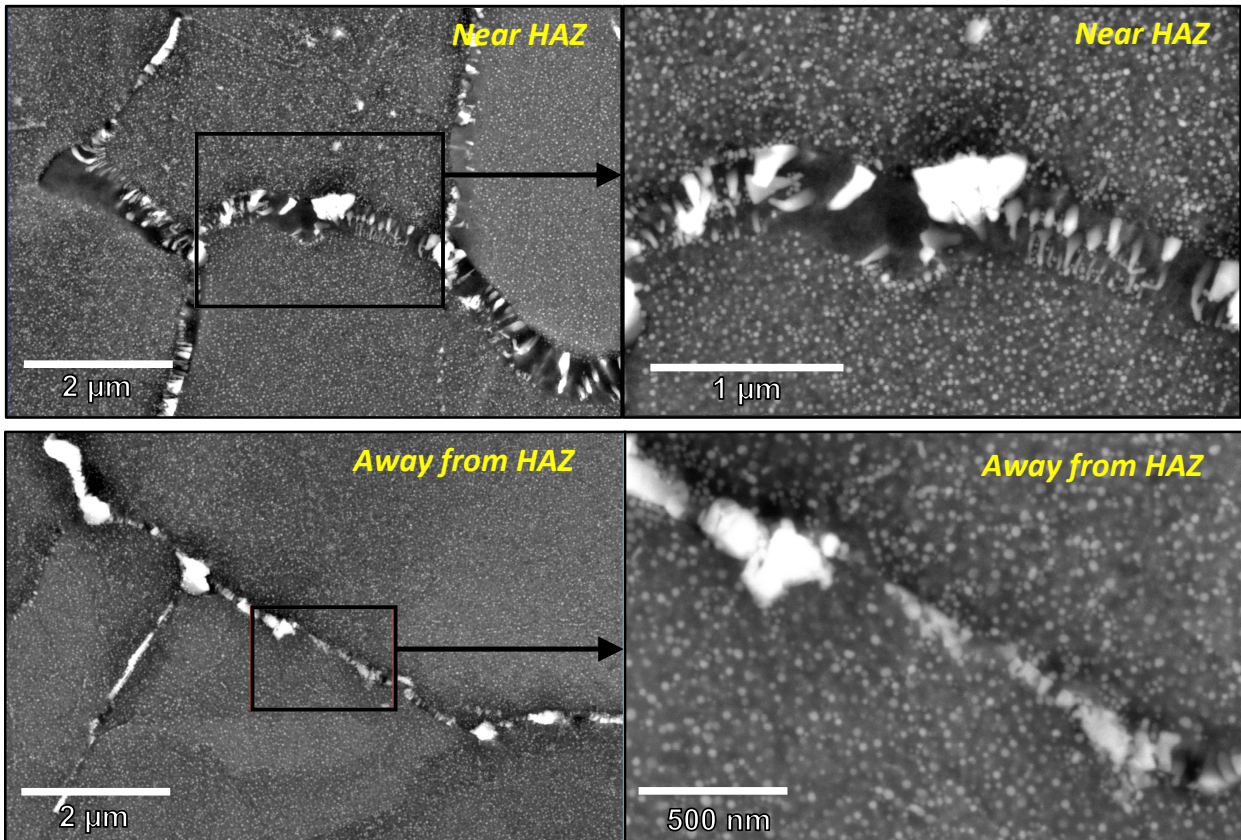
Figure 17. SEM images showing coarsened grain boundary precipitate and PFZs near the HAZ and their absence away from the HAZ

- iii. Precipitate free zone (PFZ) and coarsened zones (CZ) were observed exclusively in this same region. This is the first time, to the authors' knowledge, that PFZs have been found in the base metal of an as-fabricated 740H welded structure. Previous research on PFZs and CZs in 740H focused on long-term creep exposures of 1,000's of hours and within compositional gradients typical for as-deposited weld metal [10]. For PFZ formation, a driving force for diffusion and a moving boundary needs to be present. The relaxation of highly localized residual stresses from the welding process is hypothesized to provide this driving force.

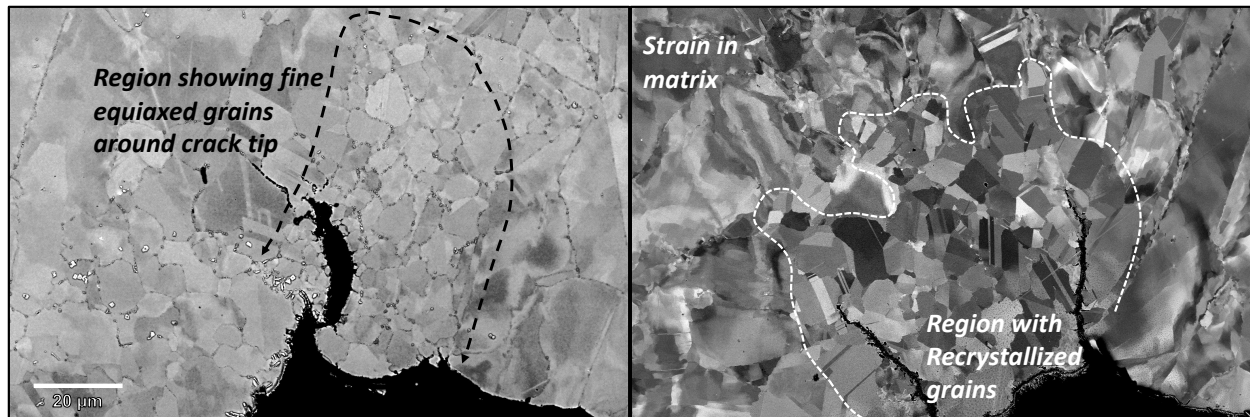
Figure 18. SEM image near weld toe showing a region of fine equiaxed (recrystallized) grains coincident with crack tip surrounded by strained grains in the matrix (channeling contrast)

- b. Significant microstructural changes occurred in the HAZ/FL area near the weld toes:
- i. A small, recrystallized zone was observed near the crack initiation location. Recrystallization in the base metal can only occur if significant plastic strain was imparted prior to heat-treatment and subsequent heat-treatment relieves this stress through recrystallization and grain growth. At least two samples showed this specific feature.
