Investigation of Weldment Cracking During Fabrication of a 700°C Fired sCO₂ Heater

John Shingledecker, John Siefert, Tapasvi Lolla
Electric Power Research Institute

February 23, 2022
7th Int. sCO₂ Power Cycles Symposium, San Antonio, TX

STEP Fired Heater Design

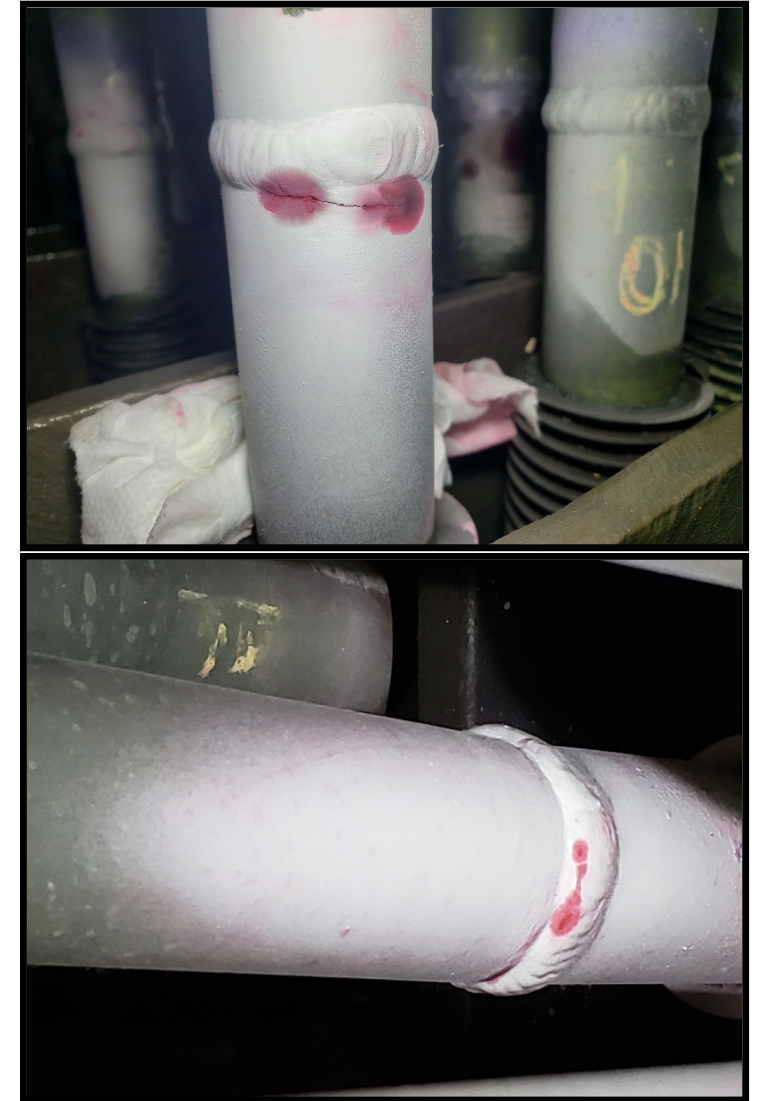
Indications after PWHT

- Linear indications found in a few welds (12) after PWHT and initial hydro test
 - Only in Tube-to-tube butt welds
- Repair method developed
 - Could not grind out (ID contamination)
 - Cut tube on either side of weld (allows for tube ID cleaning) & prep tube ends
 - Weld new tube “pup” piece in per applicable WPS, NDE via PT/RT
 - Local PWHT (ceramic heating pads), NDE via PT/RT
- Additional indications found after subsequent hydro tests (16 total)

Concern if welds may have cracks that were not identified by pressure test

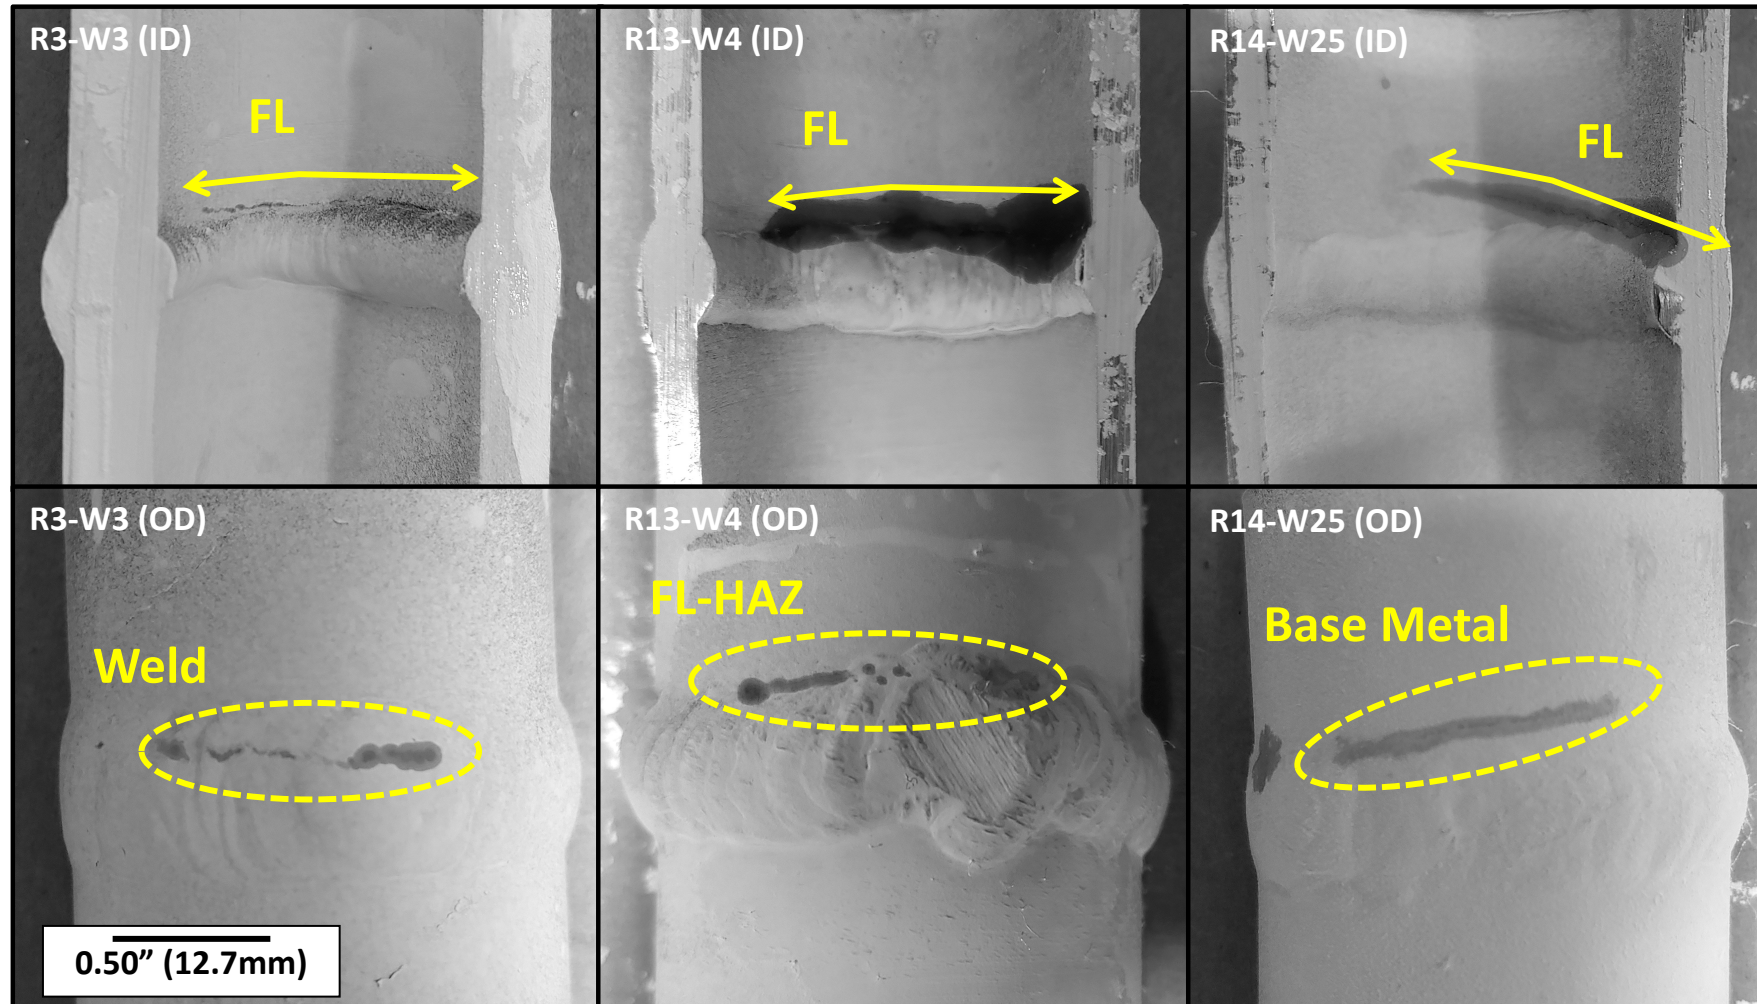
Inner Diameter:
1/3 circumference

I.D. initiated near fusion line with variable propagation

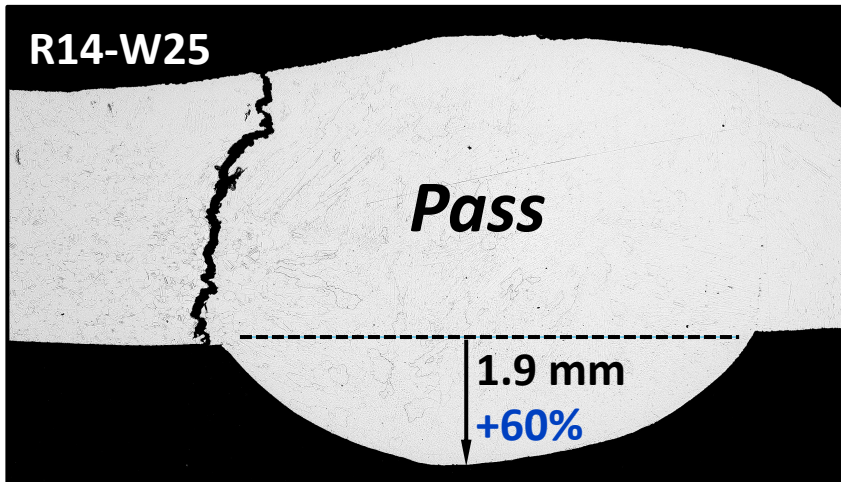
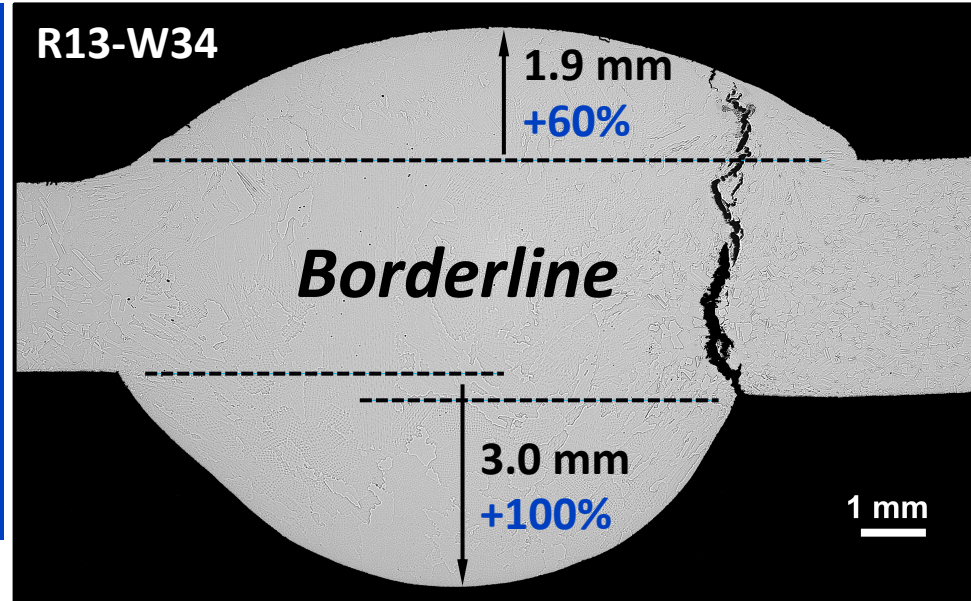
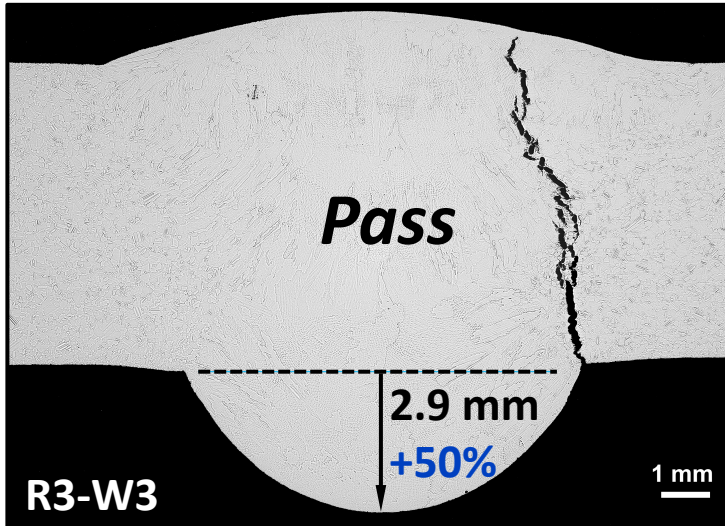
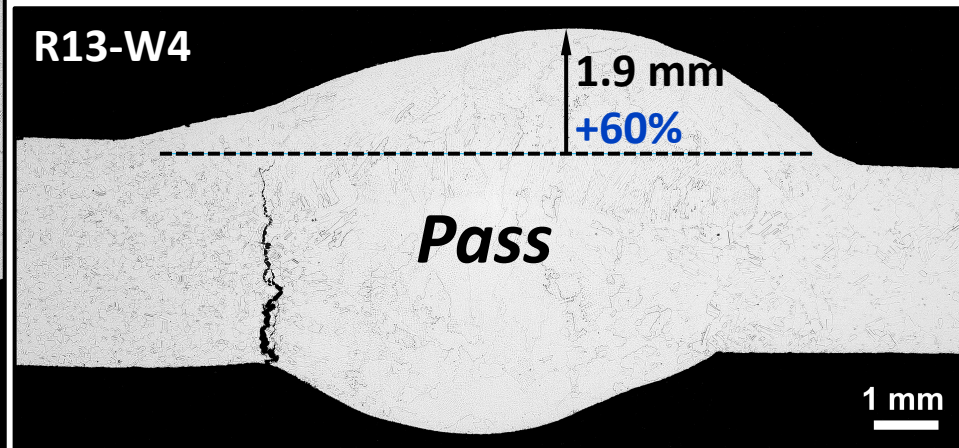
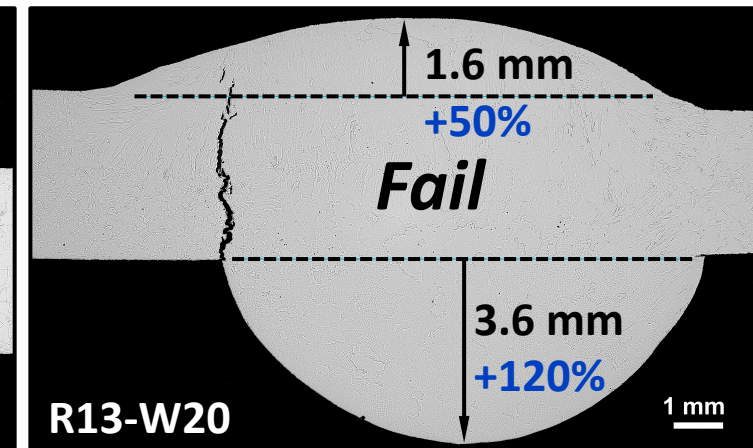
Reinforcement limitations given for each face in ASME B&PV Code Sec. I, PW-35.1 lists a maximum of 2.5 or 3.0 mm or 4.0 mm (depends on tube wall thickness)

No welding defects noted, but workmanship was variable

Crack propagation around circumference

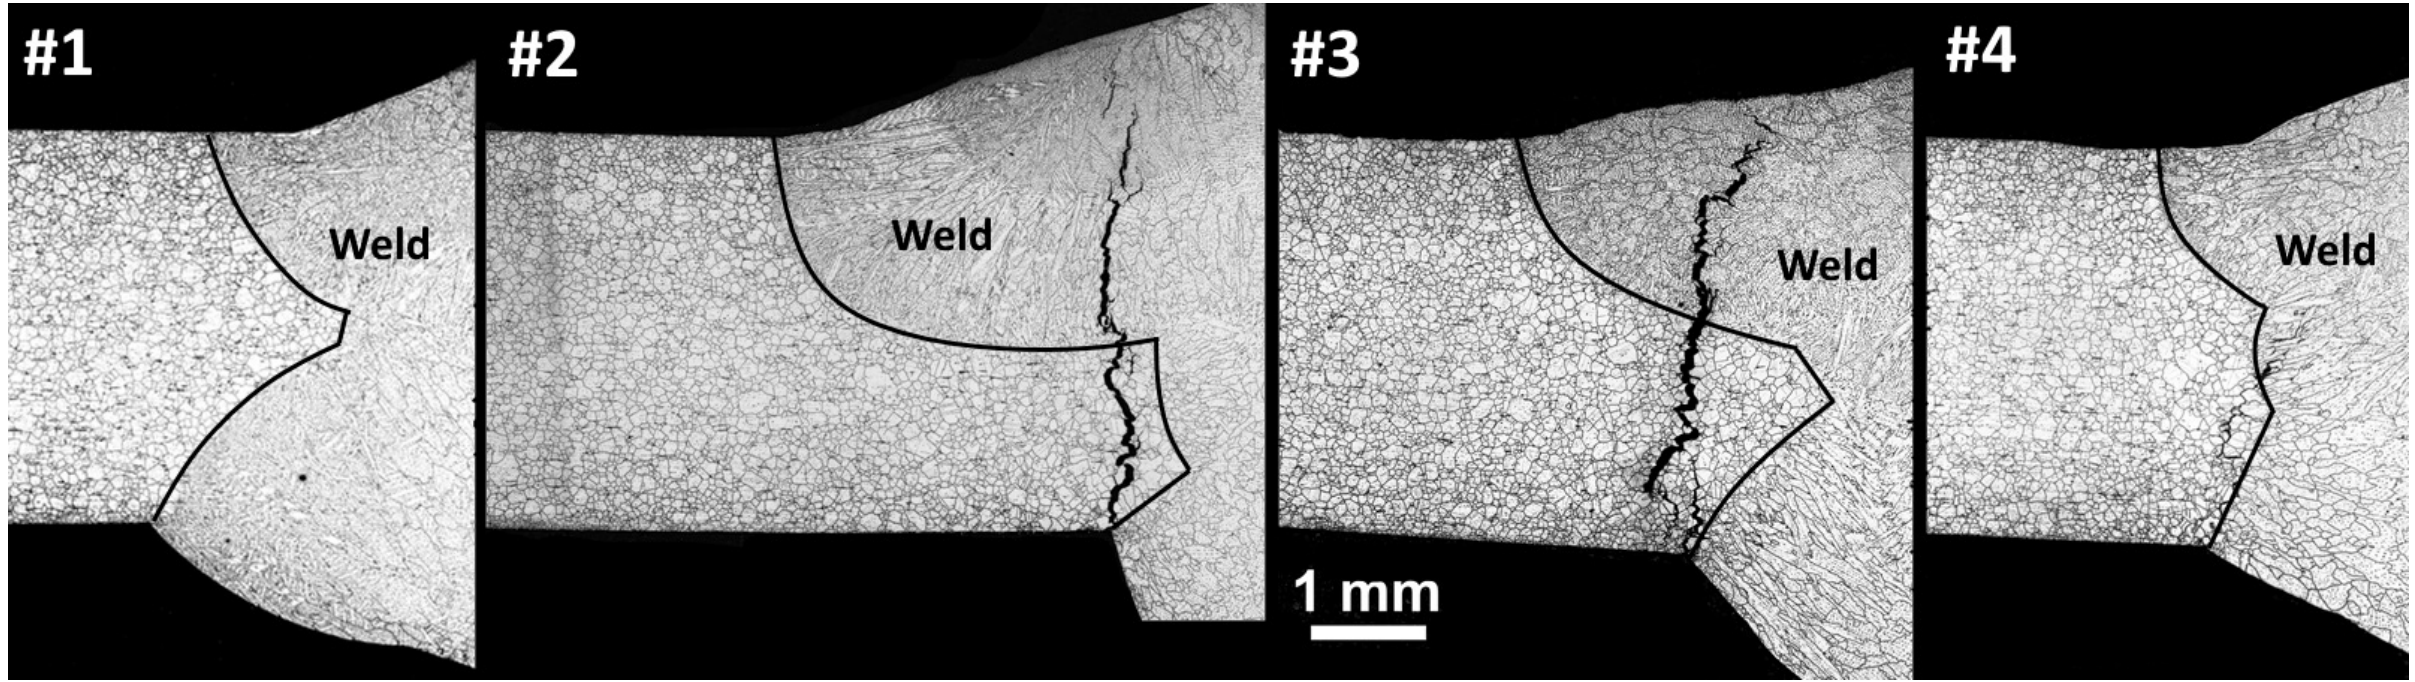
Initiation at weld toe on the ID, propagation through HAZ and into the weld

Initiation at weld toe on the ID, propagation through HAZ

Clear evidence for crack initiation at weld toe at fusion line on I.D.

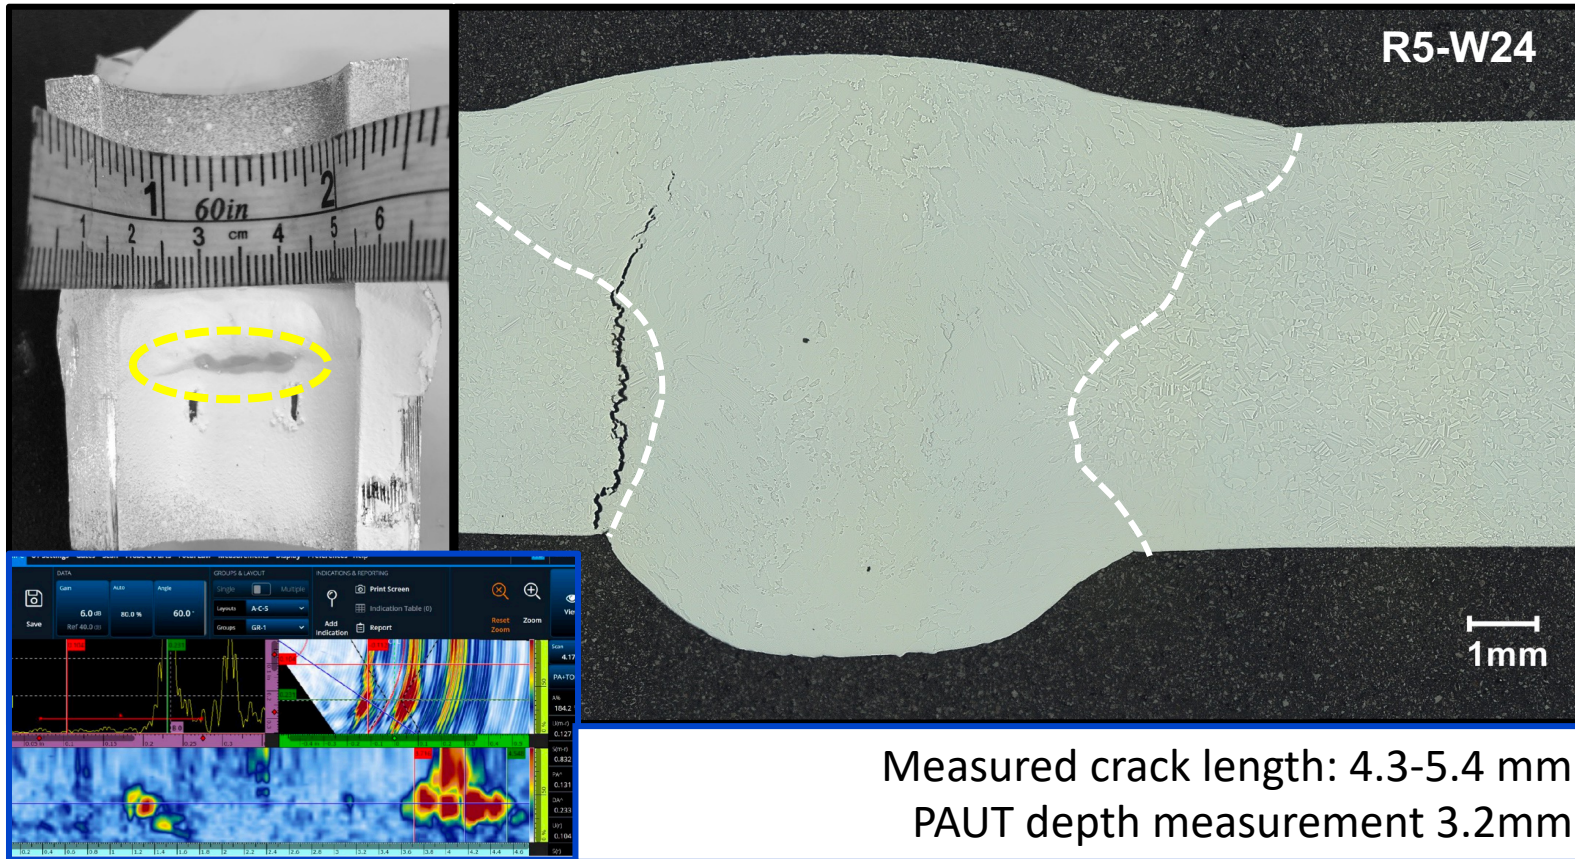
- 5 tubes with PAUT indications were removed
- All 3 crack like-indications were confirmed
- 2 indication (not crack-like) were confirmed not to have cracks

PAUT was able to identify and reasonably size significant cracks with same I.D. initiation as through-wall leaks from hydro testing

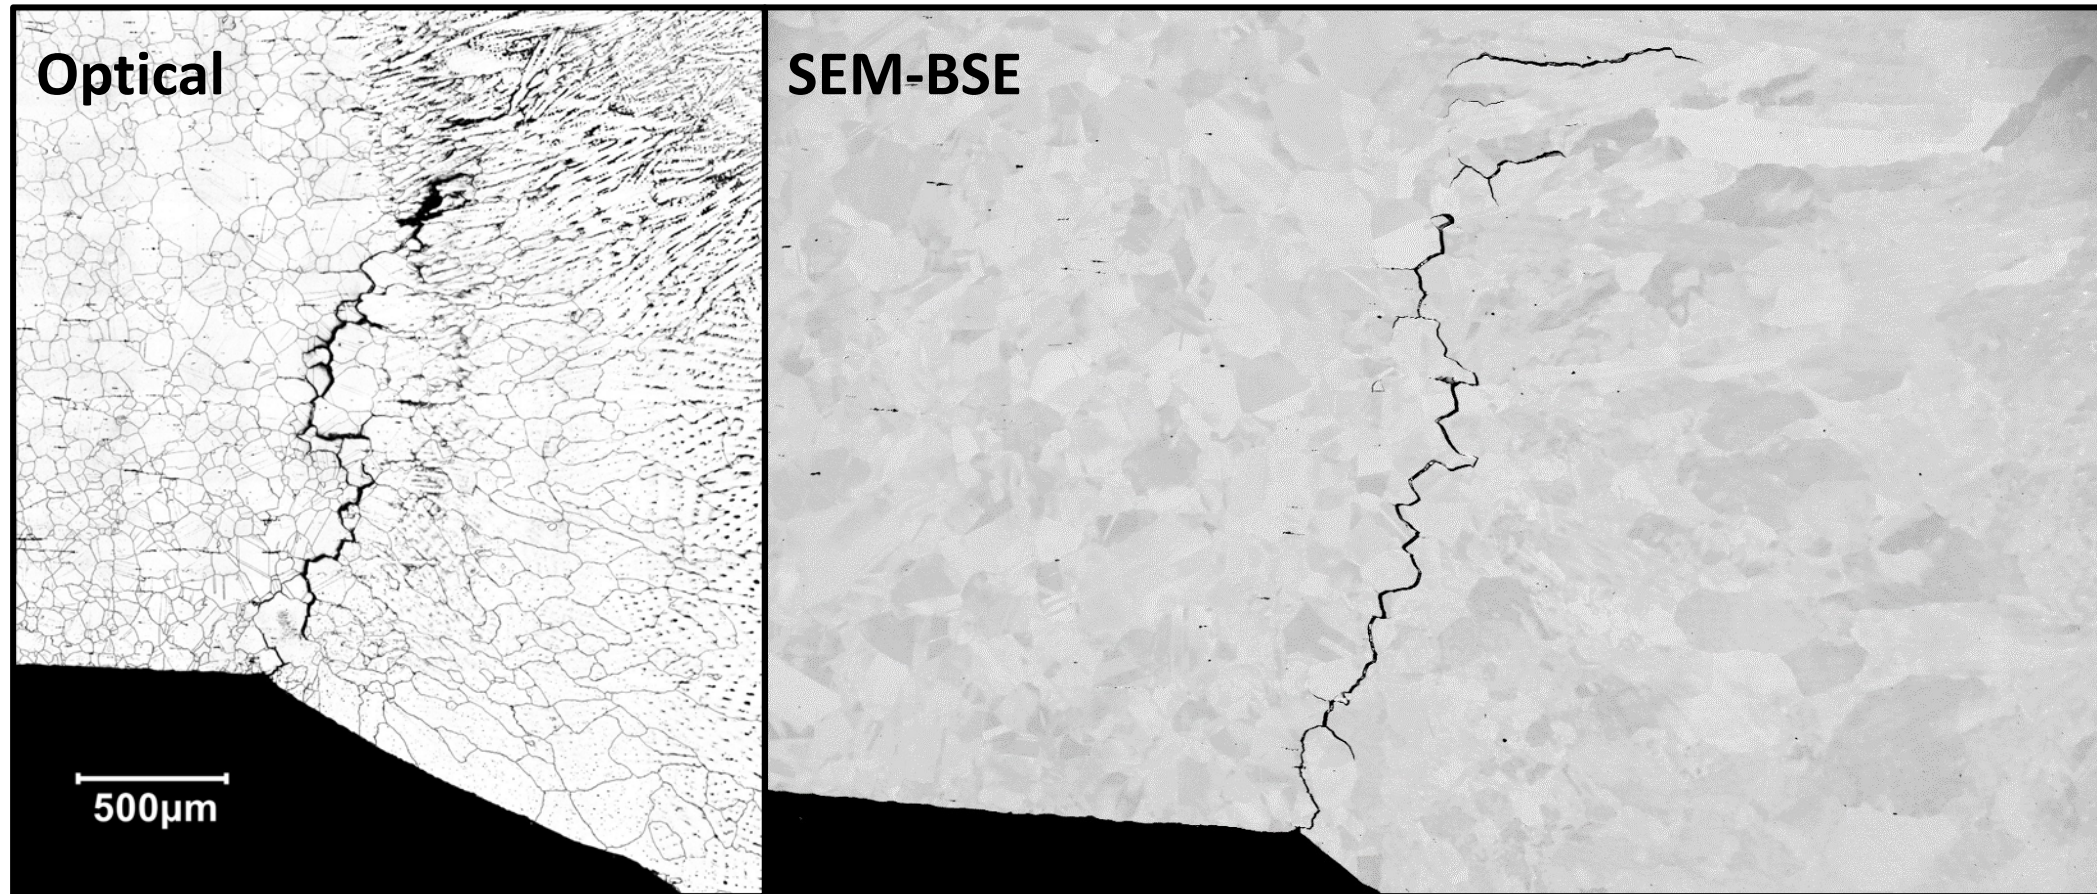
Cracking was entirely intergranular in nature with minimal branching

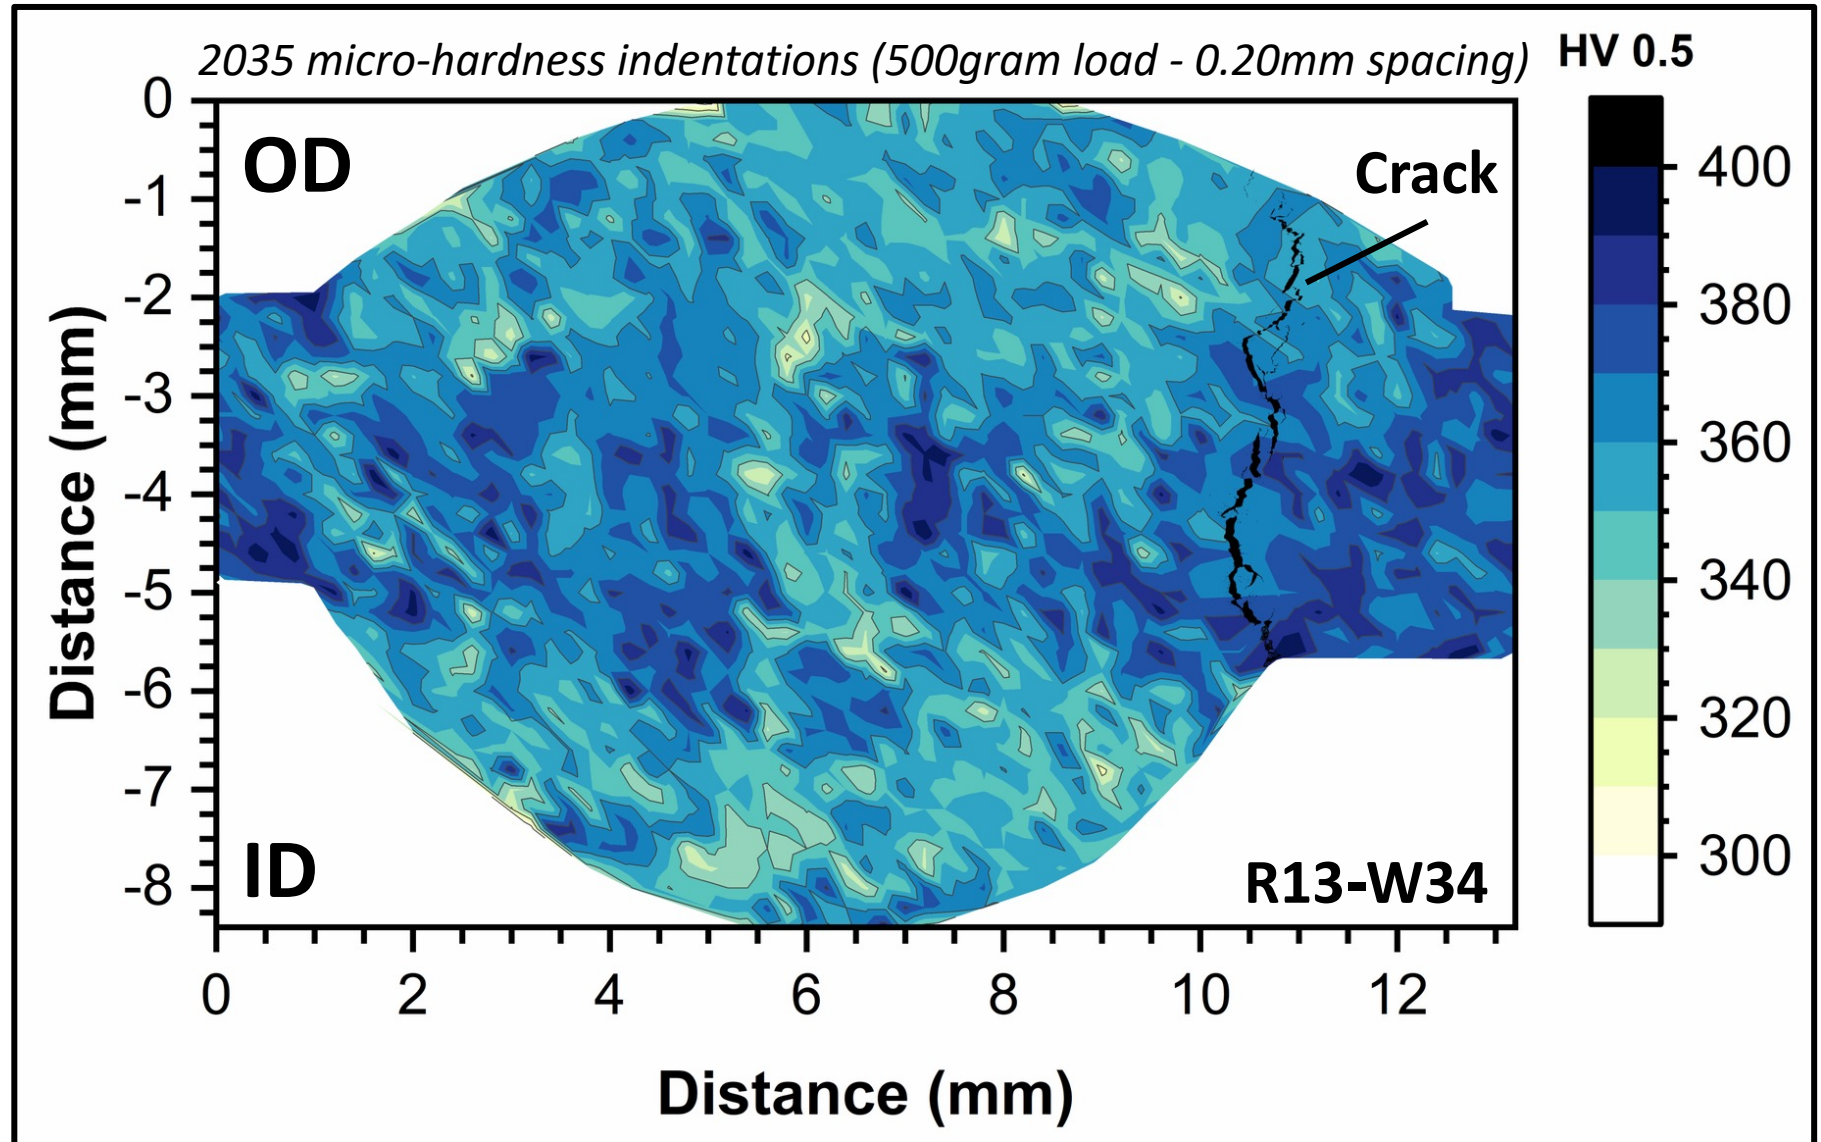
No evidence of improper PWHT or excessive cold work near weld

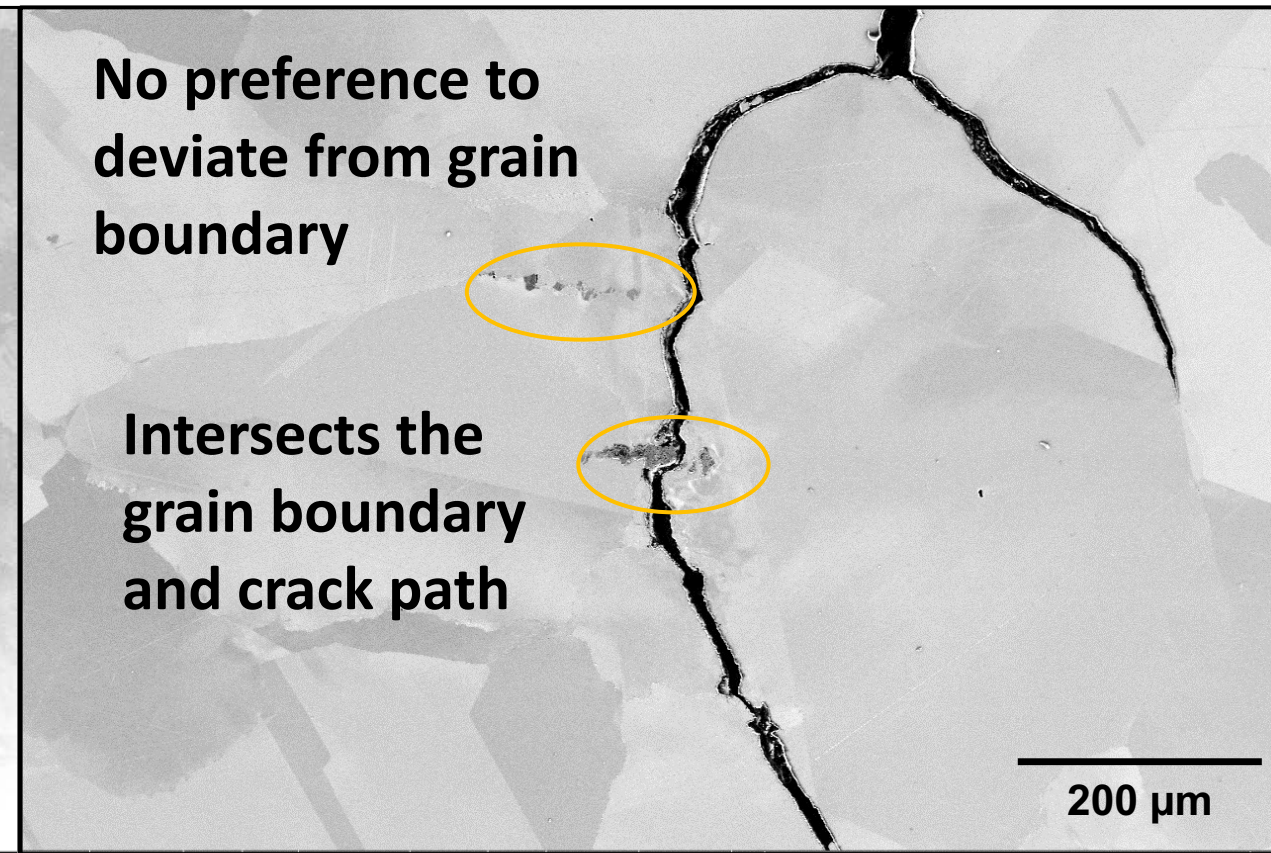
No cracking preference to typical carbide stringers in material

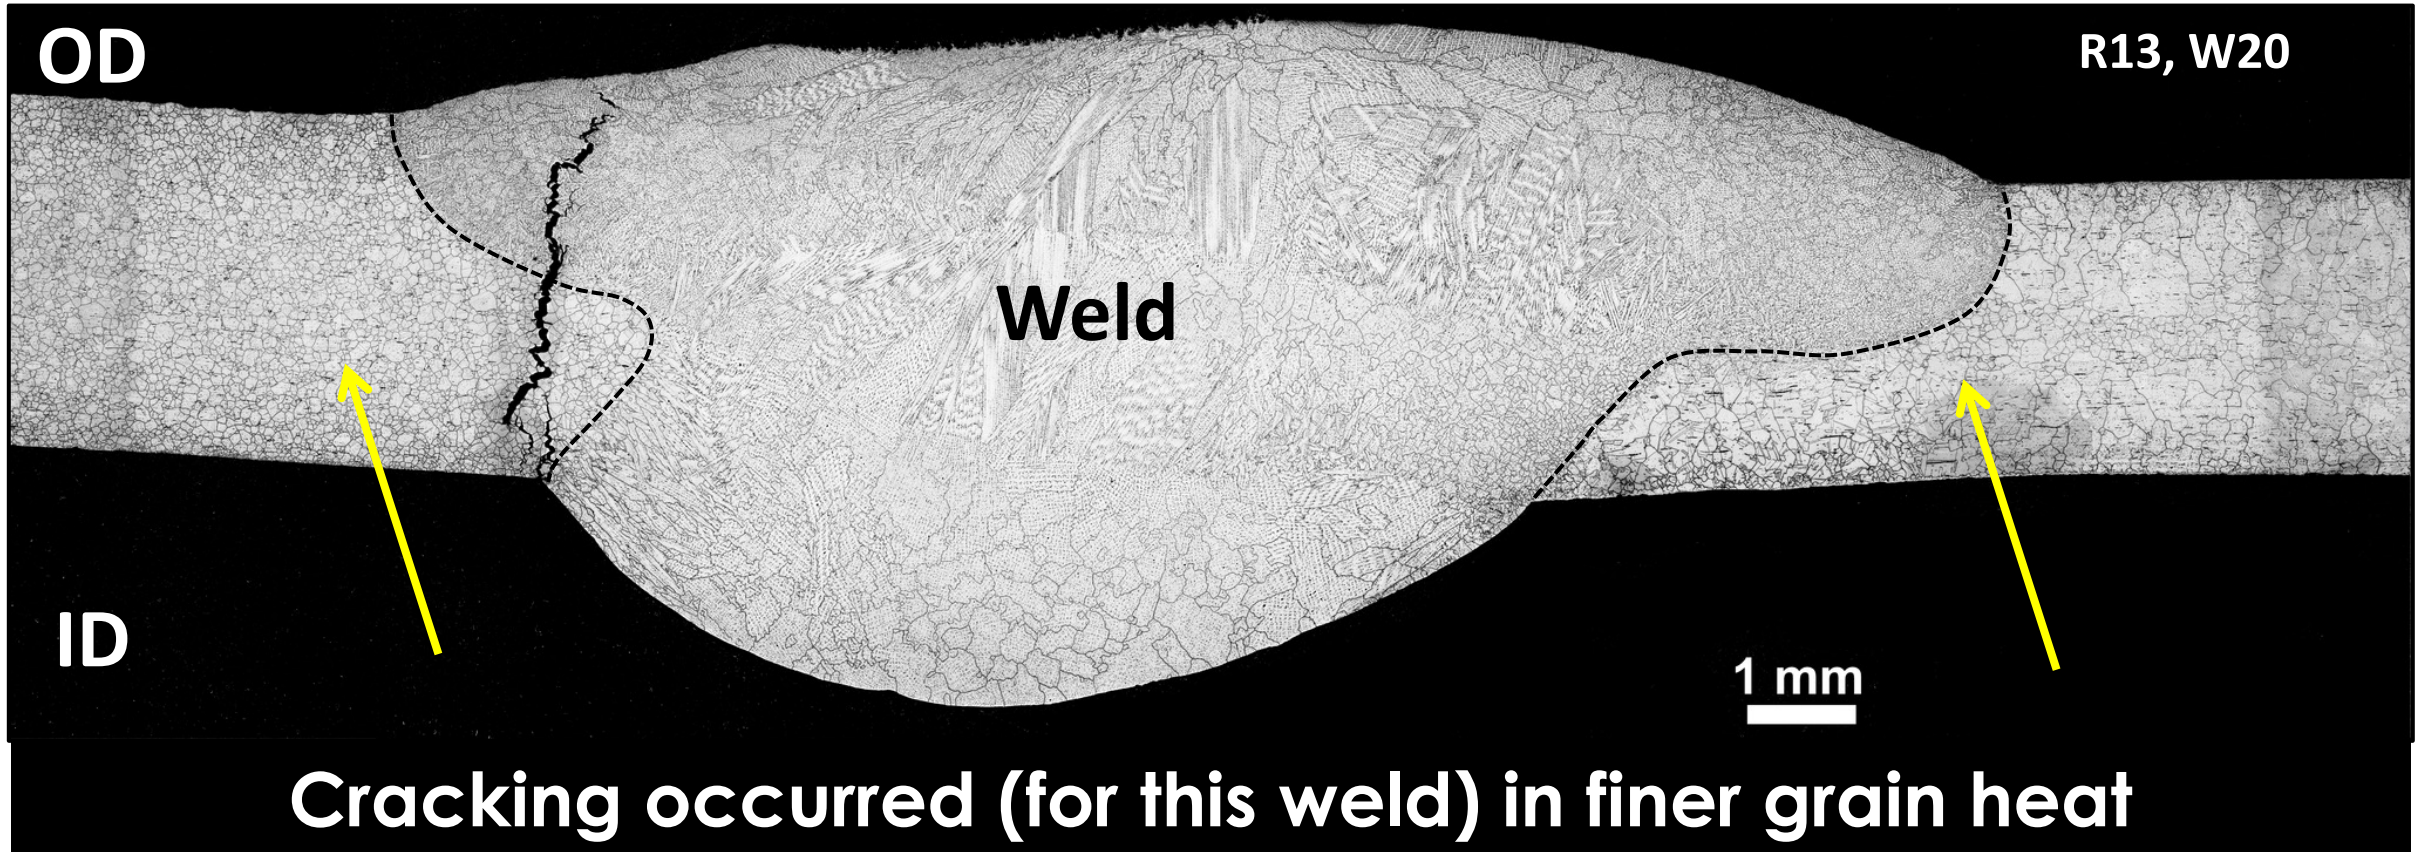
No preference to cracking based on grain size or biased to specific heats

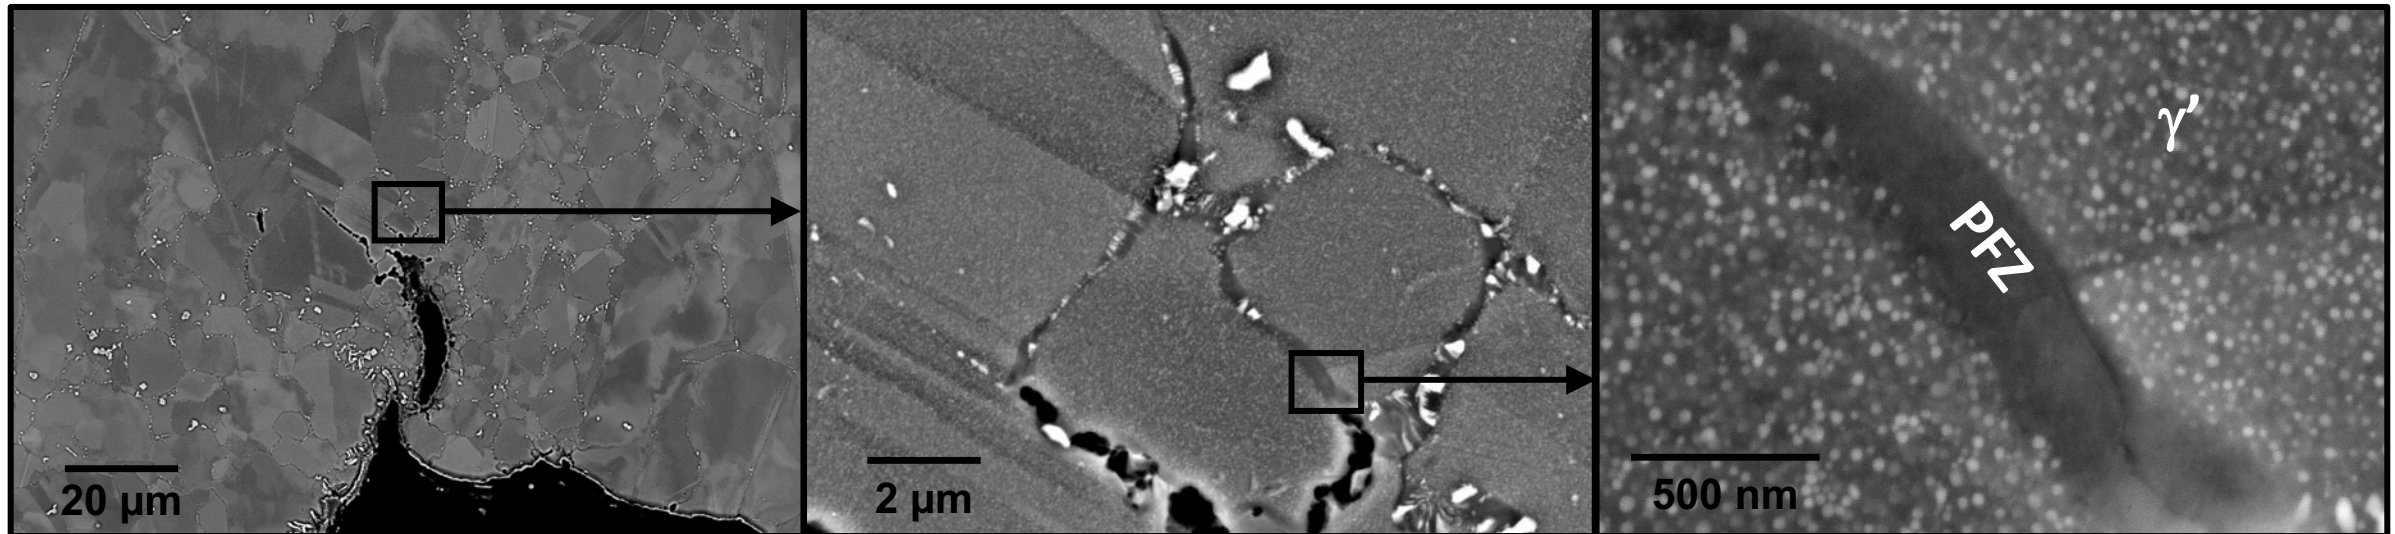
Precipitate Free Zones (PFZs) identified near the crack initiation

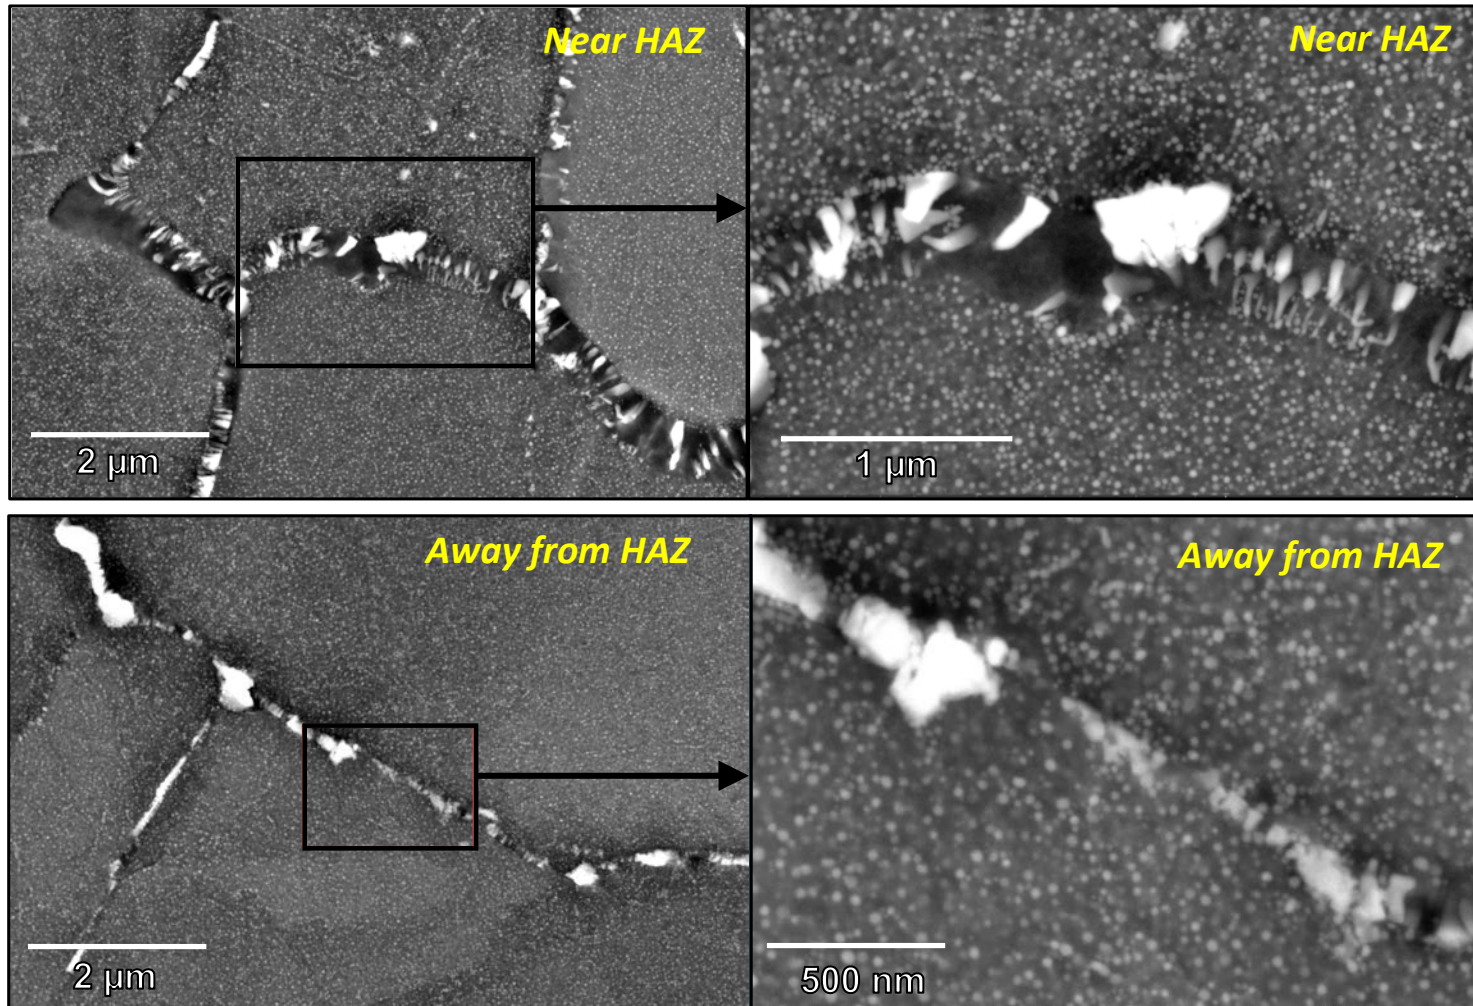
- Grain boundaries in HAZ region showed precipitate coarsening resulting in PFZs
- Regions adjacent to HAZ in base metal showed typical grain boundary morphology and fine gamma prime precipitates

PFZs generally only observed after long-term thermal (creep) exposures – new finding for weldments after PWHT

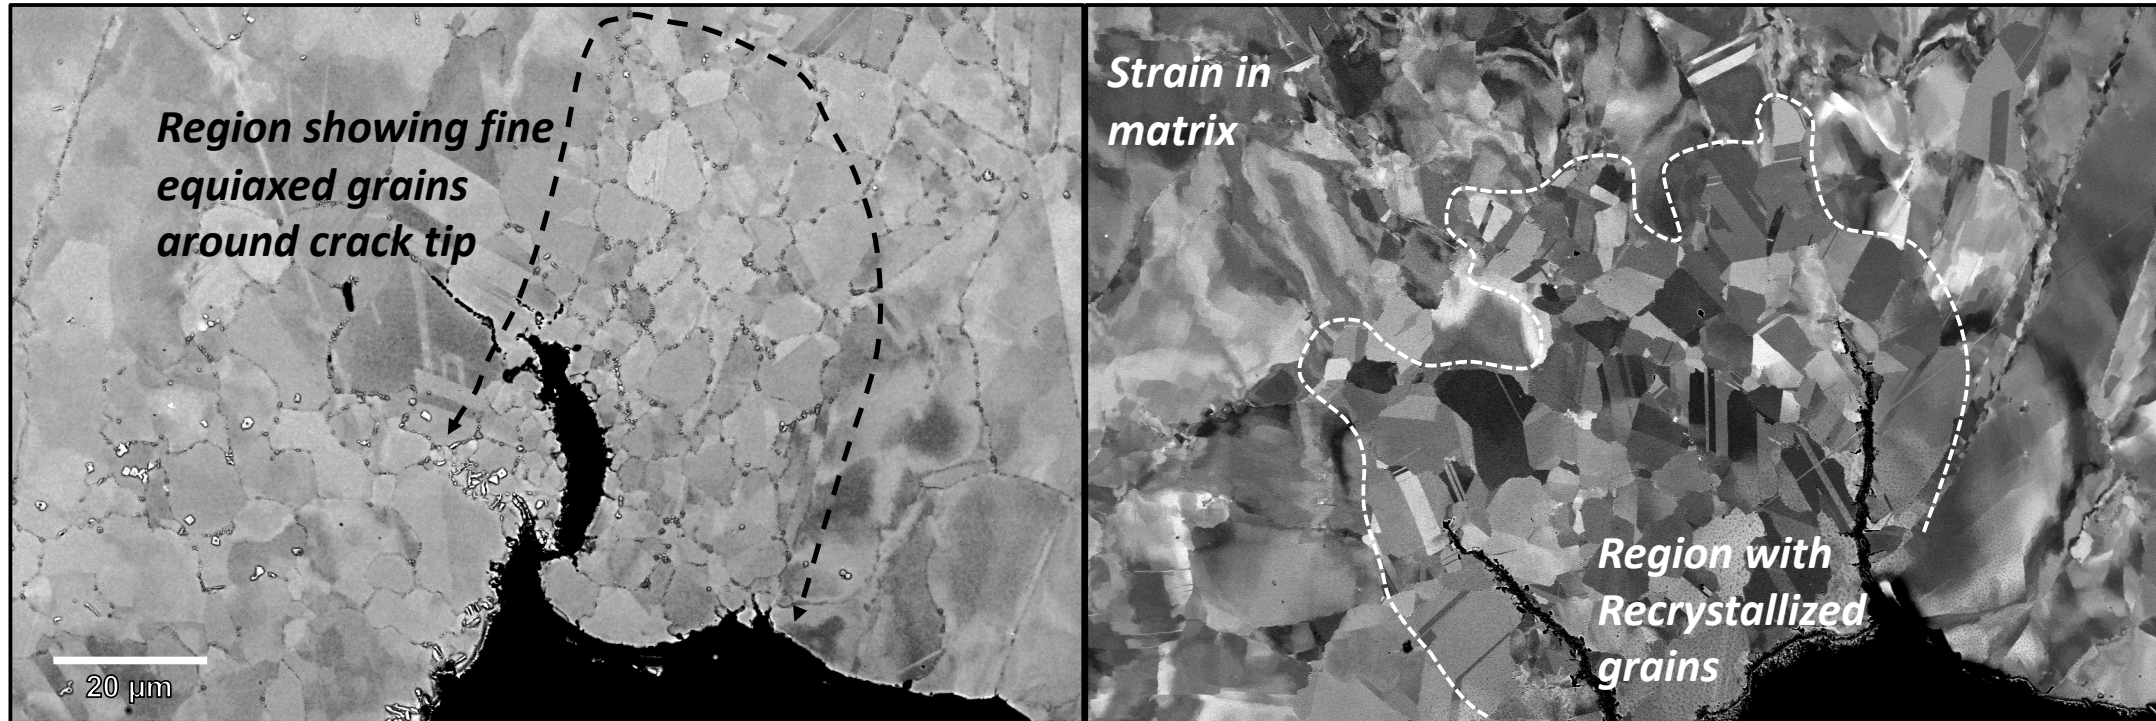
Small region of recrystallized grains identified near crack initiation suggesting very high localized strains

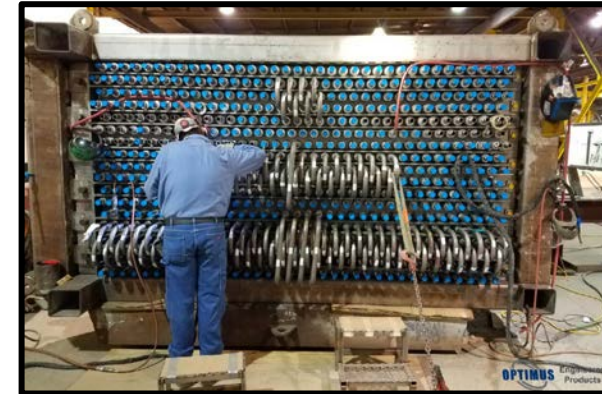
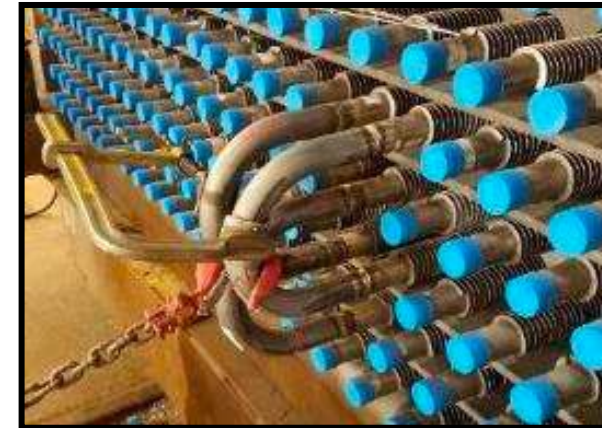
- a) While the welding process generally appears to be well controlled, the welding thermal cycle clearly had a pronounced effect on the tubular components of the STEP heater
 - a) The fabrication sequence and design of the heater appears to be a significant factor in the application of manual welding of 740H.
 - Welder Access and positioning was favorable for all thick section welds and header end tube welds
 - Return-end welds were more difficult – limited access resulted in highly variable weld geometry and stress concentrations
 - b) Welding residual stresses: scale with local constraint
 - Bias to thicker butt welds or thickness transitions (with cracking on thicker tubes)
 - Alignment was required for closure welds to be (note, no evidence of excessive cold work)

Shop fabrication was well controlled, but stress state appears to be a significant factor in the cause of cracking

- Practical considerations for 740H users
 - Consider joint location and fabrication sequence in design
 - Avoid excessive joint reinforcement and other geometric stress concentrations
 - Automated welding may help better control these variables
 - Volumetric inspection should be performed after PWHT (in addition to staged or limited inspection during welding) to ensure component is free of SRxC defects
- Current EPRI research to extend these learnings [DOE SETO funded effort (DE-EE0009378)]:
 - Detailed characterization of other industry cracking and SRxC lab studies on 740H to evaluate material, heat-treatment, and stress state variables
 - Workshop conducted (Dec 2021) with 740H users
 - End Goal is ***Industry Guideline Specification for 740H Procurement and Fabrication*** which goes above beyond the minimum code requirements
