**PRESSURE ACTIVATED LEAF SEAL
TECHNOLOGY READINESS TESTING**

ABSTRACT

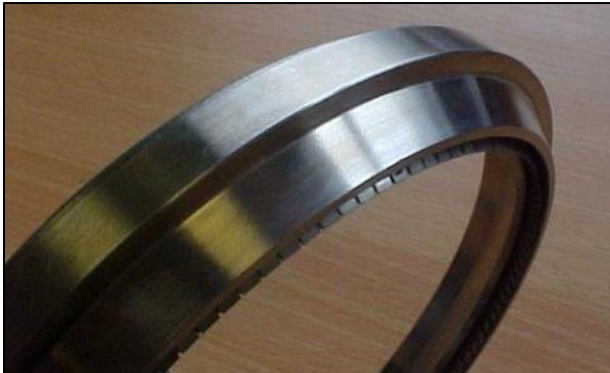
Figure 4: PALS 5.1in (130mm) Diameter Test Seal

There are 120 seal leaves in each leaf layer that are cut by wire EDM from sheet. Each leaf layer strip is then bent to the design leaf angle plus some interference of upper leaf tips with lower leaf layers to assure intimate leaf contact as strips are laid up about the cylindrical portion of the support member. When assembled with the backing ring, parts are joined by welding as shown in Figure 2. The final fabrication step is a wire EDM trim of the seal leaves while mechanically constrained in the fully deflected position. This provides a precision seal ID for desired clearance or ‘wear-in’ with respect to the rotor. The finished test seal is shown in Figure 4. Prominent in the picture is the shroud portion of the backing ring that protects seal leaves from handling damage.

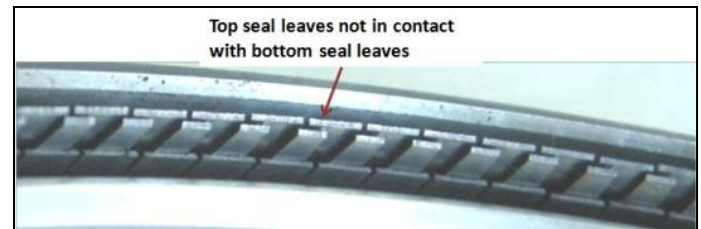
Figure 9: Test Seal Leaf Tips

contact with underlying leaves, Figure 9. This finding was recognized as the probable cause of the noise. However, a decision was taken to build a small 2D test rig and thoroughly rule out other possibilities that may be contributing to it. That 2D rig and test program are discussed in the following section. It was undertaken out of concern for prolonged off-design operation at low pressure that could result in high cycle fatigue seal failure.

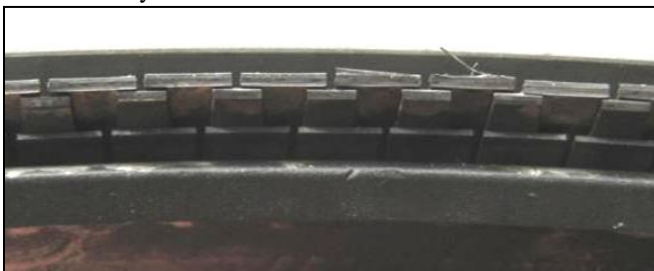
Figure 10: Leaf Tip Burr - Post Wear-in (View from Bottom)

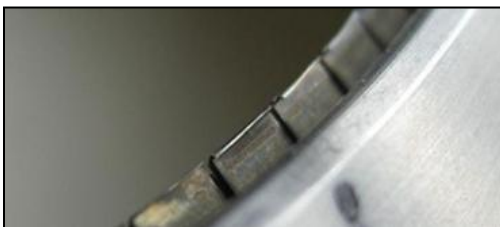
Figure 11: Leaf Tip Burr - Post Wear-in (View from Top)

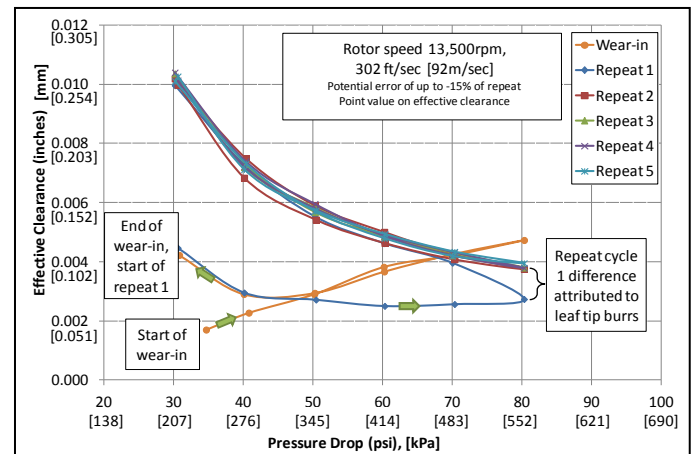
Figure 12: PALS Dynamic Test Clearance During and After Wear-in

Figure 12 is a plot of effective clearance measured during the ‘wear-in’ and 5 repeated dynamic cycles of pressure to 80 psid (552kPa) while maintaining 13,500RPM rotor speed. Irregularities during ‘wear-in’ and the first repeated cycle are attributed to shedding of burrs from seal leaf tips. Effective clearance during the five repeat dynamic pressure cycles track very closely indicating stable and consistent PALS closure with pressure.

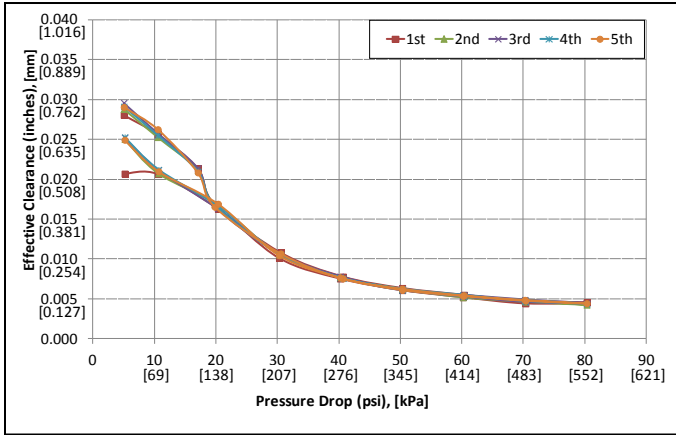
Figure 13: PALS Static Cycling After Wear-in

Repetitive static tests to 80 psid (552kPa) were performed after the dynamic cycles. That testing extended to lower pressure levels as shown in Figure 13. At seal pressure above 20 psid (138kPa) the effective clearance is essentially unchanged during the 5 pressure cycles. Below that pressure there are differences among the static cycles but airflow measurements were stable and noise was unexpectedly absent. It is believed that leaf tip burrs (Figure 10), may be bridging the gaps to mitigate leaf vibration. Five additional dynamic cycles to a higher pressure of 120psid (827kPa) were performed. Results in Figure 14 show only minor variation in pressure verses effective clearance throughout the test series. The repeatability of PALS closure with pressure was again found to be stable with no evidence of hysteresis.

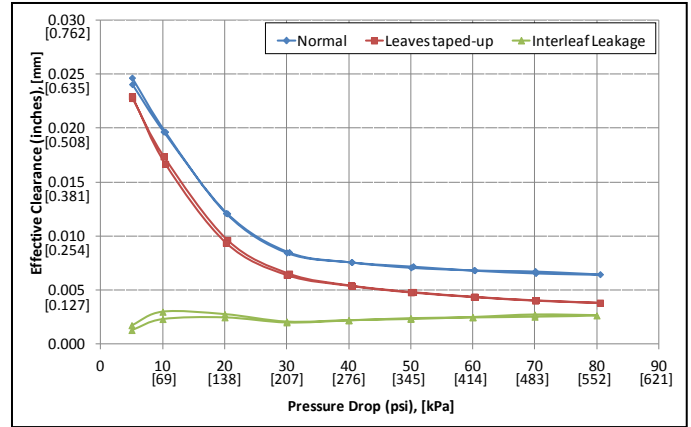
Figure 15: PALS Inter-leaf Leakage Assessment

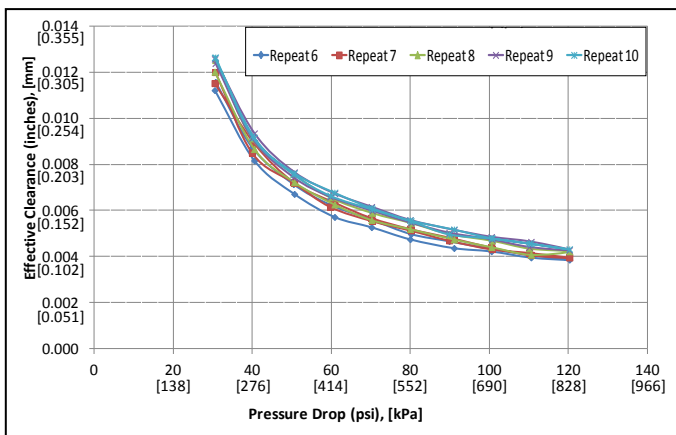
Figure 14: PALS Hi-Pressure Dynamic Cycling Clearance

The minimum effective clearance of 0.004 inches (0.1mm) is the same at 120psid (827kPa) as it was at 80 psid (552kPa) seal pressure. The incremental leaf tip deflection calculated for this seal is 0.001in (0.025mm) when seal pressure is increased to 120psid (827kPa) from 80psid (552kPa). It is worn away by leaf tip engagement with the rotor and results in a larger effective clearance at lower pressure as seen at 80psid (552kPa) in Figure 15. To assess the contribution PALS interleaf leakage to the minimum effective clearance, tests were run after the protective shroud was machined away to expose the seal leaves. The first test established a base line with seal leaves exposed normally. In the second, insulation tape covered the up-stream face of leaves to prevent passage of air between them. The difference in measured effective clearance is attributed of interleaf leakage. Results in Figure 15 show the effective clearance of interleaf leakage at 80 psid (552kPa) to be approximately 0.0025in (0.064mm). The rest of minimum measured effective seal clearance of 0.004in (0.1mm) is attributed to leakage at the seal backing ring and other test rig leaks, run-out of the rotor seal surface and instrument error.

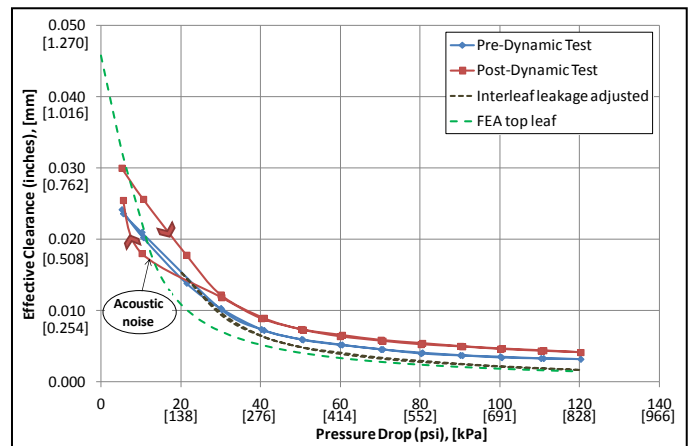
Figure 16: PALS Post Test Closure Analysis

PALS closure observed after ‘wear-in’ with the 5.133in. (130.38mm) diameter disk was compared to that predicted by the FEA model. Using the measured un-deflected seal leaf ID of 5.202in (132.13mm) the calculated FEA seal closure, tracks very closely to measured effective clearance when an adjustment is included for measured interleaf leakage. The favorable comparison (Figure 16) confirms accuracy of design analysis. Acoustic noise was present from 30psi to 0psi when reducing the pressure back to ambient. As a result there is a reduction in effective clearance compared to when applying the pressure. This reduction in effective clearance is due to the oscillation of the leaves causing disturbed flow and irregular pressure transducer readings.

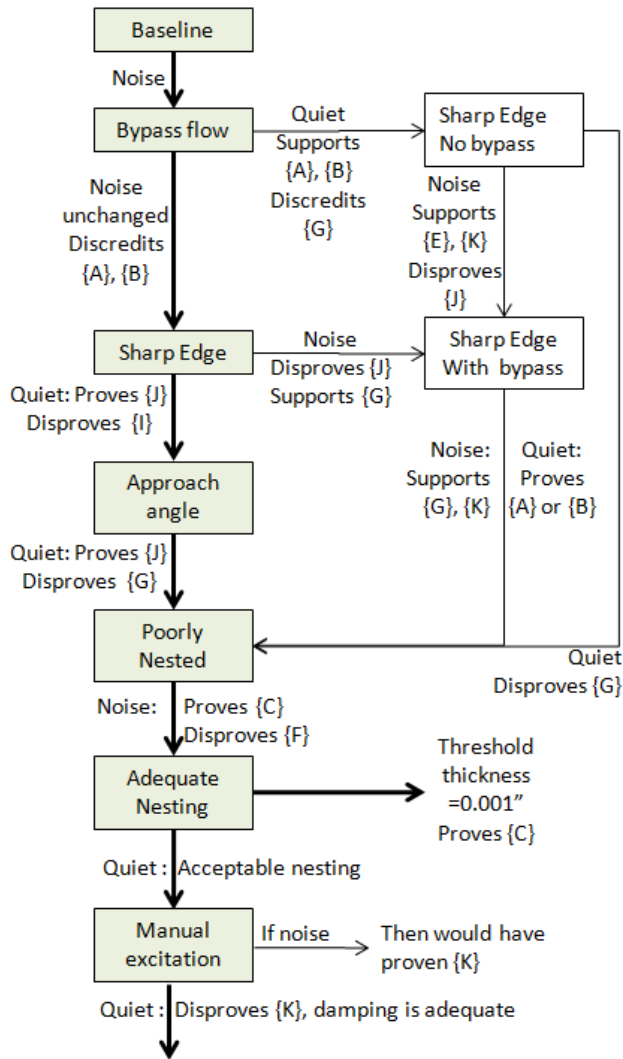
Figure 19: Sequence for Testing in 2D Leaf Test Rig

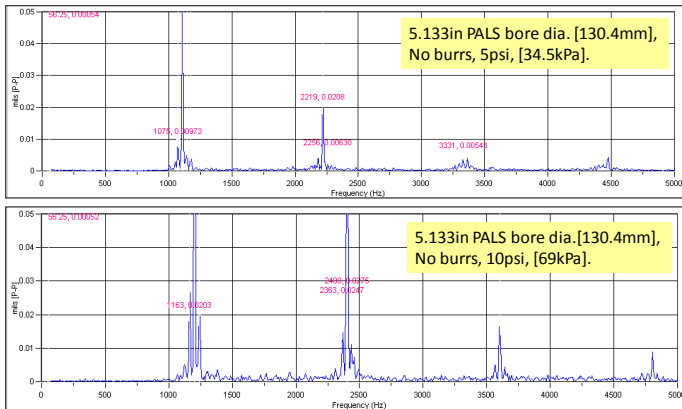
Figure 23: Damaged Seal Noise Signal at 5 and 10psi respectively

As the 2D test rig has indicated that the interleaf gaps result in leaf vibration and noise at low differential pressures a test of the impact of handling damage was conducted. Starting with the seal for the 5.1in (130mm) test rig which was quiet for all conditions, leaves were manually bent up to simulate handling damage (Figure 21 & Figure 22). Strong vibration and a loud noise resulted at 5 and 10 psid (34 and 69kPa), (Figure 23). One leaf that had been deflected to a tip radius greater than the support inner diameter did not close under pressure. Several cycles to 80 psi (552kPa) yielded repeatable results with no change in the appearance during the test (Figure 23). This test confirmed that interleaf gaps can lead to the initiation of vibration and noise.

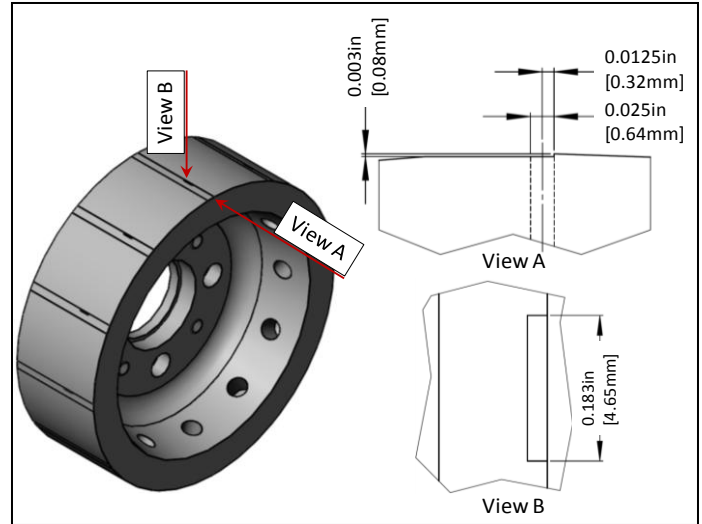
Figure 26: Rotor Slot and Step Detail, 12 Places

The radial height of each step was 0.003in (0.076mm) with slots allowing for radial air to be injected under the seal leaves (Figure 26) at a higher pressure than that at the front of the leaves. This type of rotor set-up simulates any discontinuation of the shroud sealing surfaces as typically seen in steam turbine locations. The rotor was again uncoated Aubert & Duval 819B as per the smooth rotor test.

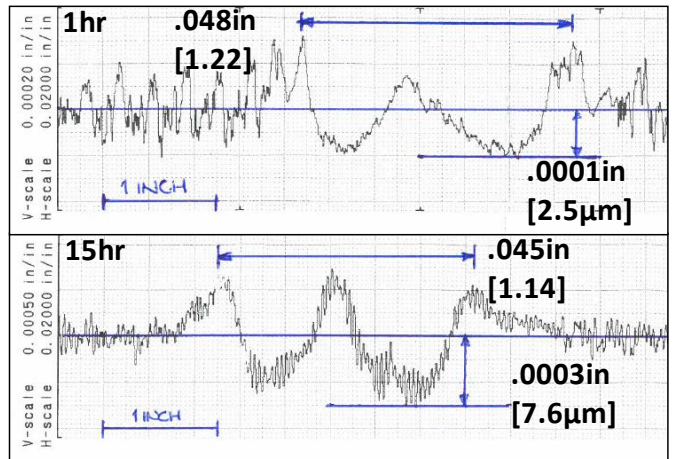
Figure 31: Rotor Wear Traces after 1hr and 15hrs of Testing

The rotor wear track was again visible, with some heat generation marking on the upstream side of the track (Figure 30) generated at the point of initial contact and wear. The majority of the track was created within the first 3 hours, with the wear track at 0.0001in (0.0025mm) depth after 1 hour of running and only 0.0003in (0.0076mm) after the full 15 hour test as seen in Figure 31. The results for the total effective clearance and wear traces indicate that frictional heating has minimal influence on sealing performance after the designed wear-in stage.

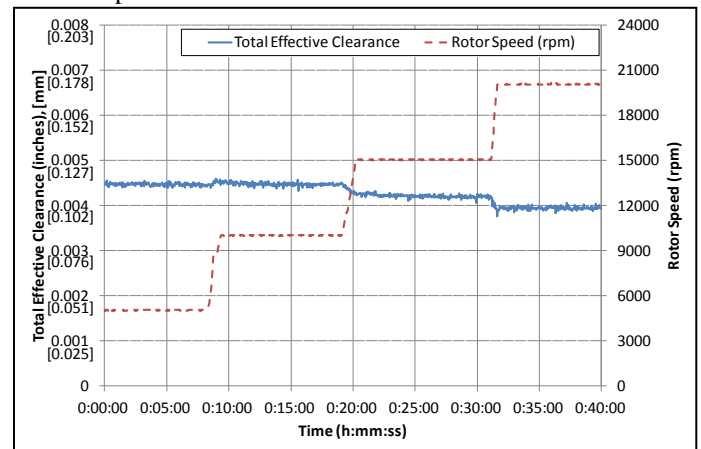
Figure 32: Total Effective Clearance running Reverse Rotation at Varying Speeds

A reverse rotation test was carried out with a seal pressure of 55psi (379kPa), rotor pressure of 65psi (448kPa) and venting to atmosphere as per the 15 hour test. The test was run at speeds from 5000rpm to 20,000rpm and held for a few minutes. The results in Figure 32 demonstrate the seals ability to run in the reverse direction, against the steps. Further, the total effective clearance improved with speed and at 20,000rpm the results were comparable to that measured in the 15 hour test.

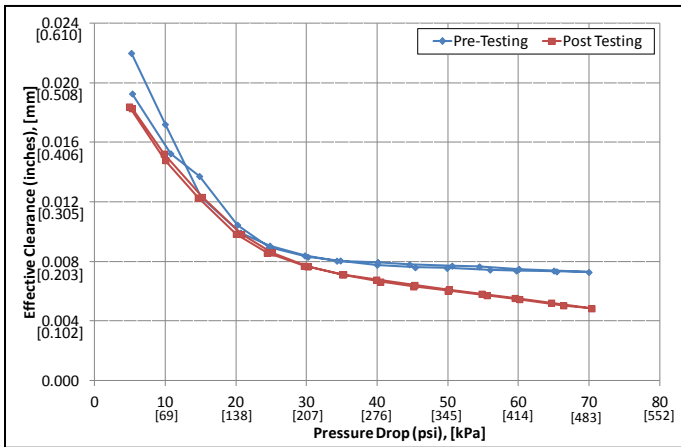
Figure 33: Static Leakage Results Pre and Post Testing

Finally static leakage tests were conducted pre and post testing with the results shown in Figure 33. These were undertaken with the leaves located over the slots, increasing the seal pressure from 0-70psi (0-483kPa). No rotor pressure was applied and the air path to the slots closed. At pressures below 20psi (138kPa) the pre-testing static leakage encountered leaf oscillation as seen by the discontinuity of the total effective clearance when applying the pressure verses removing the pressure. The leaf oscillation was not present on the post-testing static leakage test. Pressures above 20psi (138kPa) show an improvement on total effective clearance from pre to post-testing as a result of the leaf wear in. There is also an increase in effective clearance when comparing static to dynamic results. This can be attributed to the radial growth of the disk due to rotation.
