Gas Foil Bearing Coating Behavior in Environments Relevant to S-CO₂ Power System Turbomachinery

M.S. Walker, D. D. Fleming, and J. J. Pasch
Sandia National Laboratories
Livermore, CA USA

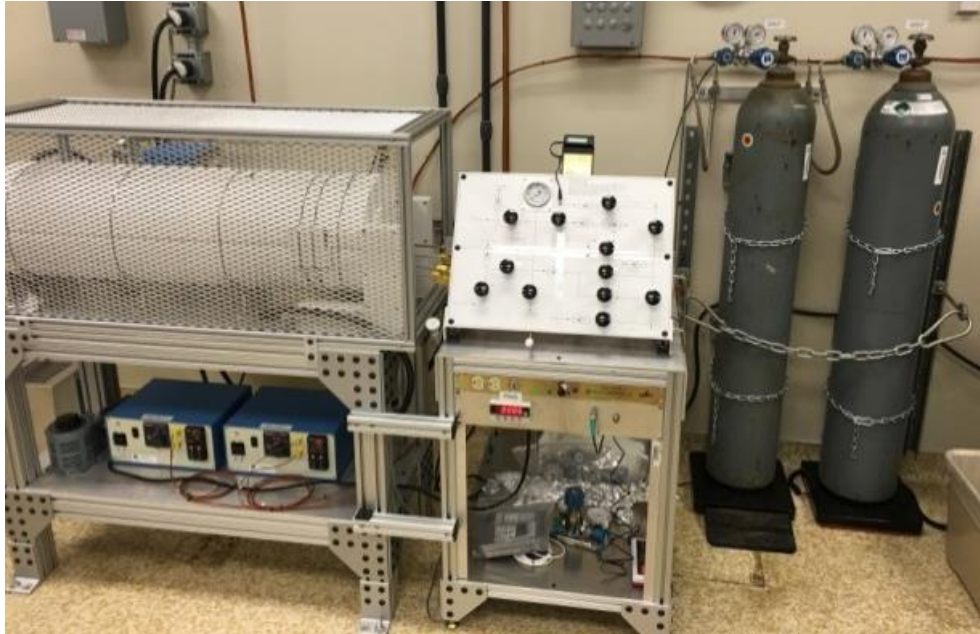
Figure 6. Modified autoclave furnace for gas foil bearing tests at 300psi CO₂

The test configuration for these evaluations was established using the high temperature autoclave furnace that was used previously for the carbon steel S-CO₂ corrosion study ^[11]; this is located at the laboratory in Livermore, CA. The furnace itself was modified to allow for tests in a controlled atmosphere of 300 psi CO₂, instead of in S-CO₂. While the pressure is maintained at 300 psi, the setup allows for a flow of fresh CO₂ through its chamber. Temperature of the internal chamber is measured across its length in three locations. A photo of the furnace setup for these tests is shown in Figure 6.

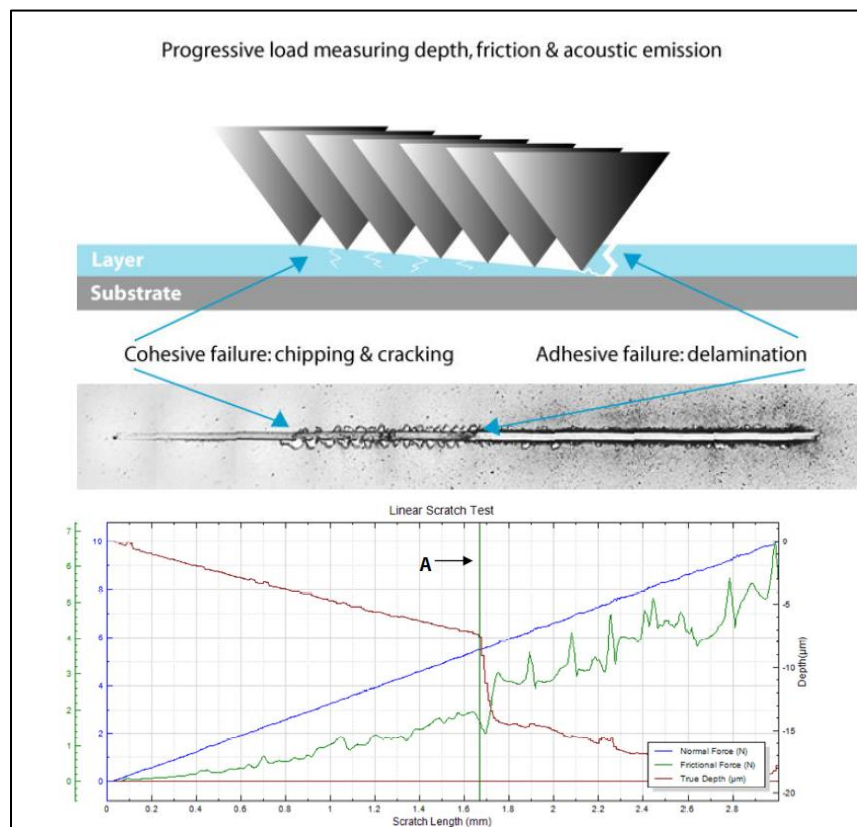
Figure 9. Illustration of multiple elements to instrumented scratch testing

In this test method, a diamond stylus of defined geometry is drawn across the flat surface of a coated test specimen at a constant speed and defined normal force (progressively increasing) for a defined distance. The damage along the scratch track is microscopically assessed as a function of the applied force. This technique is able to differentiate between cohesive failure within the coating (coating scratch damage resistance) and adhesive failure at the interface of the coating-substrate system (coating adhesion strength).

This test method is illustrated in Figure 9. Here, several pieces of information are brought together to demonstrate the method. The drawing at the top illustrates the damage that occurs to the coating material as the stylus moves across the surface. The two types of coating failure, cohesive and adhesive, are indicated here. Below this is a microscopic image of the sample surface. Again, the two distinct types of coating failure are indicated. The visual differences between these types of failure are used to indicate when these occur for a test sample. Finally, at the bottom is a chart indicating the applied normal force (blue), the resulting frictional force (green) and stylus penetration depth (red) across the length of the scratch. The microscopic image together with the chart are used to identify the force at which the two types of failure occur for a sample.

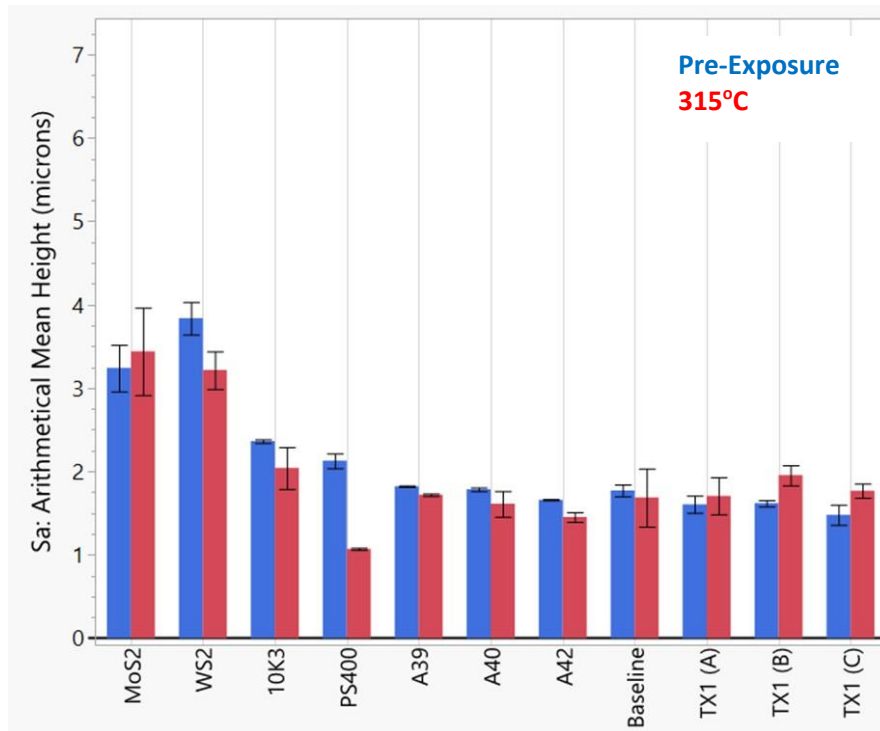
Figure 17. Surface roughness measurements for the 315°C exposure test samples

The surface roughness for samples are evaluated as a means of assessing how the various coating materials may be expected to perform in a bearing during rubbing. While it is only one variable of many that may contribute to its performance, a lower surface roughness is expected to improve bearing performance. It is useful to compare samples amongst themselves, but also to evaluate how sample roughness changes as a result of exposure to the high temperature, high pressure CO₂ environments.

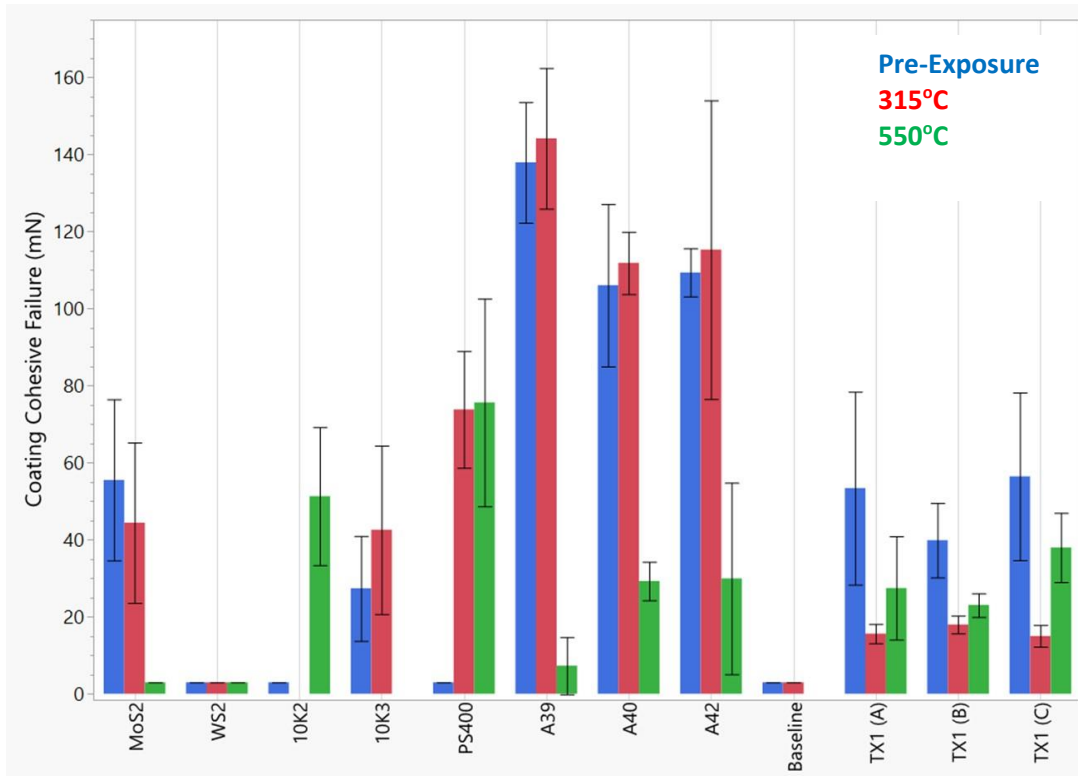
Figure 19. Measured cohesive failure values for each coating material at all exposure conditions

The two pieces of information obtained from the instrumented scratch testing are (1) the force at which coating cohesive failure occurs, and (2) the force at which coating adhesive failure occurs. The first relates to the ease with which the coating is able to be scratched or damaged, while the second relates to how strongly adhered the coating is to the substrate. Both are valuable metrics to consider in selecting bearing foil coating materials. High force values for both types of failure are desirable over low values.

The measured values for cohesive failure are provided for all of the coating materials at each of the test conditions (Pre-exposure, 315°C, and 550°C) in Figure 19. The WS₂ and Baseline thrust bearing coatings were the easiest to damage, and neither changed much with the environmental exposures. A legitimate concern for these samples would be the easy removal of the coating material from the bearing during rubbing. Some samples exhibited high damage resistance prior to exposure, but significantly lower resistance after exposures. This is particularly true for the MoS₂ and the three Mechanical Solution coatings (A39, A40, A42). For these samples, the changes in damage resistance were modest at the 315°C exposure, but decreased significantly at the 550°C exposure. For other samples, the damage resistance was low initially, but showed significant increase after environmental exposure. Obviously, this is preferable to the opposite scenario. This was observed for the 10K2, 10K3, and PS400 samples.

To summarize, the samples with the highest pre-exposure damage resistance were the Mechanical Solutions samples. These same samples also had the highest damage resistance after the 315°C exposure, while the sample with the highest damage resistance after the 550°C exposure were the PS400 sample. The samples with the highest pre-exposure adhesion strength were the Mechanical Solutions samples and the Baseline thrust bearing sample. Those with highest strength after the 315°C exposure were the Mechanical Solutions samples, and after the 550°C exposure were the MoS₂, WS₂, and PS400 samples.
