### Supercritical CO<sub>2</sub> Heat Exchanger Fouling

Sandia National Laboratories  
Albuquerque, NM USA  
email: amkrui@sandia.gov

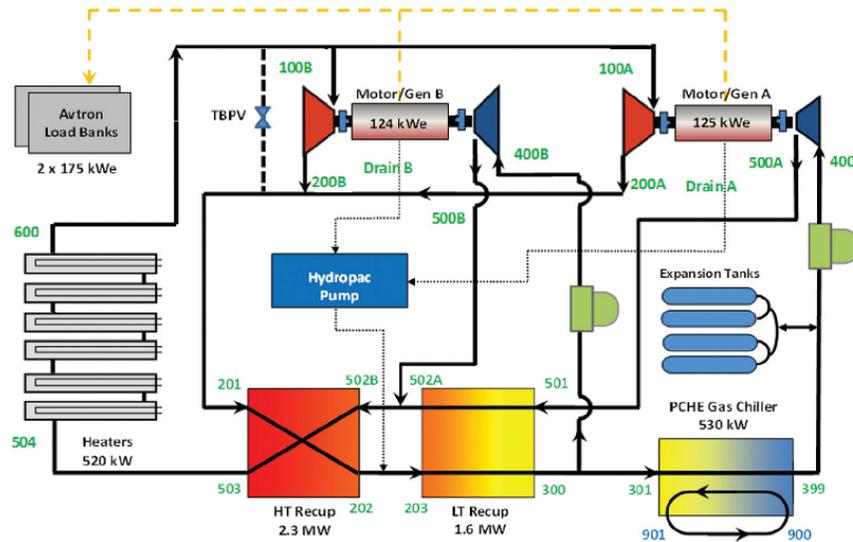
Figure 1: Schematic diagram of the SCO<sub>2</sub> RCBC test article.

The U.S. Department of Energy Office of Nuclear Energy (DOE-NE) supercritical carbon dioxide recompression closed Brayton cycle (RCBC) test assembly (TA) construction has been completed to its original design and resides at Sandia National Laboratories (SNL) in New Mexico. The cycle configuration is shown in Figure 1. Each component is subjected to different fluid conditions that may result in differing performance related concerns. Component lifetime will continue to be a heavily researched area as supercritical carbon dioxide (SCO<sub>2</sub>) continues to emerge as a working fluid for power cycles.

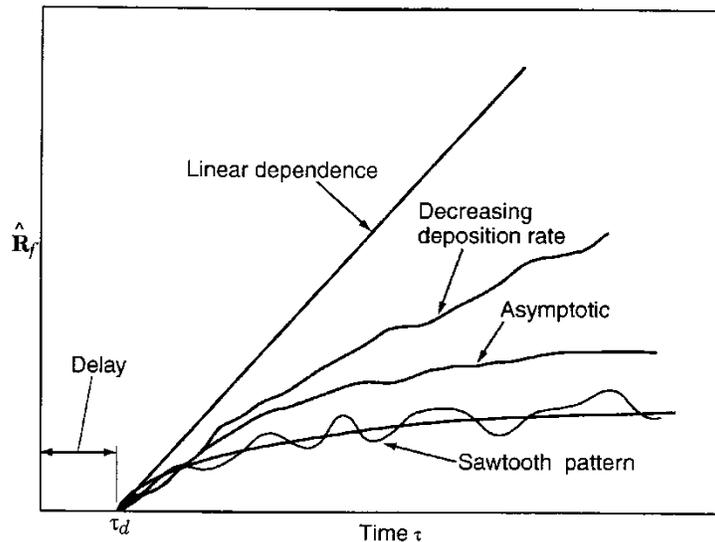
**Figure 2: Typical fouling behavior trends for heat exchangers [1].**

Fouling of a heat exchanger is a transient process that occurs over the service life of the unit and is closely coupled to the cleaning regimen it undergoes. Material build-up usually proceeds along one of the paths in Figure 2 from Shah [1] under steady operating conditions but can exhibit more complex behavior under the conditions encountered in a test system.

An initial delay period is seen as nucleation of fouling material occurs across the heat transfer surface. The length of the delay is affected by the interactions between the process fluid, surface chemistry, and surface morphology. Increasing surface temperature, roughness, and compatibility of the surface material with the foulant can all decrease this delay time.

This delay is followed by a complex period of foulant deposition, removal, and aging mechanisms. Deposition of fouling material generally increases with temperature, surface roughness, and impurity concentration while removal increases with higher wall shear stresses or flow velocities and proper surface design. Compact heat exchangers such as the Printed Circuit Heat Exchangers (PCHEs) used in the Sandia test article have relatively high wall shear stresses as well as complex flow paths that help scour fouling deposits away, leading to almost an order of magnitude reduction in fouling factors as compared to shell and tube units [3]. Corrosion fouling by a stable oxide is a common example of asymptotic fouling behavior where interaction with the process fluid builds a thin, stable oxide layer that

eventually reaches an equilibrium condition. Precipitation fouling in compact heat exchangers on the other hand will exhibit a fairly linear dependence as individual channels quickly fill and plug with precipitate.

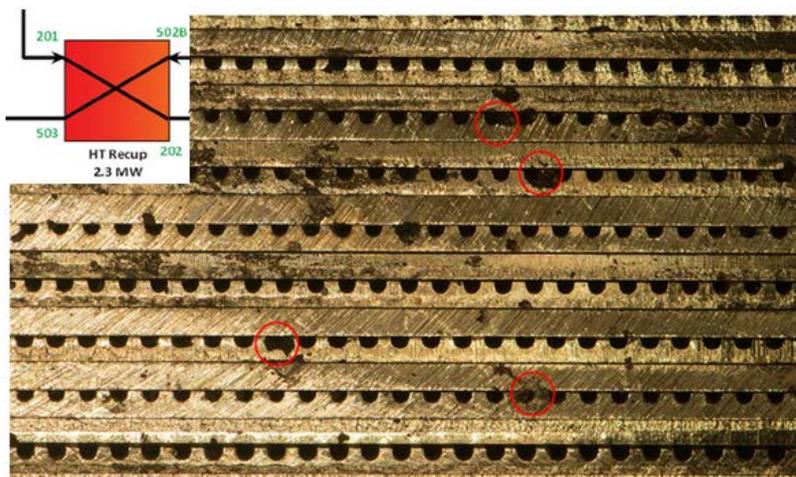
**Figure 3: Picture of high pressure, low temperature (location 502B) recuperator outlet, showing fouling and possible plugging of channels.**

Analysis of the fouling product from Figure 3 was performed using energy dispersive spectroscopy (EDS), Fourier Transform Infrared Spectroscopy (FT-IR), and Nuclear Magnetic Resonance Spectroscopy (NMR).

Fouling and build-up materials were found in the high pressure, low temperature inlet of the high temperature recuperative heat exchanger on the RCBC located at Sandia National Laboratories. Fouling products are composed of dirt, stainless steel, and hydrocarbon material. PCHEs behave as filters for agglomerates, where hydrocarbon contamination traps exfoliation products from piping and any dirt contamination that enters the system.

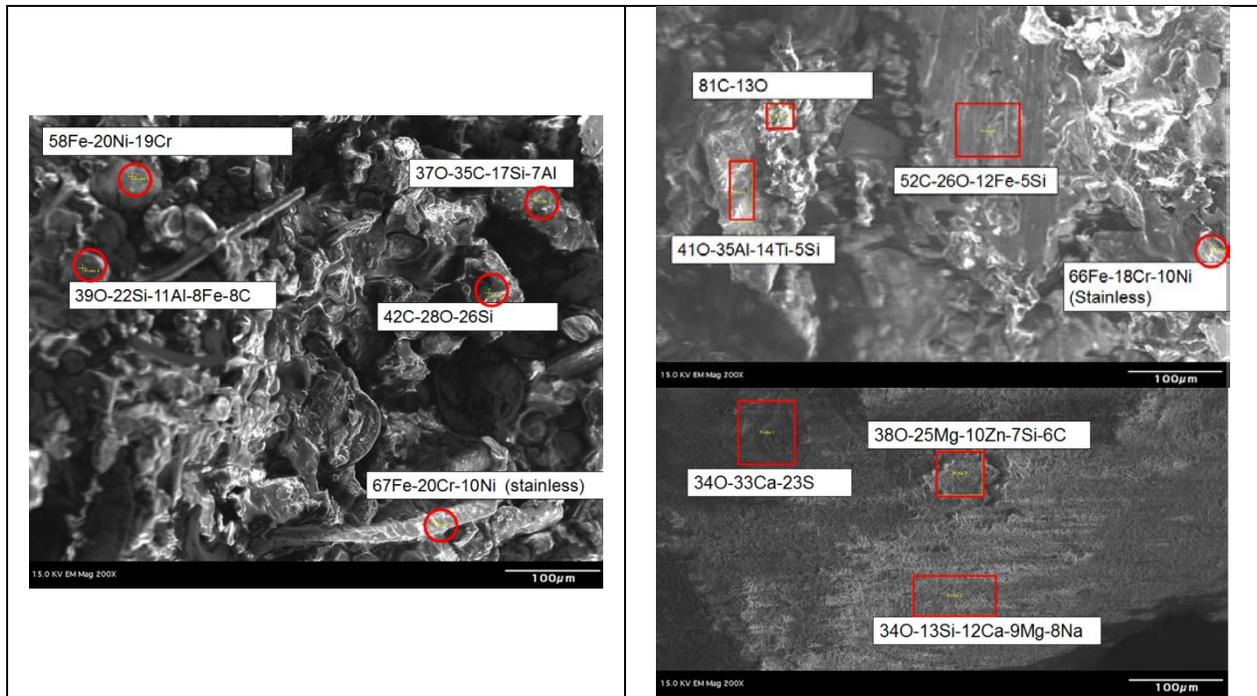
EDS analysis, shown in Figure 4, determined a variety of elements, which are likely extracted from different loop components. Metal from loop piping, graphite, and dirt were found in the analysis.

RCBC piping is fabricated from 316L (nominal max: Fe-18Cr-14Ni-3Mo-2Mn-0.75Si + minor), thus iron, chromium, and nickel rich products are thought to be from the loop piping. Uncalibrated EDS has large uncertainty when used for low Z (atomic number) elements, specifically carbon and oxygen. Regardless of this uncertainty, appreciable quantities of carbon and oxygen were detected and are likely due to graphite used in labyrinth seals on the TAC. Calcium and sodium were found and are commonly associated with compositions of dirt.

**Figure 4: EDS analysis of fouling product removed from heat exchanger. Elemental composition provided in weight percent.**

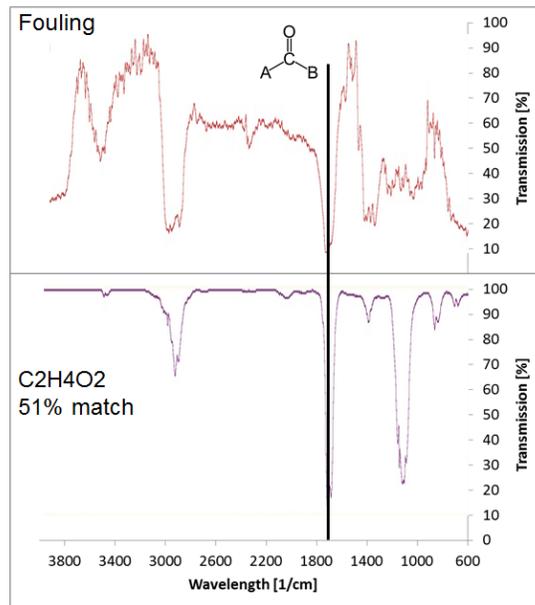
Samples were quite small and were of insufficient quantity to perform extensive analytical chemical analysis. FT-IR of the sample (Figure 5) indicated that organic products were present in the sample, but nothing more than characteristic peaks could be clearly determined from this analysis.

**Figure 5: FTIR data that yielded no clear matches. Carbonyl peak could be determined based on characteristic responses as shown in  $C_2H_4O_2$ , hence confirming presence of organic products.**

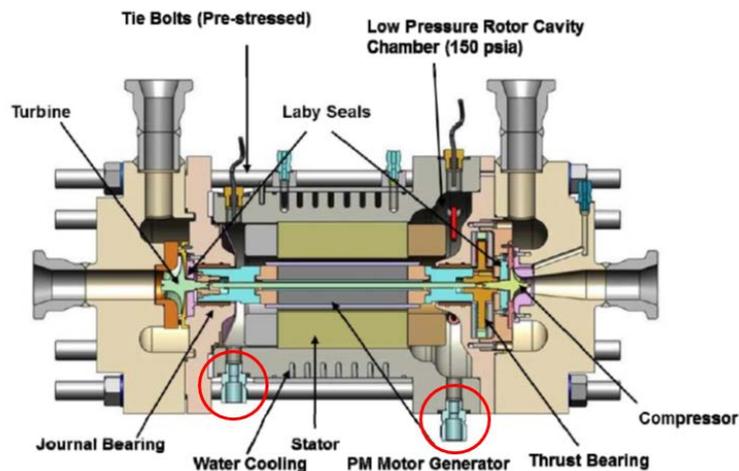
**Figure 6: A cross-sectional diagram of the turbo-alternator-compressor (TAC) unit. Two drain locations are shown on the bottom of the unit (circled in red), with one drain line currently unused and closed off by the Swagelok fitting shown in Figure 7**

Tar was found in a Swagelok fitting (Figure 7) during routine inspection and maintenance. It should be noted that all pumps are oil-free and cleaning all  $\text{SCO}_2$  wetted surfaces are done prior to installation, thus the finding of this tar was unexpected. This fitting is located on an unused drain line in one of the turbo-alternator-compressors (TACs), one of two available for draining the rotor cavity as shown in Figure 6.

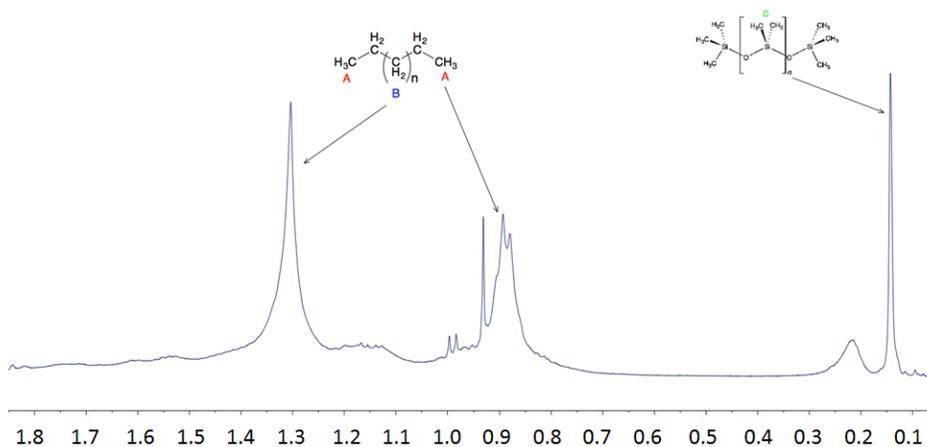
Hexane solvent is a hydrocarbon, similar in chemical structure to gasoline or kerosene, and it is low boiling (easy to evaporate and remove without further contamination). We evaporated the low boiling hexane solvent leaving behind a colorless, oily residue. This residue was then analyzed using nuclear magnetic resonance (NMR) techniques, which can detect the presence of hydrogen atoms in a material and determine the identity of the other atoms that surround that hydrogen atom. Figure 8 shows the NMR spectrum of the colorless, oily residue. If no hydrogen atoms were present, the spectrum would be a flat baseline. However, there are two features that show up in what is called the "alkane region" (1.3 ppm and 0.9 ppm). This is an indicator of either hydrocarbon oil or grease.

However, the NMR spectrum of the extract has additional features, specifically showing up around 0.1 ppm. Peaks in this region are characteristic of silicon-containing hydrocarbons. Figure 10 shows the spectrum of Fisherbrand Silicone Oil, and silicone oil shows a sharp peak at roughly 0.1 ppm.

**Figure 8: NMR spectrum of tar dissolved in hexane. The first two peaks correspond to a hydrocarbon oil such as Welch DuoSeal Pump Oil as shown in the spectrum of the oil alone in Figure 9. The third peak corresponds to silicone oil such as Fisherbrand Silicone Oil shown alone in the spectrum in Figure 10.**

The hexanes solvent extracted both hydrocarbon oil and silicone oil from the tar, and these were confidently identified based on known literature values and also standards (Welch Pump Oil and Fisher Silicone Oil).

Since oil-free equipment is used in the RCBC the source of the hydrocarbon is unknown. Hydrocarbon impurities are present to some extent in the CO<sub>2</sub> used for experiments. 99.9% CO<sub>2</sub> purity currently used in the RCBC and, between tests, the CO<sub>2</sub> is vented. Successive fills of the RCBC may be sufficient to cause

an accumulation over time of hydrocarbon material. Estimations, based on the number of fills and 5ppm of total hydrocarbon, would contribute 22 grams of hydrocarbons over the operation lifetime of the RCBC.

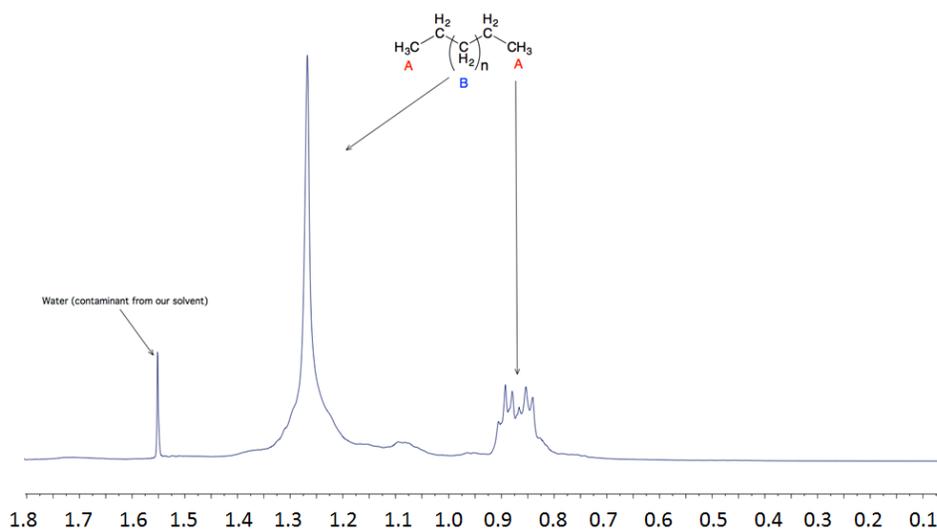
In order to provide evidence for this hypothesis, a sample of Welch DuoSeal Pump Oil was tested (Figure 9). The NMR spectrum of pump oil shows two features, which are unmistakable as a long-chain

hydrocarbon (oil). These features are also present in the extract, which confirms that they are also some form of hydrocarbon oil.

**Figure 9: NMR spectrum of Welch DuoSeal Pump Oil with characteristic peaks at 1.3 ppm and 0.9 ppm in the “Alkane” region. The peak at 1.55 indicates water contamination in the solvent.**

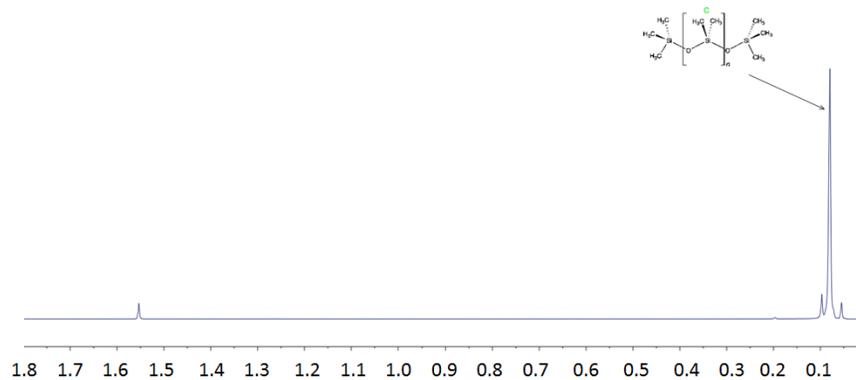
**Figure 10: NMR spectrum of Fisherbrand Silicone Oil with a characteristic peak near 0.1.**
