# Approach for Ultra-Low Piping Stress in a High-Pressure/High-Temperature Integrally Geared Compressor

Jason Wilkes, Ph.D., Kelsi M. Katcher,  
Southwest Research Institute

sCO<sub>2</sub> Symposium  
Feb 22-24, 2022, San Antonio, TX

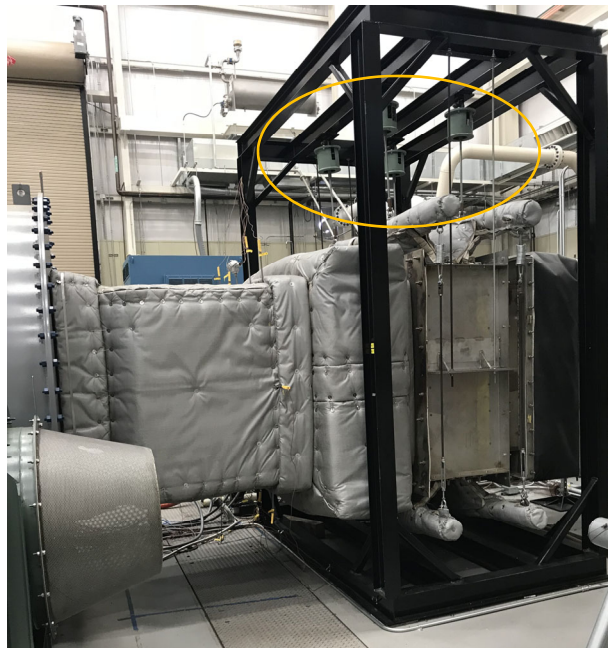
Heater supported with spring hangers

- Significant thermal growth in the hot section
- Heavy-wall piping required is very stiff
- The combination can cause elevated piping stresses and elevated equipment nozzle loads during operation
- The primary heater and the recuperator were softly supported to allow movement.

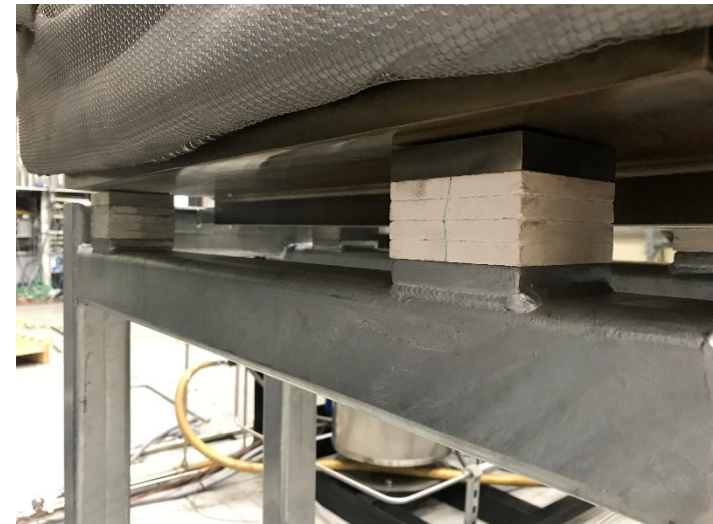
Recuperator Supports – insulated footing with polished stainless steel contact

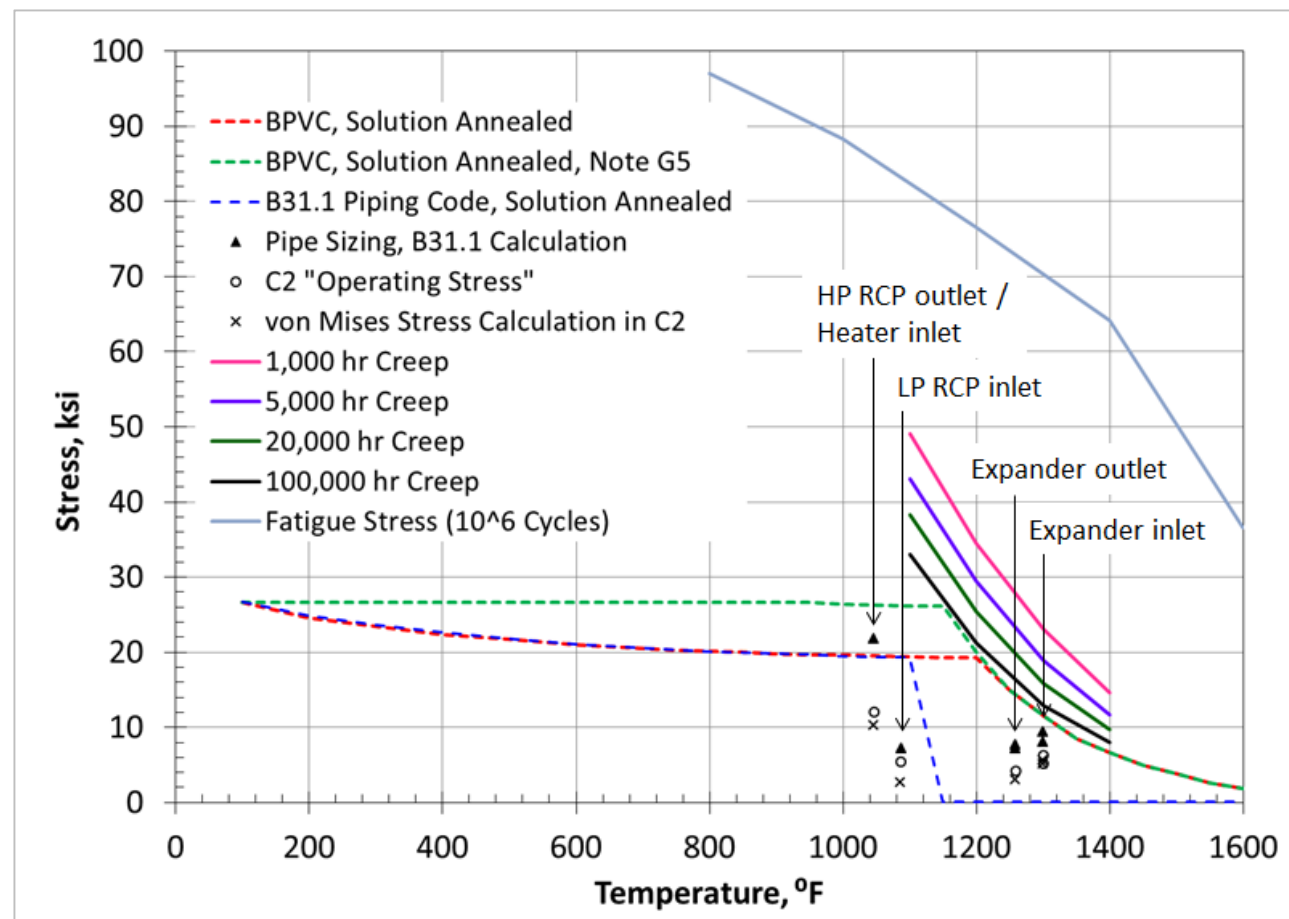
- INCO 625 selected
- Strength from B31.1 Piping Code goes to 0 at these conditions.
- Strength values validated with B&PV code, material creep strength, and fatigue strength
- Actual material stresses pulled from pipe sizing analysis and Caesar II pipe stress results

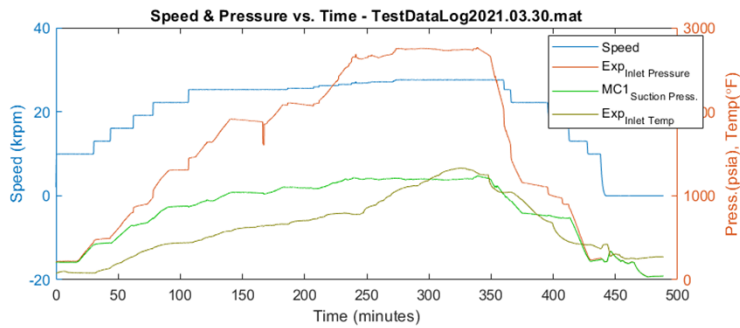
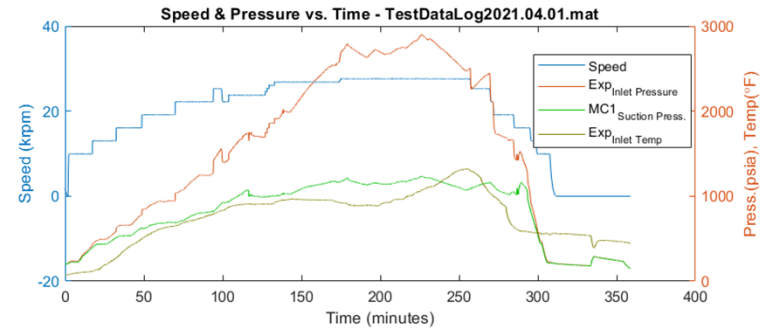
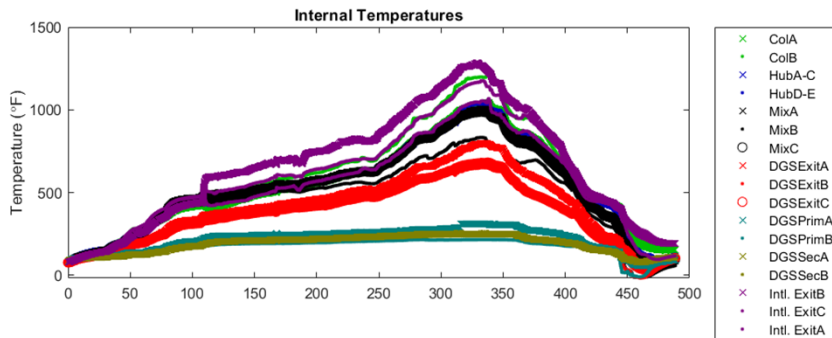
On the first run to temperature we achieved a turbine inlet temperature of 1329°F, or 720°C

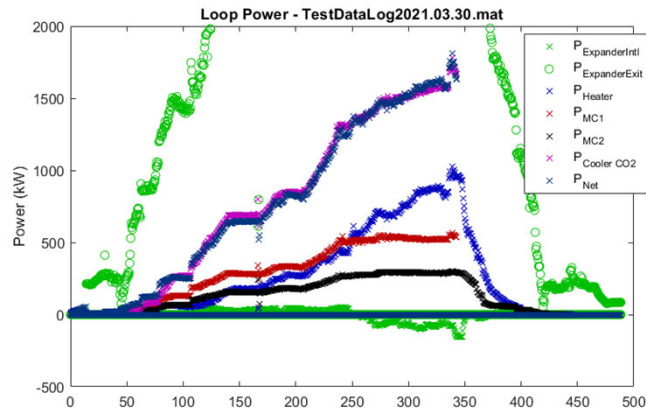
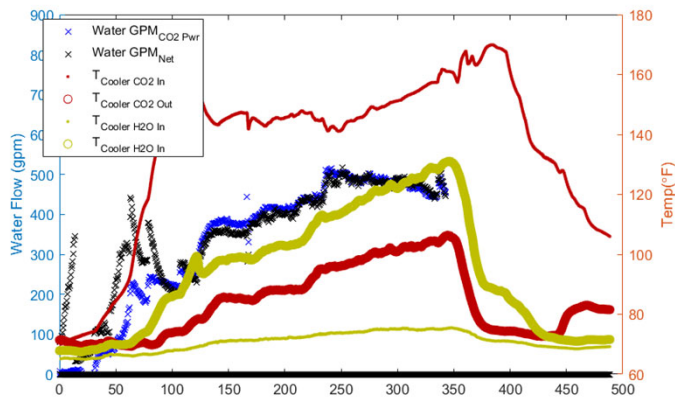
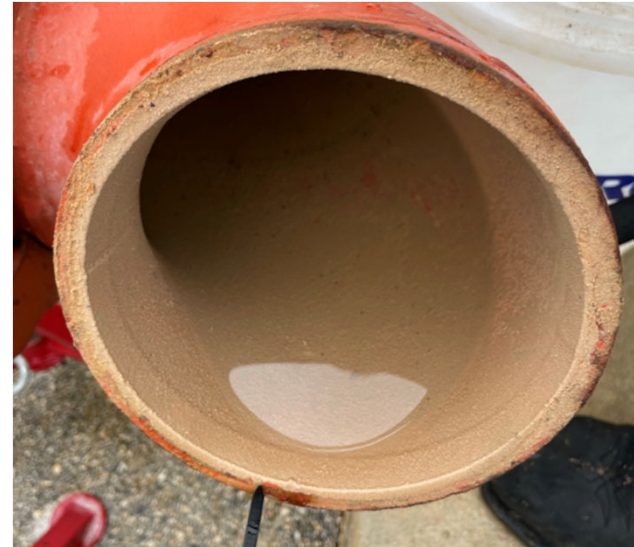
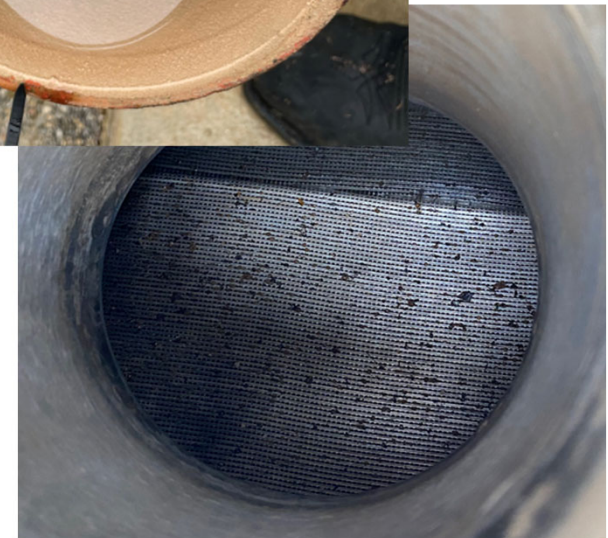
# Loop Power balance simulations showed that water flow rate was drastically lower than anticipated

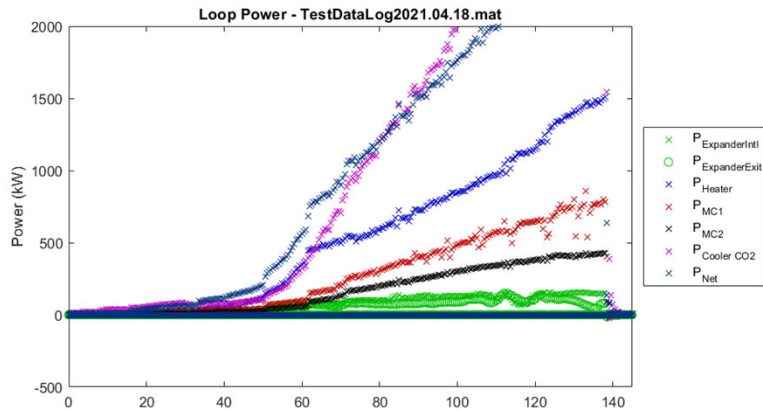
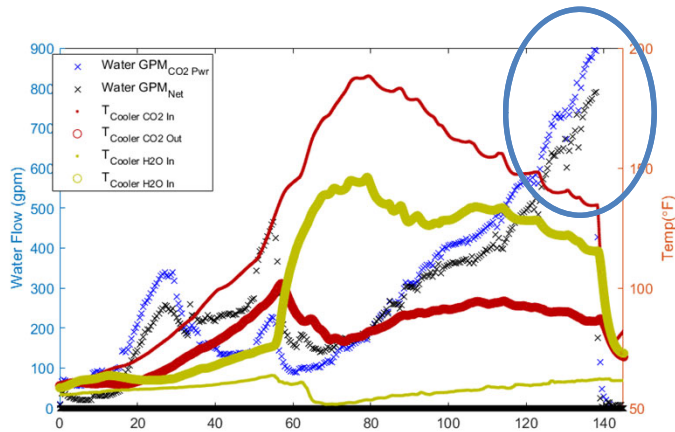
*Cleaning the cooler with CLR showed a drastic improvement in water flow, allowing increased operating power for the loop*

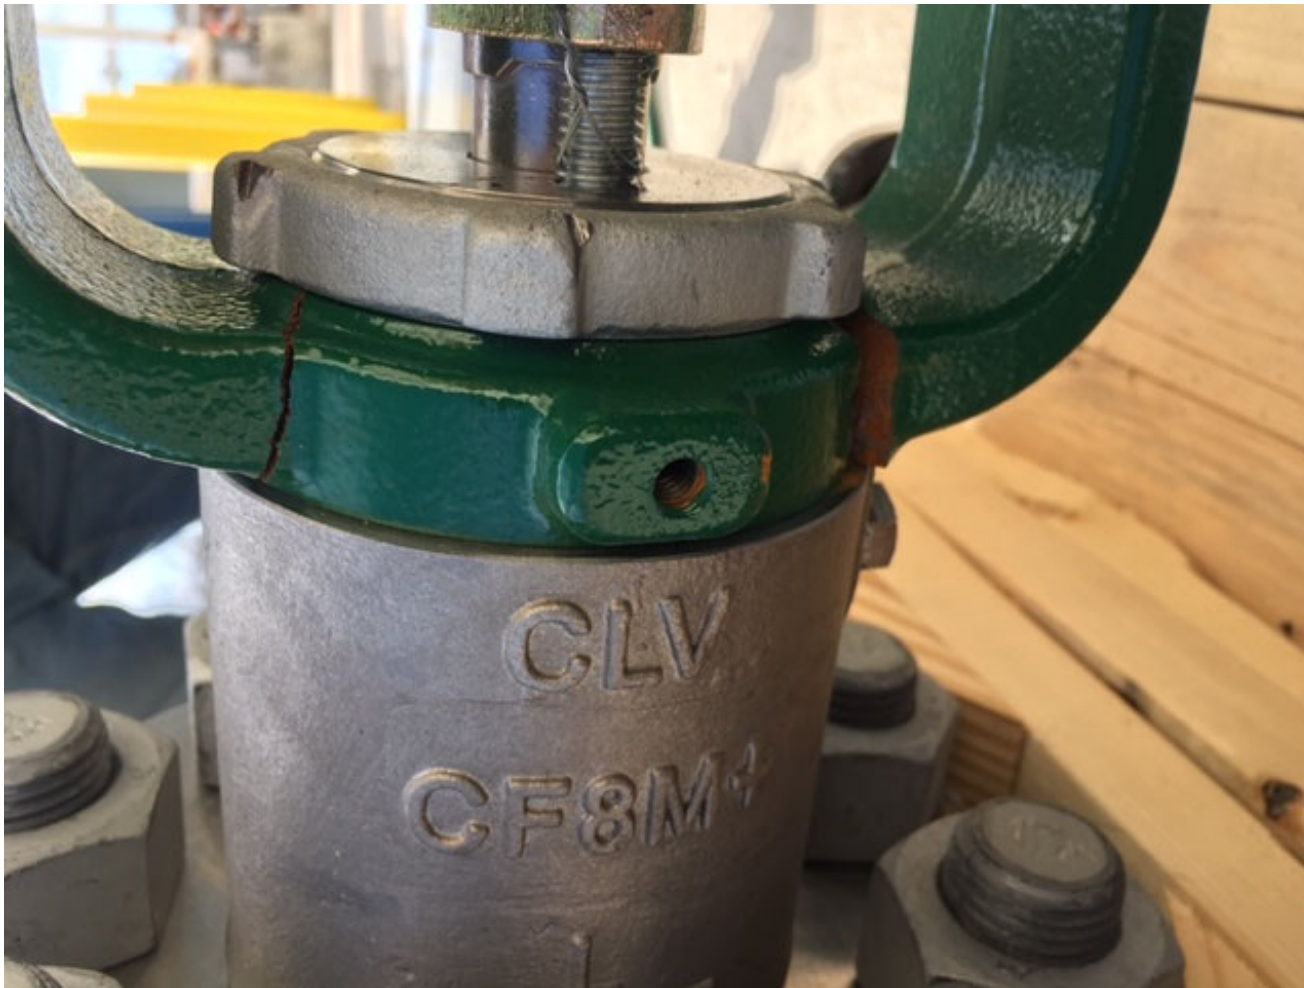
**The damage valve was sent back for inspection,  
where a bent stem was observed**

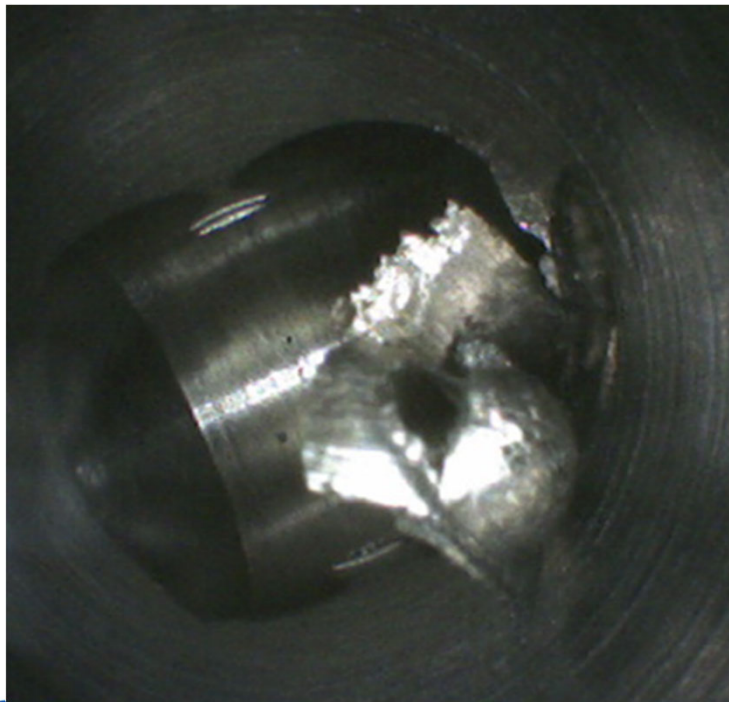
## *Machining debris found in the compressor seal ports*

- During inspection of DGS ports to determine if oil was present, large burrs were found in the DGS ports that presented debris risk

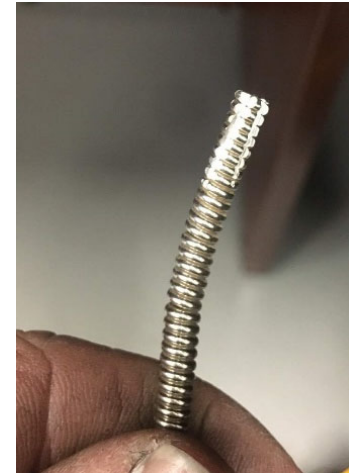
*Flexible Deburring Tool*

# Using a flexible choke cord, a deburring tool was constructed to deburr the ports in place

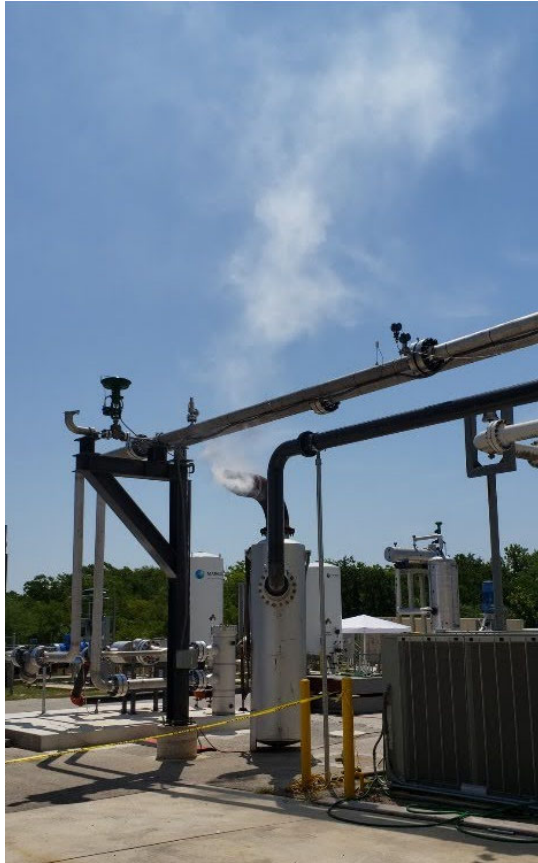
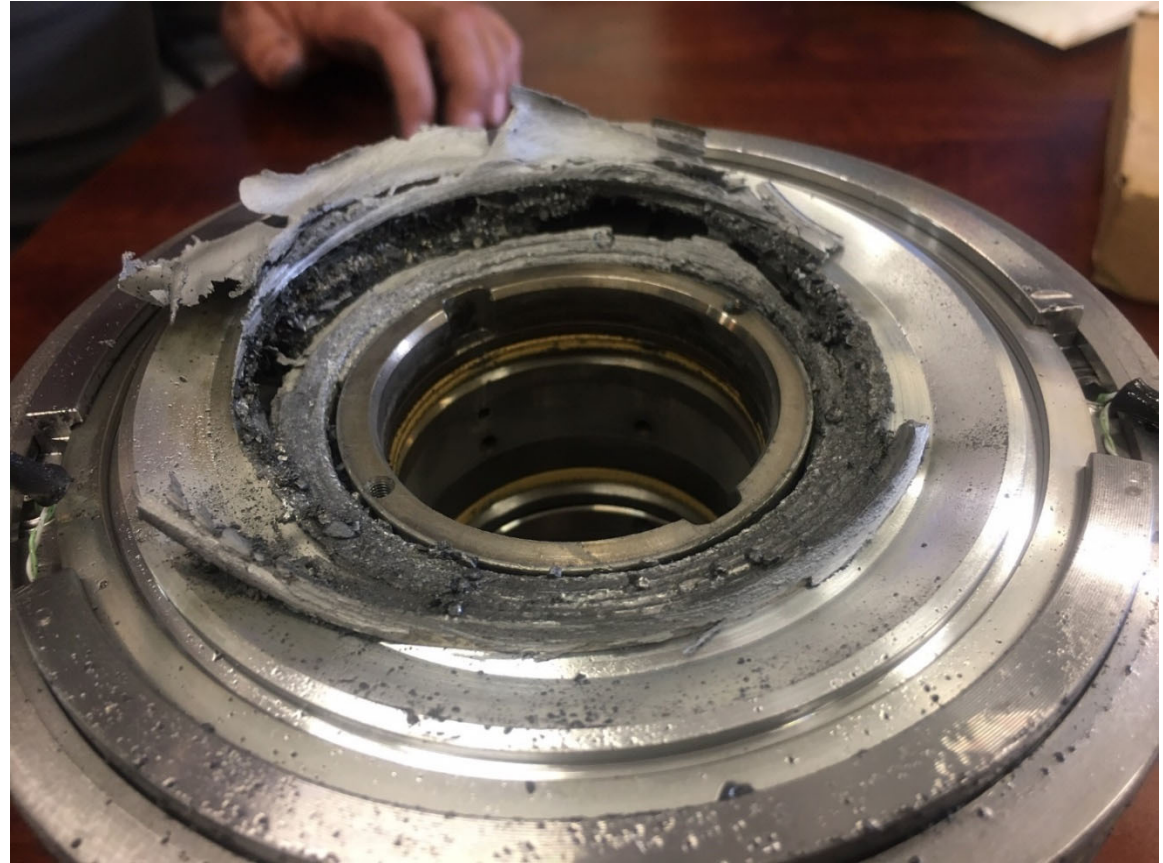
# Dry Gas Seal Failure

**1. While operating it was observed that main gearbox vent had opened**

- Vibration and temperature was all within normal operating conditions at the time of the DGS failure

**2. Inspection found that the stage 2 DGS had failed**

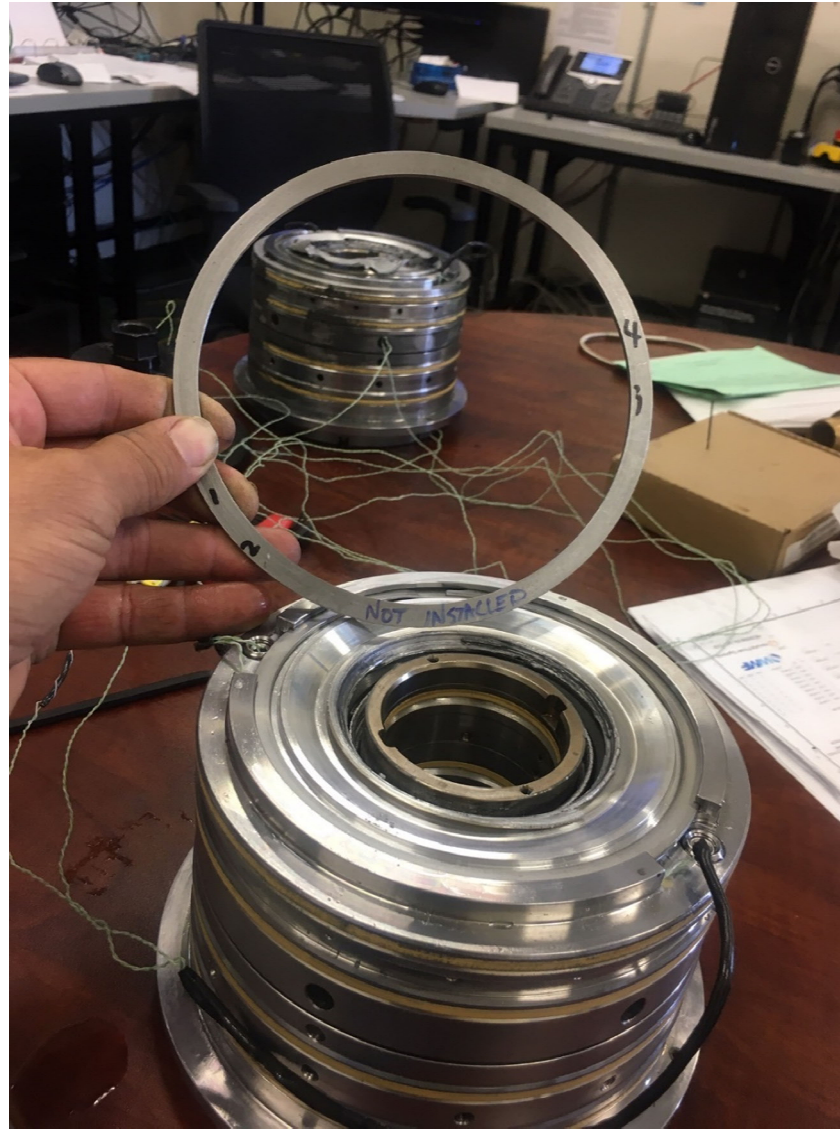
1. The shimming for the MC2 DGS was found to be incorrect during disassembly following the seal failure. This would have allowed contact between the stationary separation seal laby and the rotating slinger on the shaft once a back pressure had been established on the primary vent.

# Shim found missing on the DGS

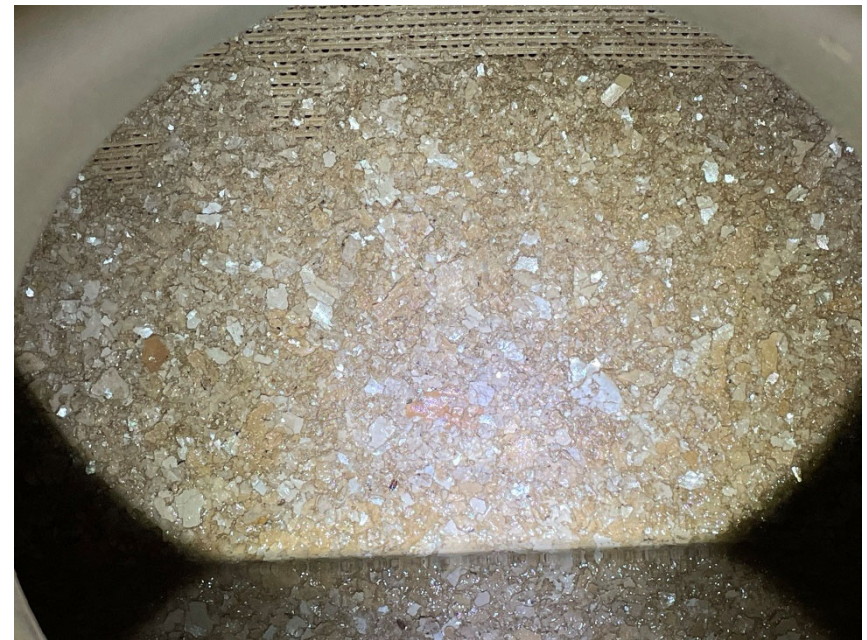
**PCHEs are great for closed water systems – our facility was not originally design with the use of PCHEs in mind**

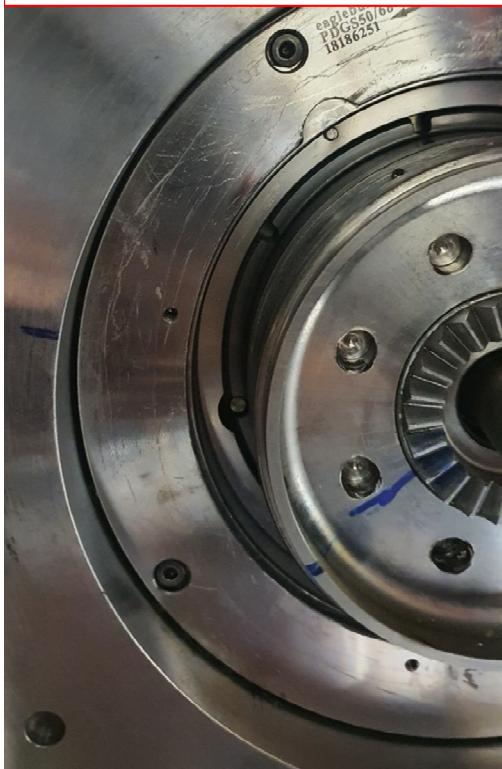
DGS Still Installed –  
Process Side Laby and  
Retaining Snap Ring  
Missing

Snap  
Ring

O-ring  
Pieces

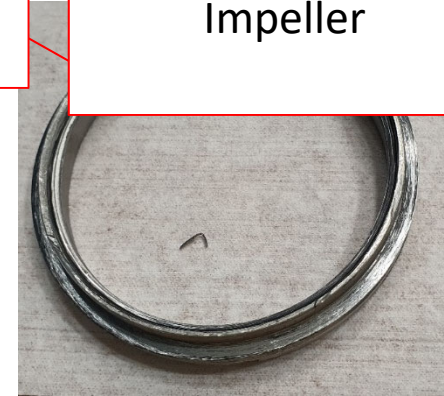
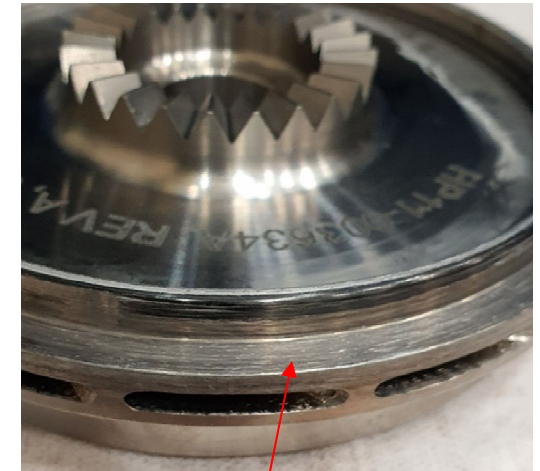
Process  
Side Laby

Process Side Laby  
Has rubbed on  
Impeller

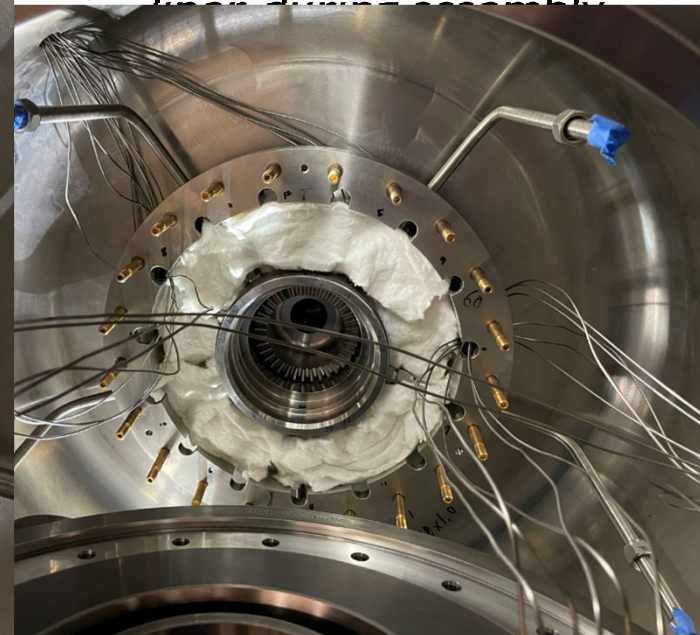
# Thermocouples were also added to the housing to determine housing temperatures

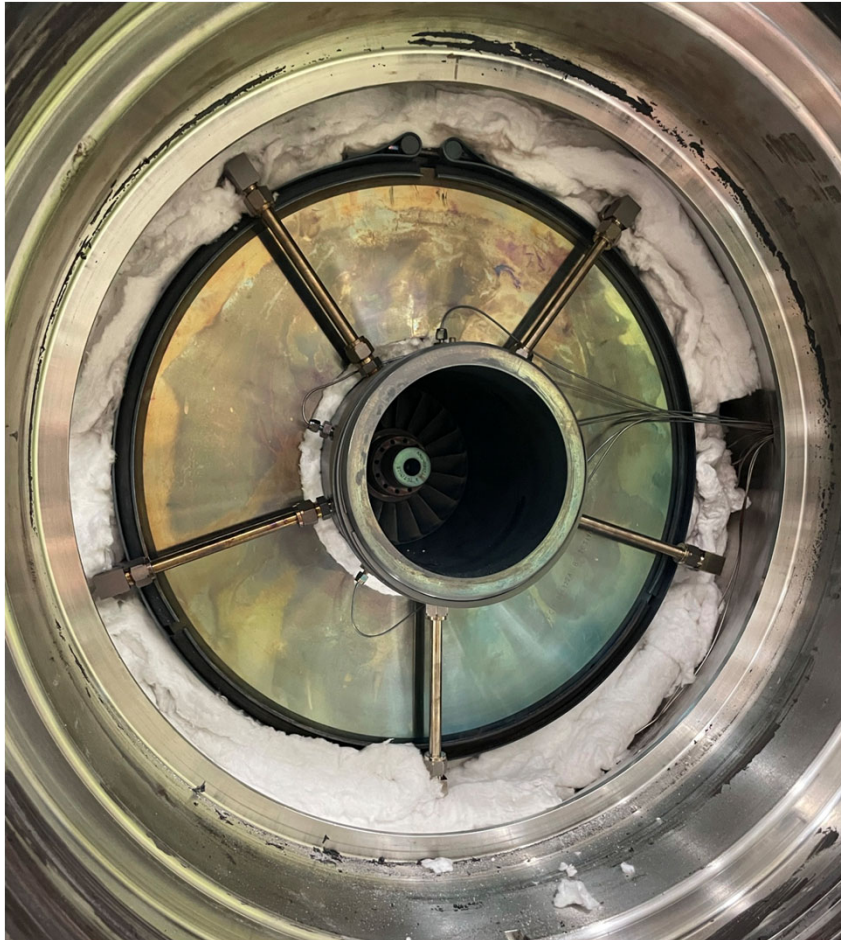
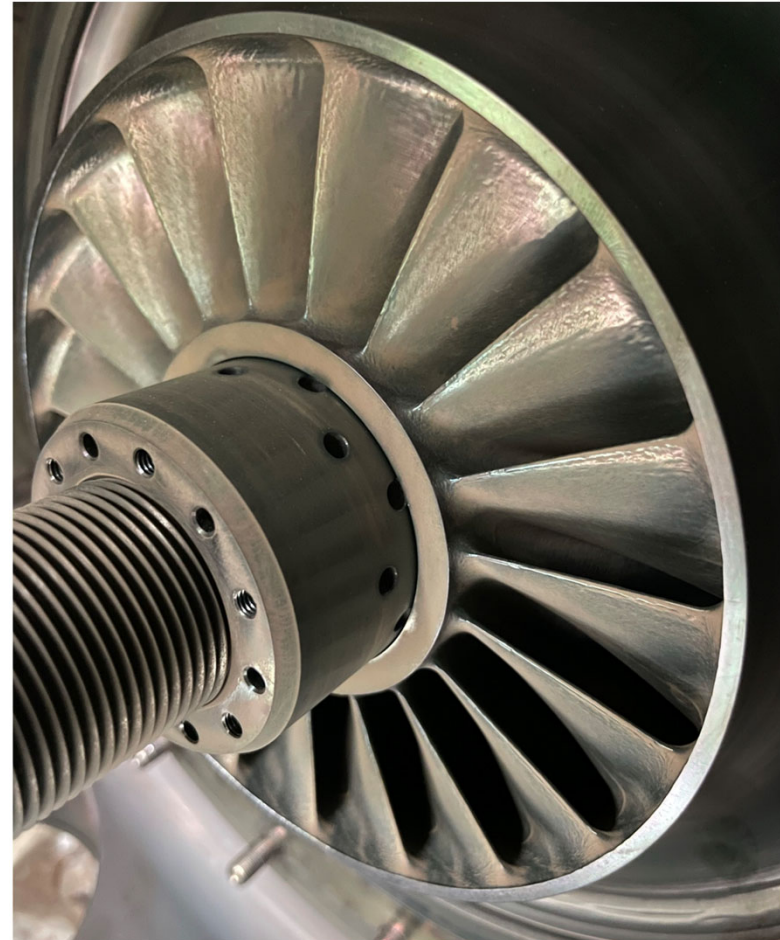
*Turbine disassembly showed good condition of parts*
