## The effect of elevated temperatures and pressure on five metallic materials in a quasi-static supercritical CO<sub>2</sub> environment

### ABSTRACT

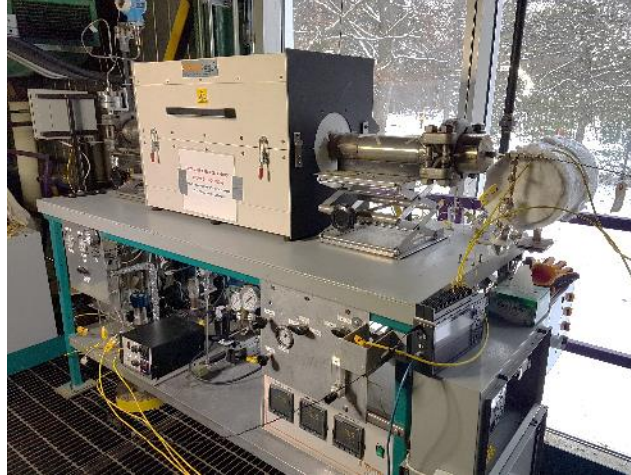
Figure 1: High pressure and temperature supercritical CO<sub>2</sub> corrosion test rig, jointly developed by Natural Resources Canada's CanmetENERGY-Ottawa and Carleton University.

The candidate materials were tested in a unique corrosion test rig that was jointly developed by CanmetENERGY-Ottawa (CE-O) and Carleton University [11]. Figure 1 shows the corrosion test rig, and Figure 2 provides a schematic of its process flow diagram. The supply CO<sub>2</sub> gas comes from a bulk tank located on the facility's premises and is pneumatically boosted to the test's target pressure using a sCO<sub>2</sub> compatible booster pump. Target pressure is achieved by adjusting a pressure regulator downstream of the booster pump. A series of heat-traced lines are used to preheat the fluid before it enters the pressurized vessel that is, in turn, installed inside a ThermCraft three-zone tube furnace XST-6-0-36-3V; the preheating allows for better control in reaching the target temperature. The tube furnace can be set to achieve a wide range of temperatures, including 550°C and 700°C. The metal samples are held in an alumina (Al<sub>2</sub>O<sub>3</sub>) specimen boat at the centre of the furnace (Figure 3). The corrosion test rig has been designed to operate at maximum temperatures of 750°C at 294 bar, or 800°C at 176 bar.

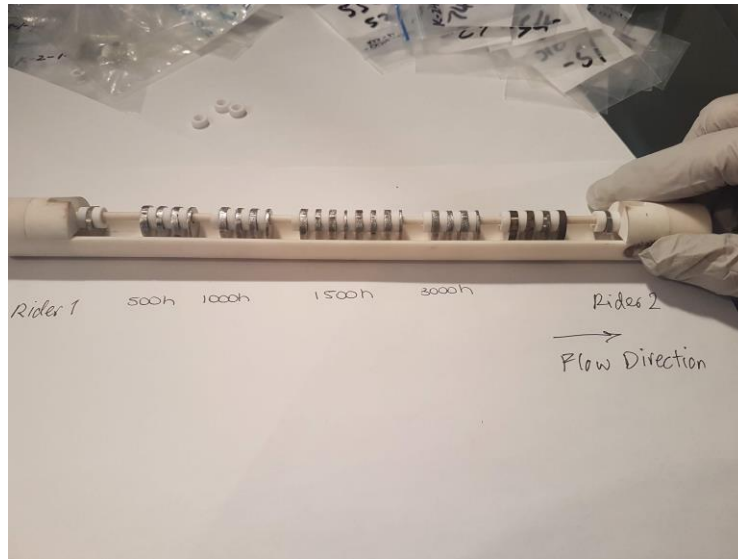
Figure 3: Test samples inside the alumina specimen boat prior to the first test.

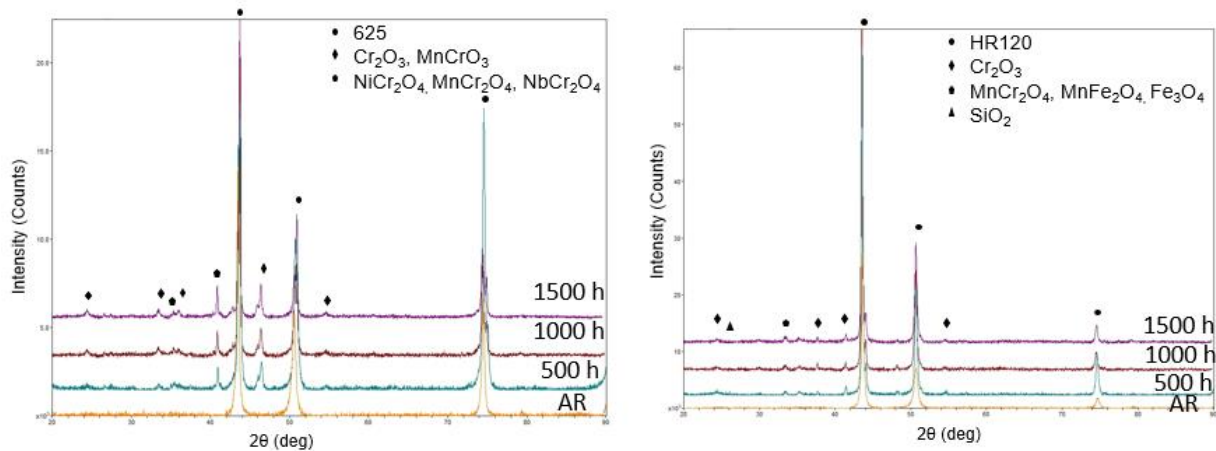
Figure 10: XRD analysis of Inconel 625 and Haynes HR-120 after exposure to  $\text{sCO}_2$  at  $550^\circ\text{C}$  and 200 bar.

XRD results for the four alloys are presented in Figure 10 and Figure 11. These results confirm that the primary oxide for the two nickel alloys is  $\text{Cr}_2\text{O}_3$ , whereas  $\text{Fe}_3\text{O}_4$  is primary oxide for the steels. Further observations indicated that the level of oxidation identified for 625 and HR-120 is relatively low, based

on the intensity peaks in Figure 10. The peaks associated with the substrate materials are significantly higher than those of the oxides. In addition to the primary oxide  $\text{Cr}_2\text{O}_3$ , Inconel 625 exhibits the formation of additional crystalline phases, including Mn, Ni and Nb substitutions in the chromia or spinel crystal structures, whereas HR-120 displays the formation of additional oxides, in the form of Mn-Fe-Cr spinel structure. It is evident that the 316L stainless has significant oxidation due to the higher intensity peaks and the number of oxide peaks. A split in the austenite peak can be seen at  $\sim 44^\circ 2\theta$ , which corresponds to the alteration of cell size in austenitic lattice [13]. Finally, GR 91 shows high intensity peak associated with  $\text{Fe}_3\text{O}_4$ , which is indicative of lower corrosion resistance in this type of alloy.

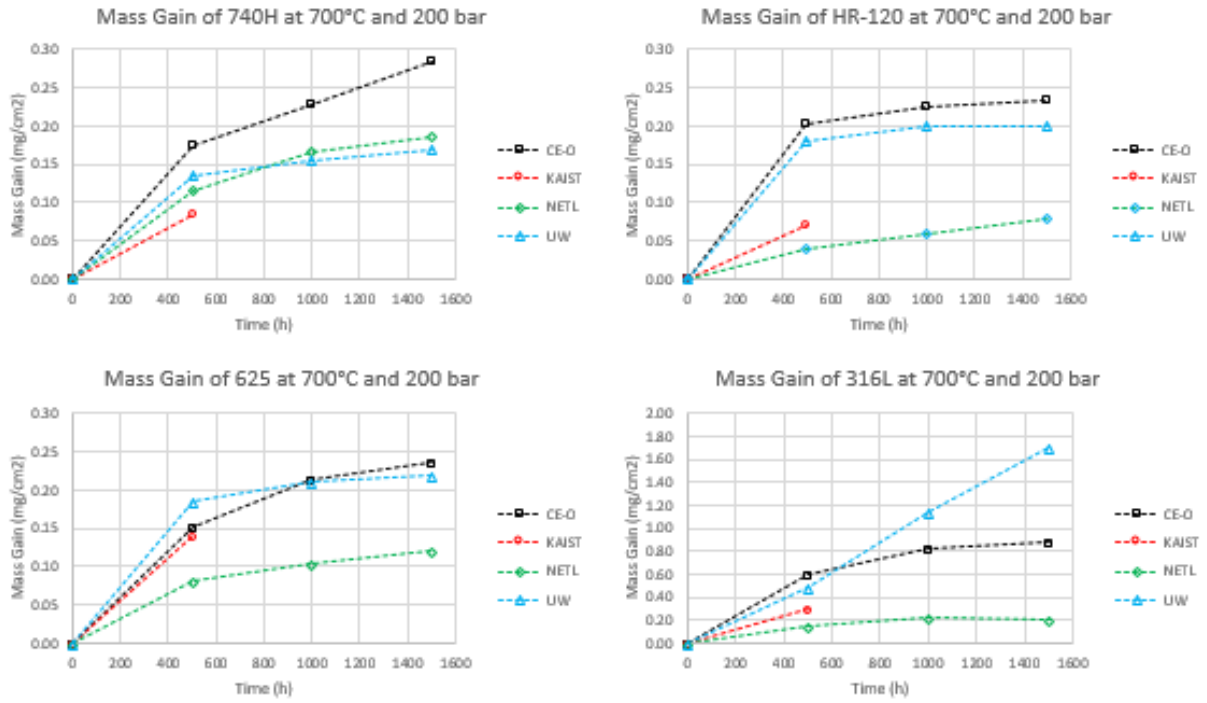
Figure 13: Mass gain of sample coupons exposed to  $s\text{CO}_2$  at 700°C at 200 bar compared to results obtained by other institutions [10]

Figure 13 depicts the mass gain experienced by the tested alloys. The results obtained through this study are plotted in black dashed lines (CE-O). The 316L stainless steel presented the highest mass gain of 0.88 mg/cm<sup>2</sup>. The three Ni-base alloys all displayed a similar mass gain between 0.23 and 0.28 mg/cm<sup>2</sup>, with the lowest mass gain experienced by HR-120 (0.233 mg/cm<sup>2</sup>), closely followed by 625 (0.235 mg/cm<sup>2</sup>). The trends observed are consistent with the results reported by others participants of the round robin test campaign [10]. The lower mass gain observed for 316L after 1500 hours, in comparison to the results obtained at UW, is likely due to spallation of some oxides during the final exposure (based on the physical appearance of the sample).

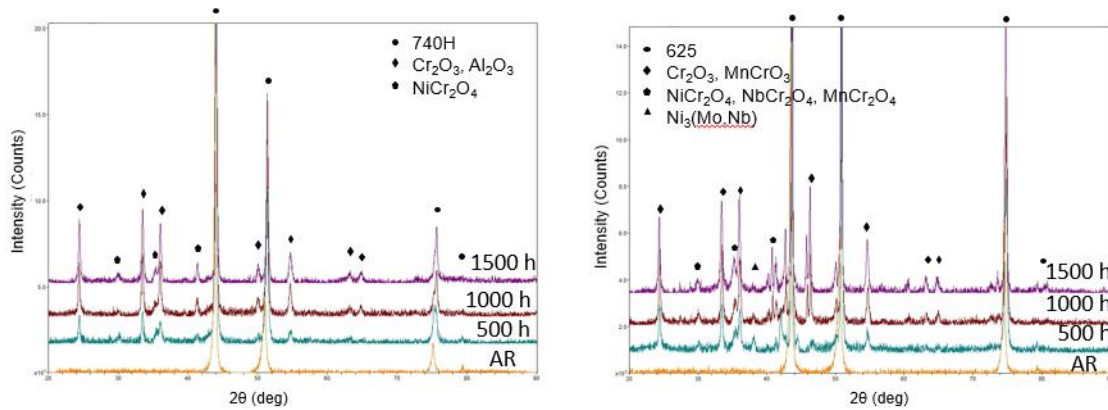
Figure 18: XRD analysis of Inconel 740H and Inconel 625 after exposure to  $\text{sCO}_2$  at  $700^\circ\text{C}$  and 200 bar.

Figure 18 and Figure 19 present the XRD results for the samples. The primary oxide for all three nickel alloys was Cr<sub>2</sub>O<sub>3</sub>, while for 316L, the primary oxides were both Cr<sub>2</sub>O<sub>3</sub> and Fe<sub>3</sub>O<sub>4</sub>, as well as Fe<sub>2</sub>O<sub>3</sub>, and MnFe<sub>2</sub>O<sub>4</sub> spinel. The splitting of the austenite peak at ~44° 2θ was also observed, similar to the observations reported at 550°C. Examination of HR-120 detected Cr and Mn oxides (Cr<sub>2</sub>O<sub>3</sub> and spinel MnCr<sub>2</sub>O<sub>3</sub>) as the predominant crystalline phases. Presence of some SiO<sub>2</sub> crystalline phase was also detected during XRD analysis for HR-120 and 316L, which could be a result of the sample preparation agents. Cr<sub>2</sub>O<sub>3</sub> made up the majority of the oxide on Inconel 625 throughout the test campaign with

some Mn, Ni, and Nb substitutions in the chromia or spinel crystal structures. The peak intensity of  $\text{Ni}_3(\text{Mo, Nb})$  crystal phase, formed on the surface of substrate, was noted to reduce over the course of exposure. Finally, 740H also displayed  $\text{Cr}_2\text{O}_3$  as the primary oxide with a minor phase of spinel such as  $\text{NiCr}_2\text{O}_4$ . One feature of 740H, which was not detected in the other alloys, was the formation of an  $\text{Al}_2\text{O}_3$  layer at the surface of the substrate, as detected in the XRD pattern (Figure 18). The formation of a protective  $\text{Al}_2\text{O}_3$  oxide is desired particularly in gas turbine applications as it forms a barrier to oxygen ion diffusion [14]. However, in this study 740H displayed many voids along the grain boundaries and a fairly sizable Cr-depletion zone, which is indicative of metallic ion migration to the oxide layer.
