Mechanical and Rotordynamic Test Results of a Supercritical CO₂ Compressor Operating Near the Critical Point

Power Cycle

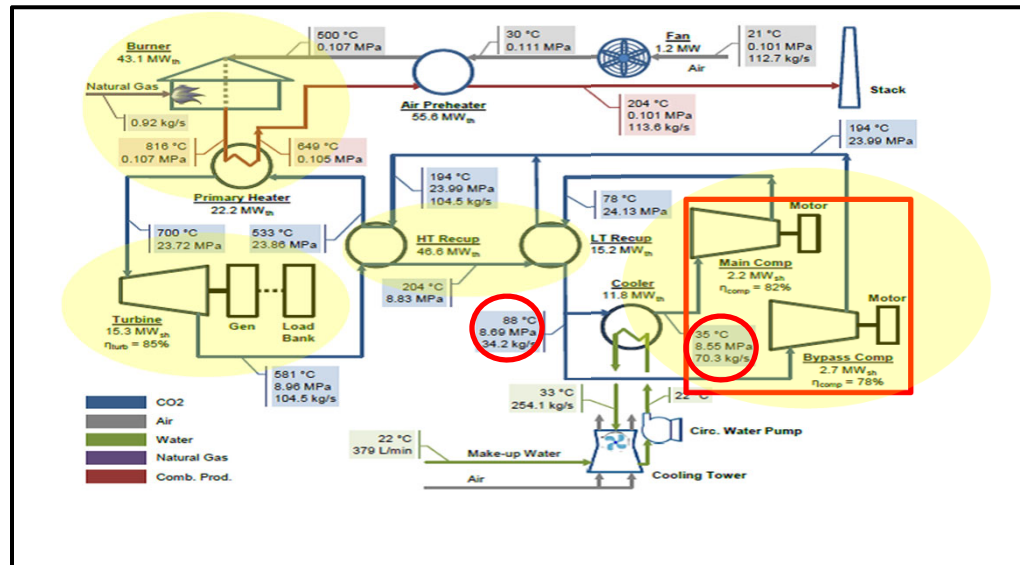
- 10 MWe, Re-compression Brayton Cycle
- Main Components
 - High and Low Temperature Recuperator
 - Main and Bypass Compressor
 - High Temperature Turbine
- Main Compressor Conditions
 - Inlet: 35°C and 8.5 MPa
 - Exit: 74°C and 27.2 MPa
 - ~70 kg/s
 - Mean Gas Density: 677.3 kg/m³

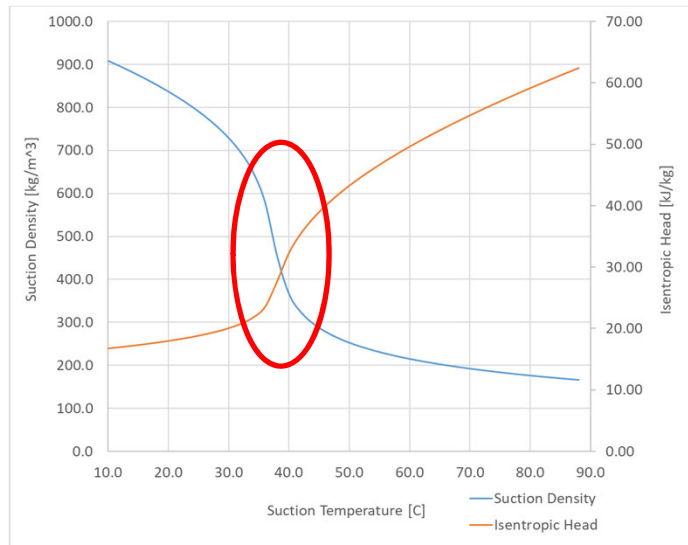
- Design conditions are driven by achievable suction temperatures from water / air cooling
 - While colder suction temperatures (liquid) requires less compression power, chilling coefficient of performance is much greater than water / air cooling
- Inflection point around 35°C at 8.5 MPa

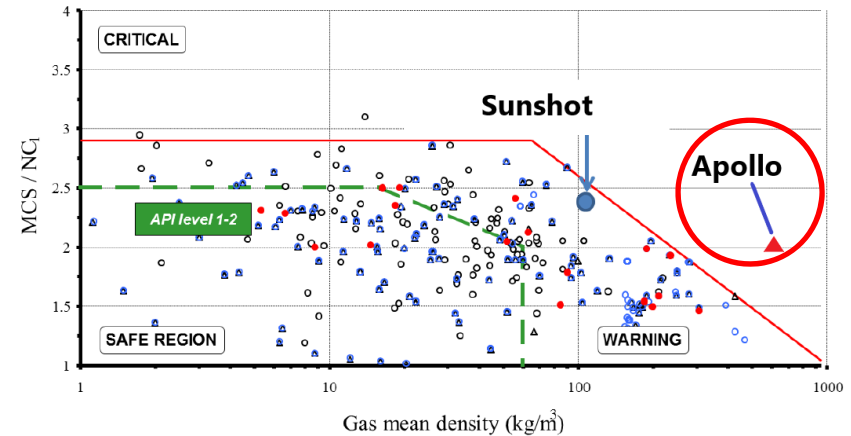
- High density and large density swings are challenging for a compressor to manage
- High density → large fluid forces to could excite lower modes (subsynchronous)
- Large density swings → large changes in mass flow
- Fulton Chart (top right) highlights Critical Speed Ratio (CSR) vs Gas Mean Density along with experience limits and checks for API analysis requirements

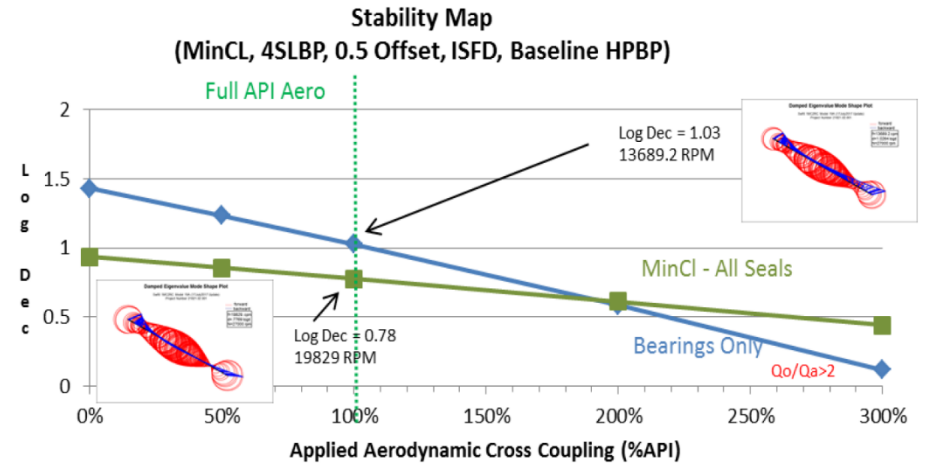
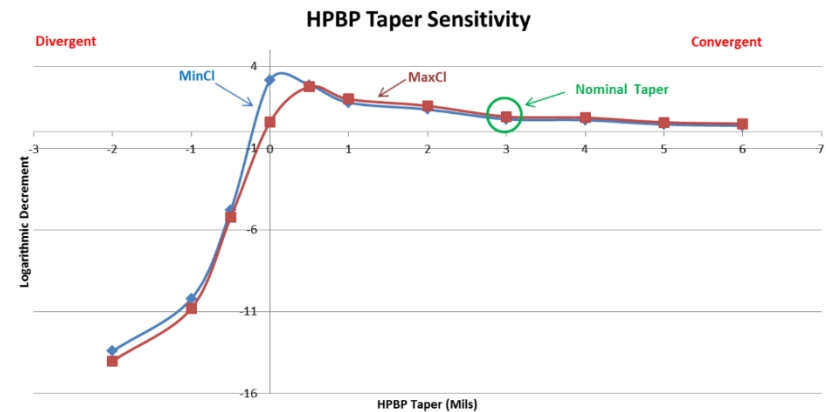
- Rotodynamic forces amplified by high density fluid
- Swirl brakes and damper seals
- Damper seal carrier design to minimize conin of the seal clearance

$$K_{xy} = \frac{C_{mr} \rho_{dis} U^2 L_{shr}}{Q / Q_{design}}$$

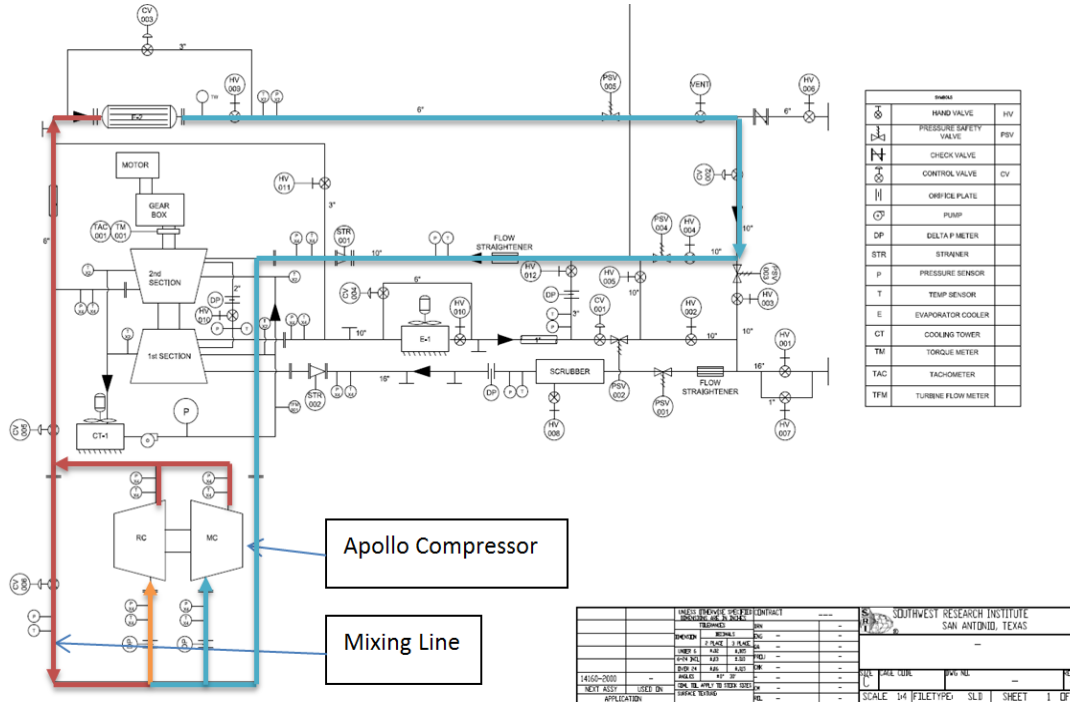
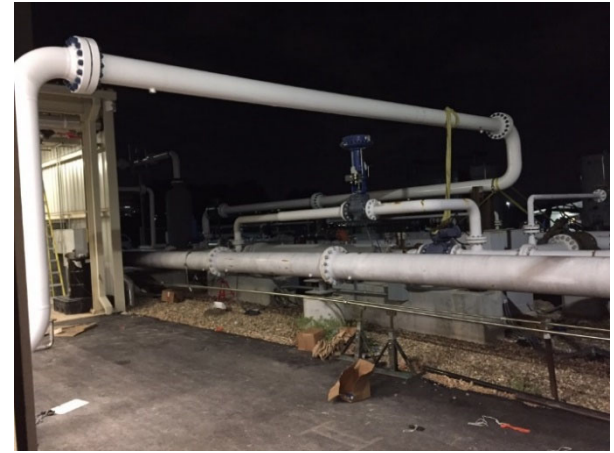
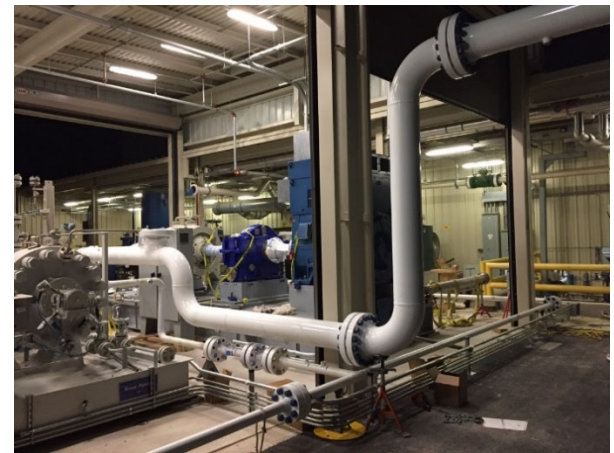
- Modified existing CO₂ loop
- Driven by 3 MW electric motor through two step-up gearboxes

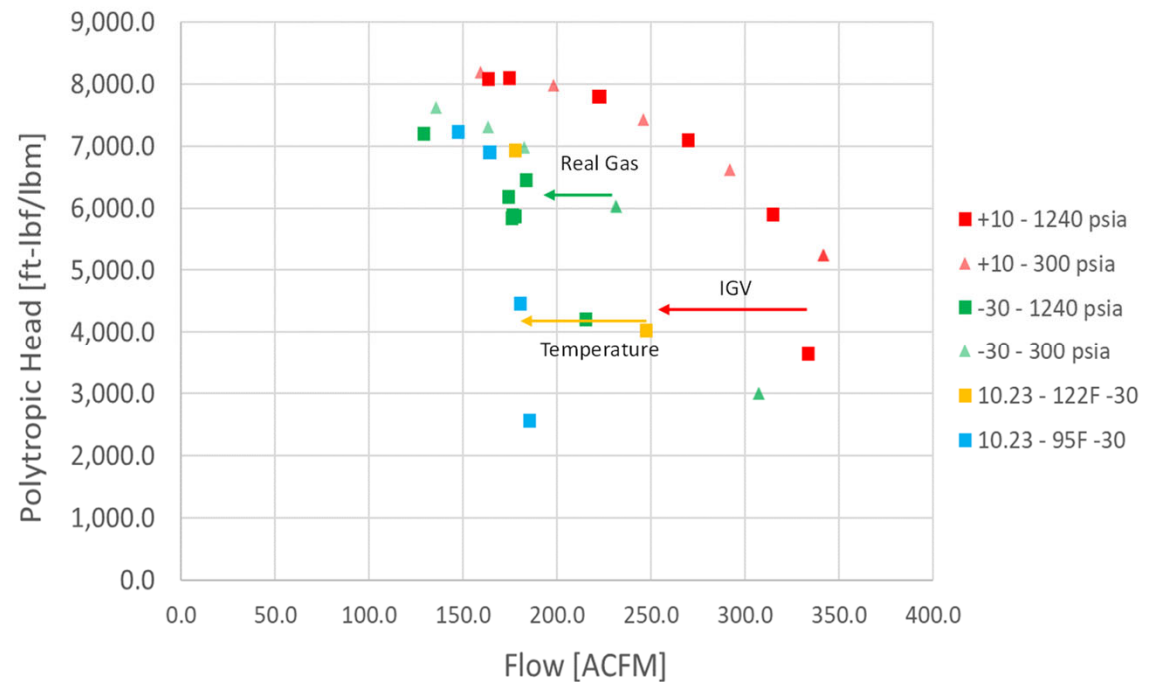
- After break-in, testing performed at medium and full pressure
 - 300 and 1240 psi suction pressure
 - +10° and -30° IGV setting angles
 - 95° and 122°F suction temperature
- Both speed of sound and IGV setting has strong effect on the flow capacity of the compressor

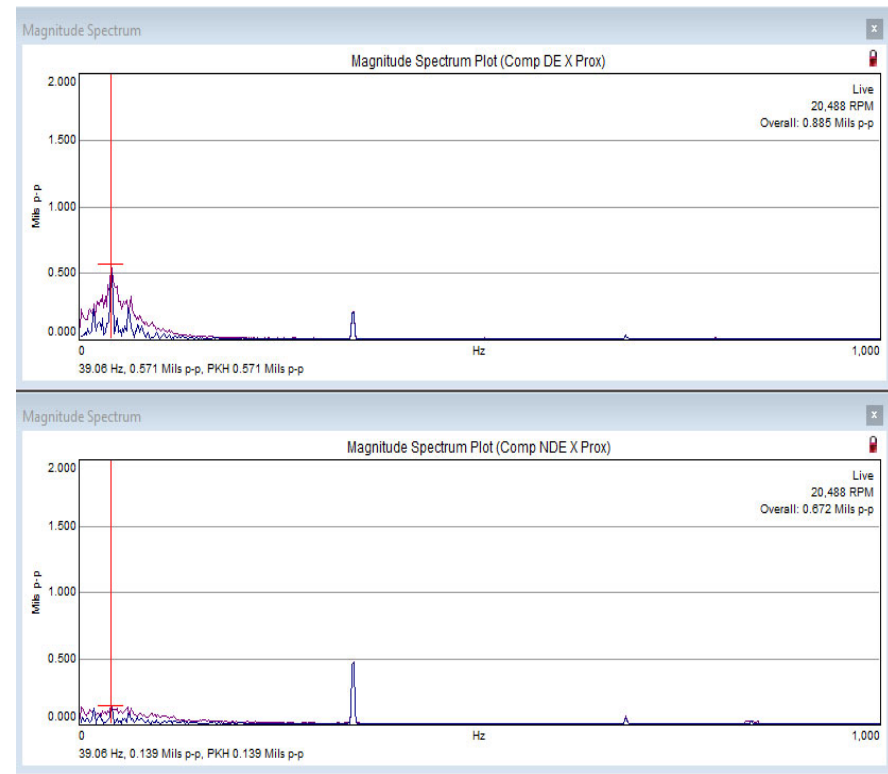
- Compare bearing vibrations at 2.0 MPa and full speed (27,000 rpm) and 8.5 MPa and lower speed (20,500 rpm)
- Around 8X increase in Sub Synchronous vibrations

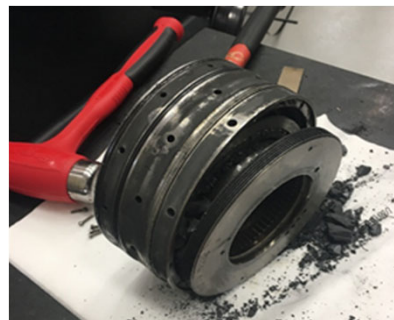
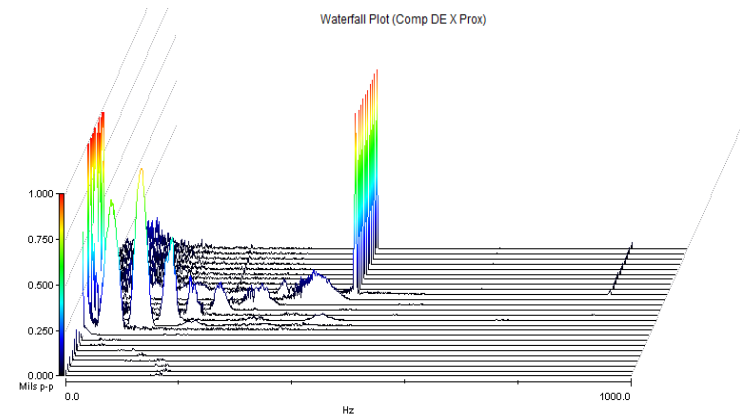
- A dry gas seal failure occurred at around 41.6°C (107°F) inlet temperature
- Temperature was changing slowly and is unlikely the cause of the seal failure
- A root cause failure investigation determined that a bad lot of seal material was obtained from the seal supplier for the silicon carbide seal ring
- A second set of seals for a different vendor was used for subsequent tests

- Dry gas seal failure was encountered which was attributed to a material defect in the seal ring
- The volute forces acting on the rotor had an influence on the vibration orbits but were able to be accommodated by the bearings

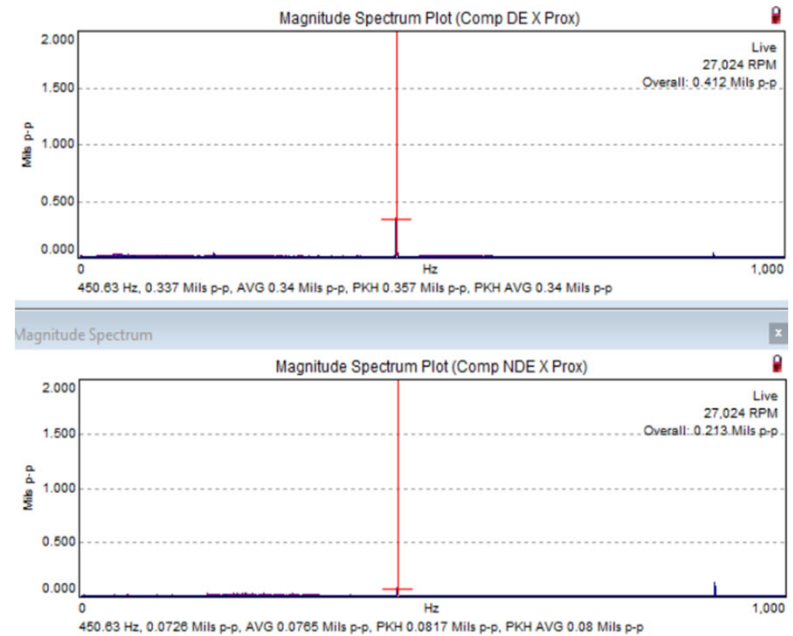
- Final test at full speed and pressure with -30° IGV shows even lower SSV
- P1=1,248 psi, P2=,3341 psi, 27,000 rpm
- discharge density is 710 kg/m³ (44.5 lbm/ft³), which is 71% of water
- Highest density compressor reported in literature

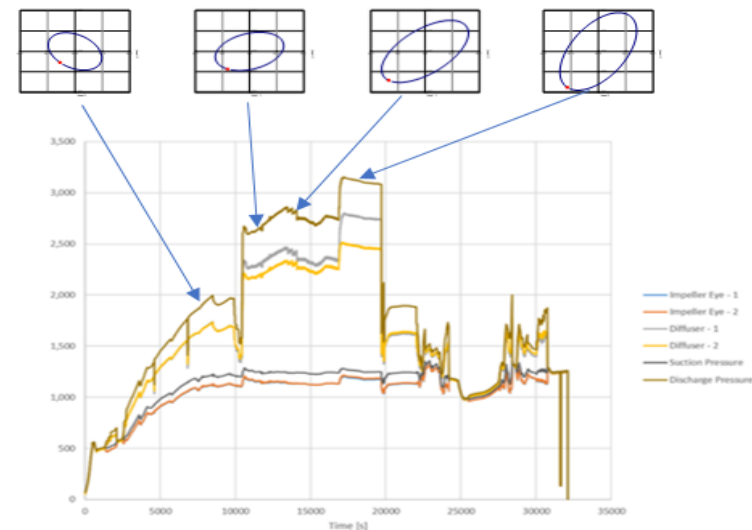
- Internal pressure measurements in the diffuser showed different pressures as compressor is throttled
- The vibration orbits showed a corresponding change in shape
- These are caused by non-uniform velocities in the volute resulting in a static pressure distribution and radial force reacted by the bearings.

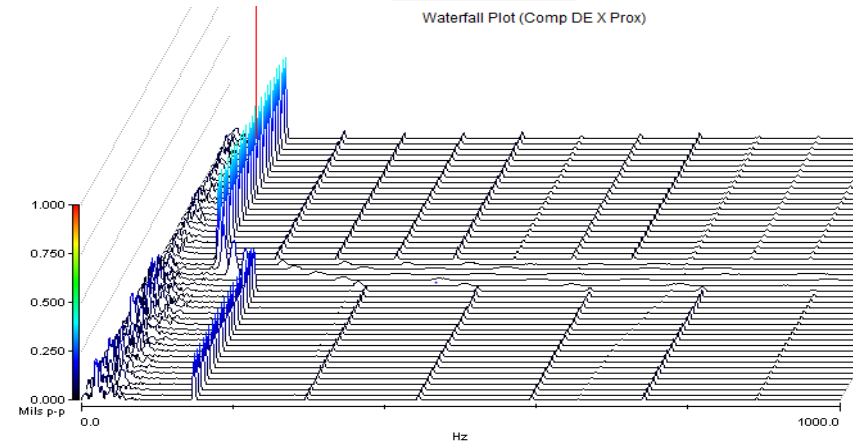
- Cold start was initiated where the loop had cooled to 27°C (80°F) and the pressure reduced to 68.6 bara (995 psia)
 - Below the critical pressure
 - Inlet conditions were multi-phase
- Compressor was started to 5,000 rpm and then increased to 9,000 rpm
 - Cooling water turned off to warm the loop and pressurize it without having to add mass
- Some subsynchronous vibration occurred but was well controlled
- Once pressure climbed to design point (83 bar, 1200 psi), the rotor was accelerated to full speed

Direction of Time

Point at which compressor was sped up to attempt full speed

- Cold start inside the liquid-vapor dome performed without any operational issues
- Full speed reached and tested at 350C and 8.5 MPa. Highest density compressor in operation - (618 kg/m³) steady state operation and peaked at 720 kg/m³ during off-design operating conditions
