EXPERIMENTAL TESTING OF A 1MW sCO₂ TURBOCOMPRESSOR

Logan Rapp
Sandia National Laboratories
Albuquerque, NM, USA

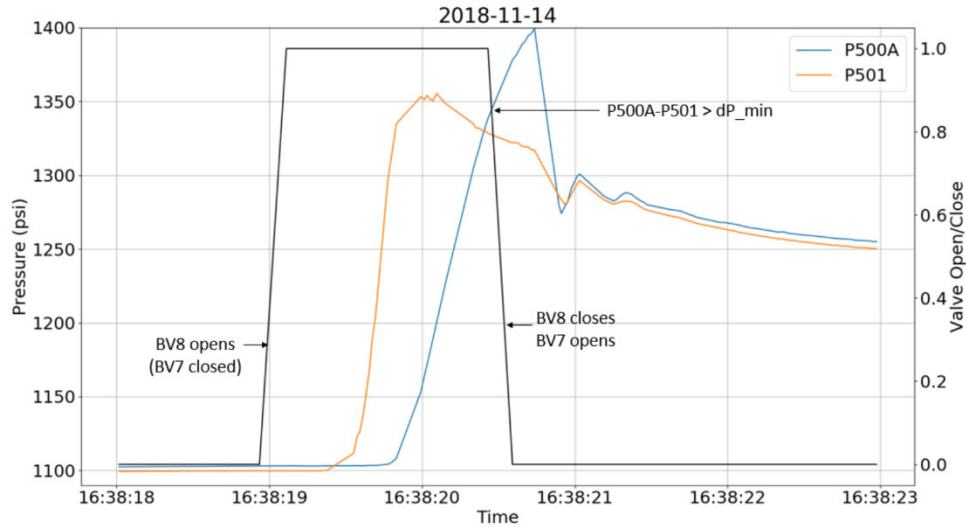
Figure 3: Blowdown start process - pressures and valve positions. Blowdown pressure = 1670 psi

As can be seen by comparing Figure 3 and Figure 4, the lower blowdown pressure reduced the pressure ramp rate of P501 from ~250psi to ~100psi. This decreases the severity of the blowdown event and reduces the possibilities that the radial foil or thrust bearings could be damaged during the blowdown process.

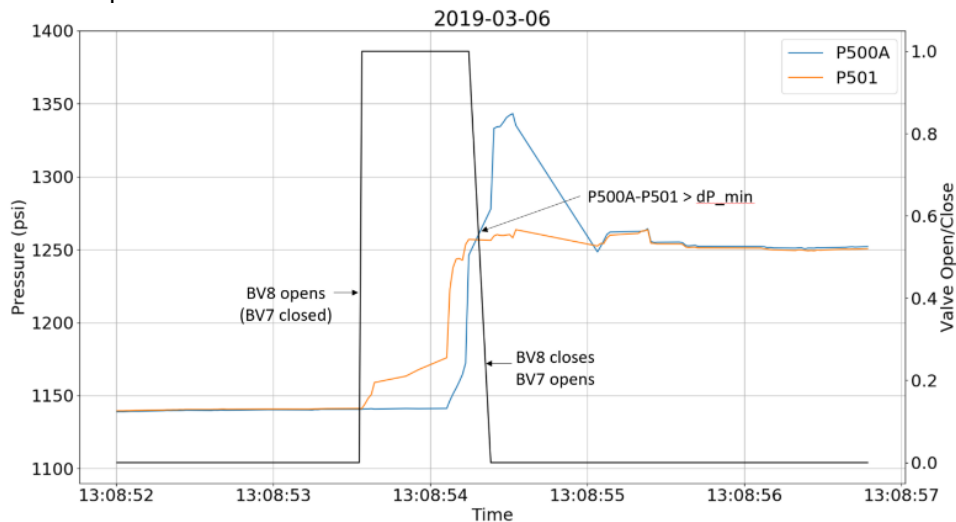
Figure 4: Blowdown start process - pressures and valve positions. Blowdown pressure = 1400 psi

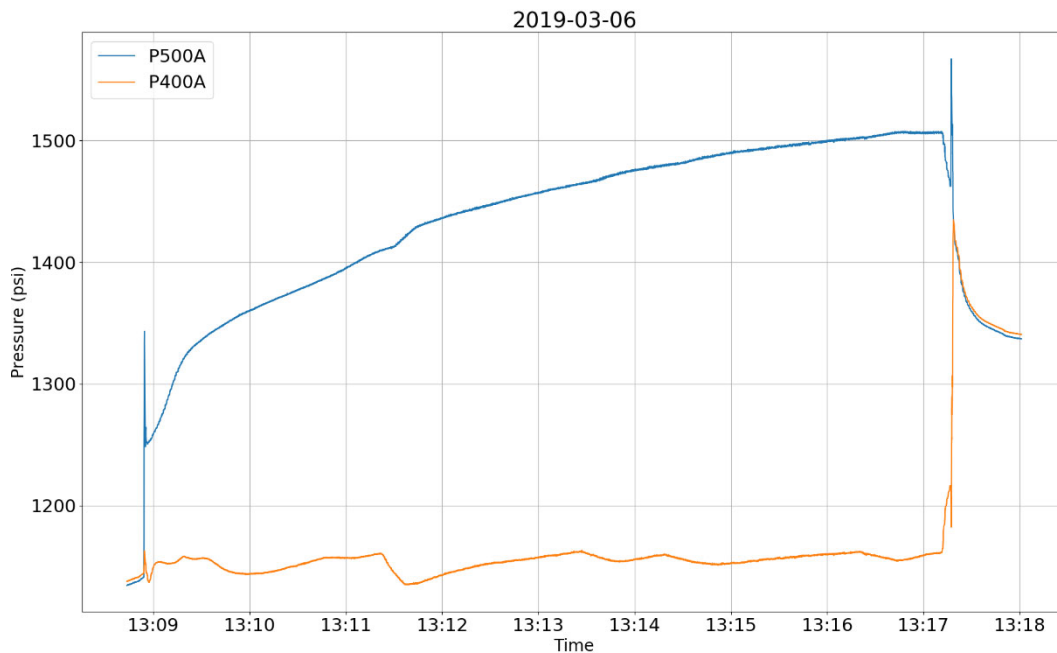
Figure 6: Compressor inlet and discharge pressure – thrust bearing issue resolved

As can be seen in Figure 6, there are no longer spikes in pressure due to a thrust bearing rub. Additionally, when the turbomachinery was disassembled after the test there was no indication of thrust bearing contact. In Figure 7, the horizontal lines indicate the minimum and maximum proximity before a rub occurs; that is, at 0.0095in and 0.0115in, a thrust bearing rub would be expected. The proximity sensor data shows there was very little axial movement during the test. The initial drop in distance was due to the blowdown start and the position quickly recovers to approximately 0.0101in. The other dramatic change in proximity is during shutdown. The method used to shut down in Test #5 was closing BV7 and BV6 at the same time. This causes the shaft to stop spinning abruptly and thus some axial movement is expected during this event. The proximity probe data, as well as the lack of physical evidence of thrust bearing wear, gives confidence that the thrust balance problem has been resolved. However, the turbine end radial bearing continued to fail at some point during each test until the bearing design was improved for Test #7.

By adjusting the back pressure on the turbine using the turbine control valve (TCV) as well as adjusting the setting for Valve F in the secondary flows, the thrust balance on the rotor can be equilibrated. Valve F is part of the secondary flow control system and regulates the venting pressure on the aft side of the thrust disk of the rotor. This serves as a balance piston in the design and permits real-time adjustment of rotor thrust within a certain range. The testing on 2018-11-14 was performed with Valve F completely closed, so for the next test, both TCV and Valve F were opened using prescribed settings from the updated secondary flow analysis. Additionally, a proximity probe was added to monitor the axial movement of the shaft during the test. This allowed the proximity to be monitored and valve adjustments to be made in real time should the axial position start to change during a test. The plot of compressor inlet and discharge pressure for Test #5 is shown in Figure 6 and the proximity data is shown in Figure 7.

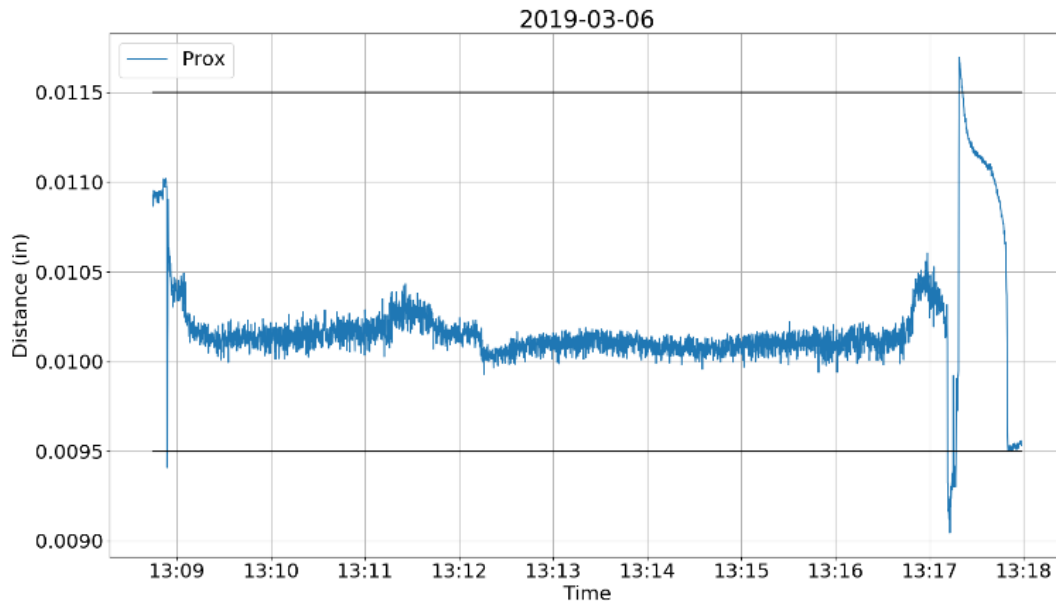
Figure 7: Proximity probe data for Test #5 showing axial position of the shaft with lines showing high and low proximity limits

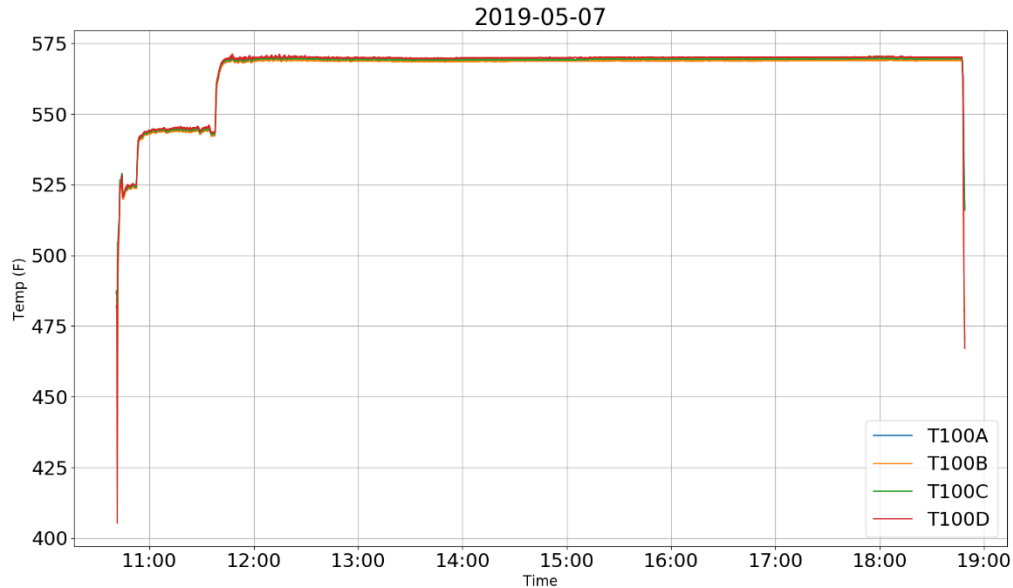
The next test of the turbocompressor demonstrated that the insertion depth of the RTDs was the issue and was resolved with the installation of new RTDs. Figure 14 shows the turbine inlet temperatures are in very good agreement with each other during Test #7.

Figure 14: Turbine inlet temperatures with new insertion depth

As can be seen in Figure 12, the T100A was not inserted into the flow at all. Figure 13 shows that the temperature discrepancy of T100A is no longer a problem. New RTDs were ordered and the existing T100A-D were replaced with closer detail paid to the insertion depth. Figure 13 shows the original and new insertion depths of T100A-D.

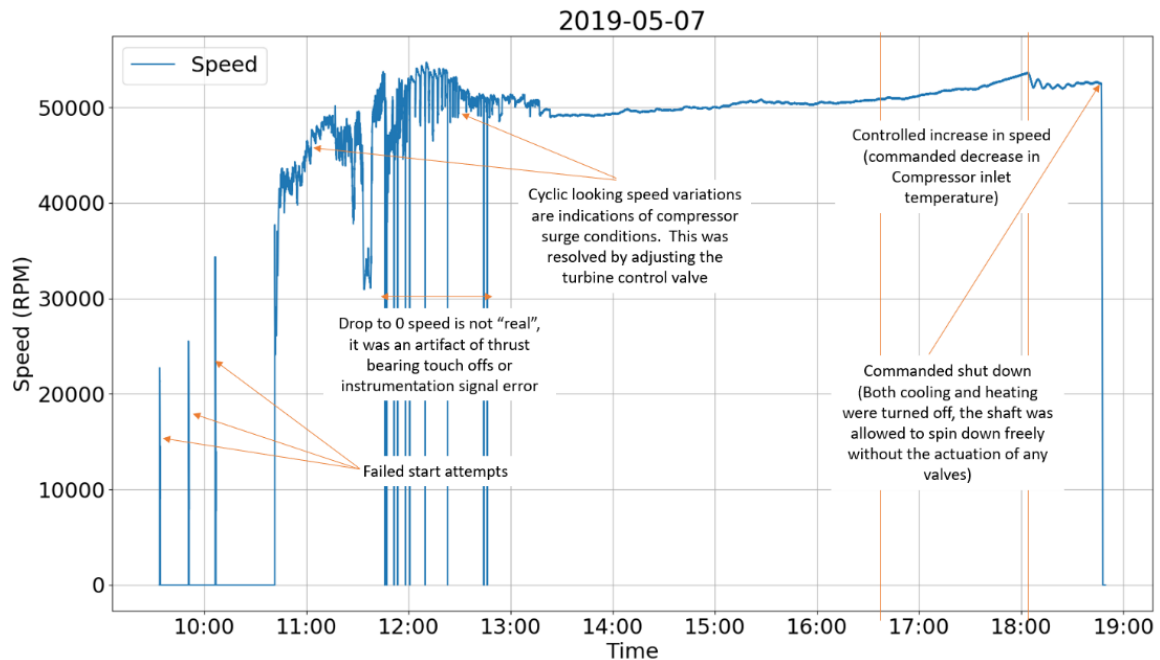
It is interesting to note the peak speed for each unsuccessful start attempt in Figure 15. It is clear that increasing the TIT and blowdown pressure impart more energy to the turbocompressor, but the conditions were not sufficient to achieve a successful start until the fourth attempt. It is believed that the stiffness and damping added by the new bearing increased the energy needed to start the turbocompressor. Further tests will explore the minimum TIT and blowdown pressure that is required for a successful start with the new aft radial bearing.

Figure 15 – Speed plot for Test #7
2019-05-07

It was decided to increase the length over diameter ratio of the aft radial bearing to increase the load capacity as well as the damping of the bearing. This resulted in the successful operation of the turbocompressor for 8 hours with a controlled shutdown. The speed vs time for Test #7 is shown in Figure 15 and the proximity data is shown in Figure 16. As can be seen in Figure 15, there were three unsuccessful start attempts before the turbocompressor was started successfully. The conditions for the attempted starts are shown in Table 3.

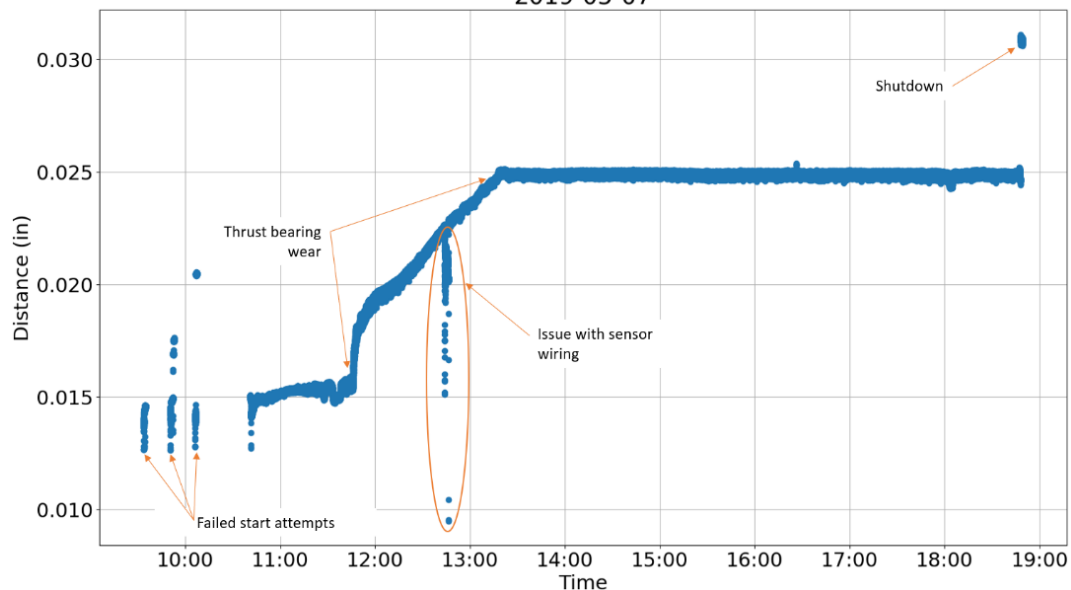
Figure 16 – Proximity probe plot for Test #7

After the successful start of the turbocompressor, it took some time to achieve steady state operation. As can be seen in Figure 16, there was very little axial movement for approximately the first hour of operation. However, during that time the operation was not steady state as the compressor was seeing surge conditions indicated by the fluctuations in speed in Figure 15. At approximately 11:45 the rotor began slowly moving in the aft direction and moved approximately 0.01 inches in the aft direction until it settled into an axial position of 0.025 inches. This movement was the result of a force unbalance and was corrected by adjusting the TCV and Valve F. The movement resulted in the wearing away of the thrust bearing which was evident in the post-test tear down of the turbocompressor. However, the ability of the thrust bearing to withstand wear and continue to perform acceptably is an impressive display of the robustness of the thrust bearing. In future testing, the valve positions will be adjusted more aggressively to attempt to arrest the movement of the shaft faster and prevent wear on the thrust bearing.
