Investigation of Weldment Cracking During Fabrication of a 700°C Fired sCO₂ Heater

John Shingledecker, Ph.D., FASM
Senior Technical Executive
Electric Power Research Institute
Charlotte, NC USA

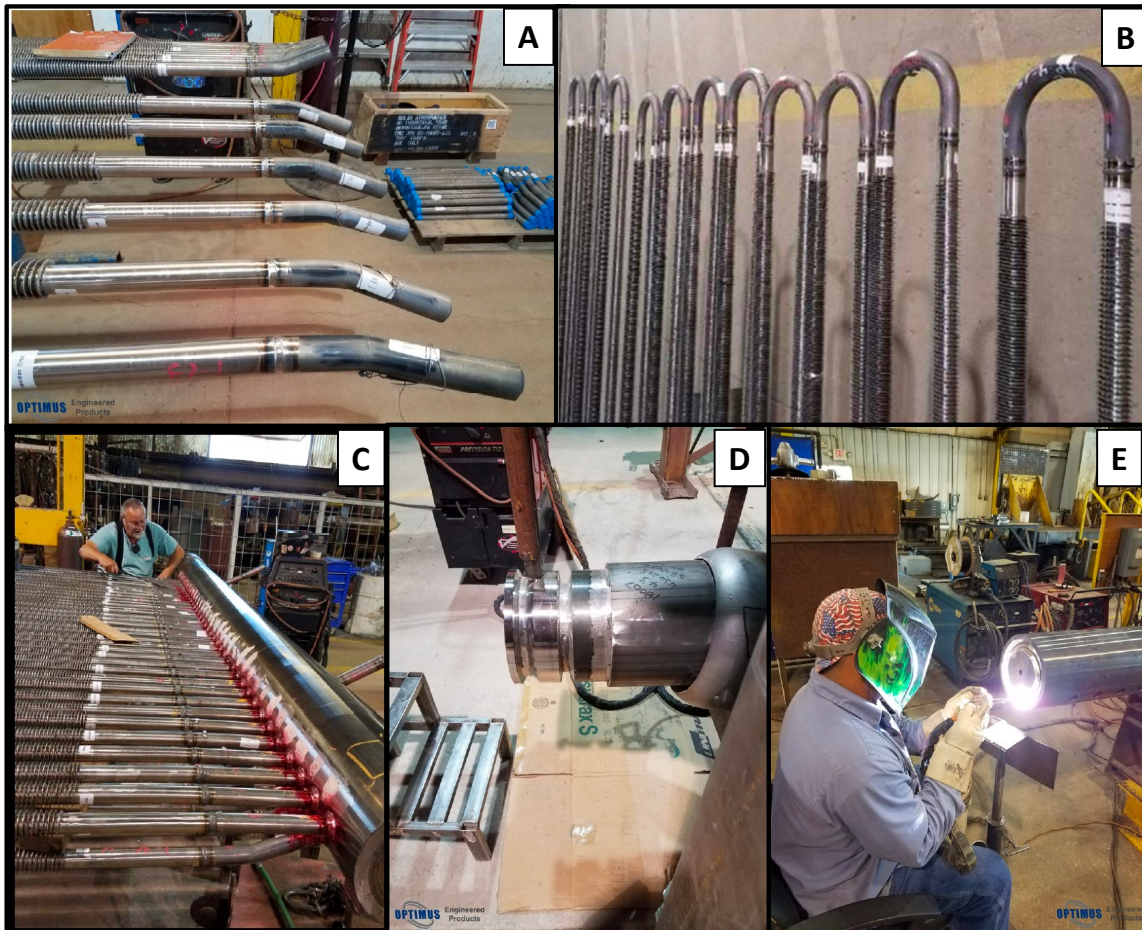
Figure 2. Types of 740H welds in STEP heater: tube-to-tube bend (a), fin butt welds tubes (b), tube-to-header welds (c), pipe-to-flange girth weld (d), and header end cap (e).

- The fabrication sequence and design of the heater appears to be a significant factor in the application of manual welding of 740H. As shown in Figure 2, all header end welds were made on a table with good welder access. Additionally, all other header welds (flange, tube-to-header, endcap) were made with favorable access and positioning. Conversely, as shown in Figure 3, the welds made on the return end of the coil were more difficult for the welders to execute with restricted positioning and very limited access (especially for the final closure welds). It was also noted that since the return end was welded last, as overall flexibility decreased in the coil, some of the tubes had to be 'jacked' into place for welding. The result was highly variable weld profiles with excessive re-enforcement (even if within code limits) on the return end leading to the introduction of stress concentrations where cracking initiated. Tube circumferential weld modeling suggests that in some thinner-wall tubes the highest axial stress is present at the ID even without a geometric concentration [12]. Examination of Table 3 clearly shows that the return end had a cracking incidence of 4.5% compared to only 1.5% in the

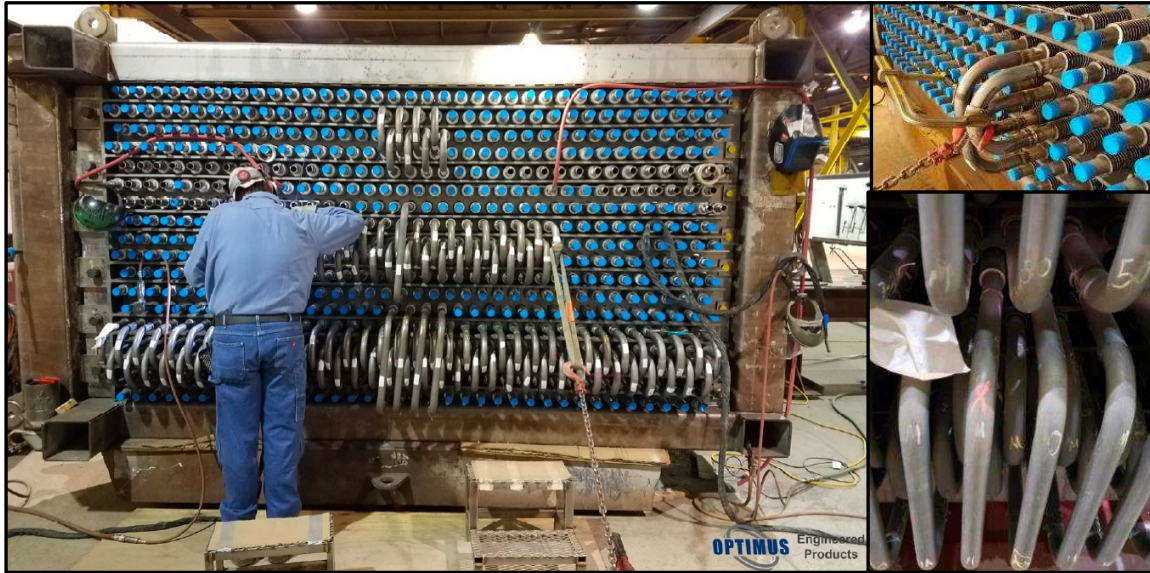
Figure 3. Final welding of the assembly on heater coil return end

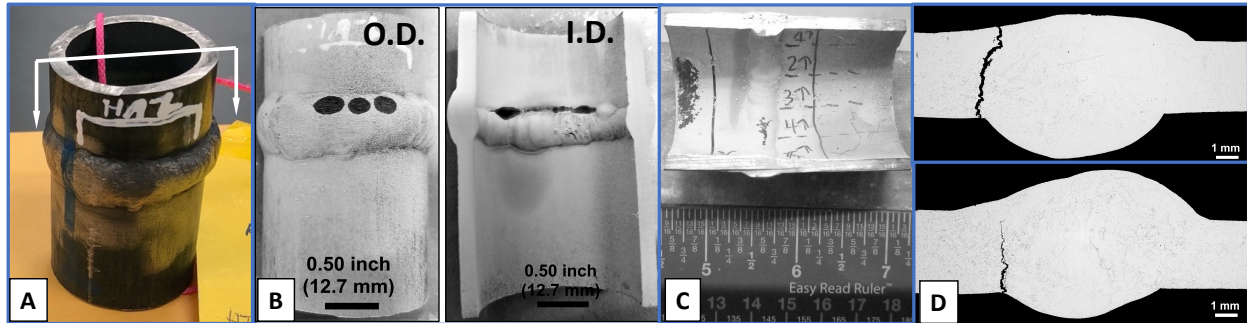
Figure 6. Tube failure investigation sectioning approach. (a) split tube lengthwise, (b) die penetrate inspection on OD and ID to identify extent of cracking, (c) removal around circumference of entire weld including areas with and without cracking, and (d) cross-sectional metallographic mounts.
